# Energy performance evaluation of a nearly Zero Energy Building and the reasons for the performance gap between expected and actual building operation

The studied building is a detached one-story, single-family house, located in Ry, in central Denmark. The building was constructed at the end of 2017 and is characterized as a nearly zero energy building, based on the Danish energy labeling standards [16].

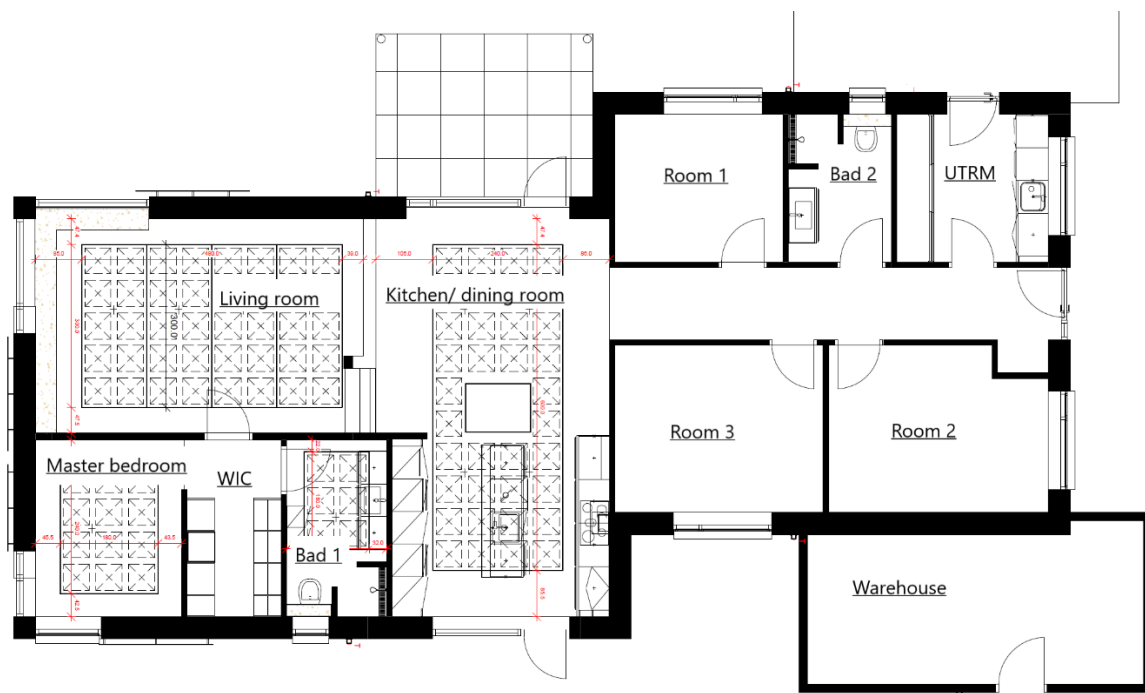
**Figure 1.** Floor plan of the study case.

The dwelling has a total floor area of 160 m<sup>2</sup>. It is constructed on two levels, with a height difference of 0.5 m. It includes 4 bedrooms, 2 bathrooms, 1 kitchen, 1 dining area, 1 living room, and a utility room. The kitchen, dining area and living room are connected to form an open space. There is also an unheated storage space attached to the building. There are windows towards all directions, while the openings in the South, East and West façades are equipped with sunscreens. Figure 1 shows the plan of the dwelling, while Figures 2 and 3 give an external view of the house.

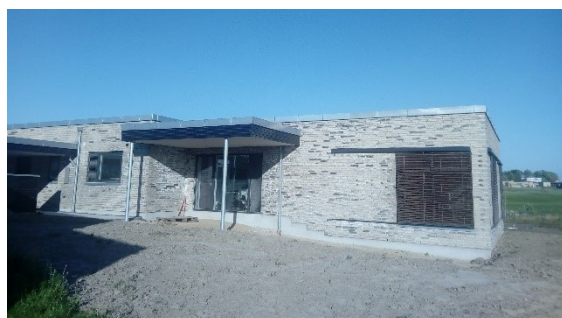
**Figure 2.** External northwest view.

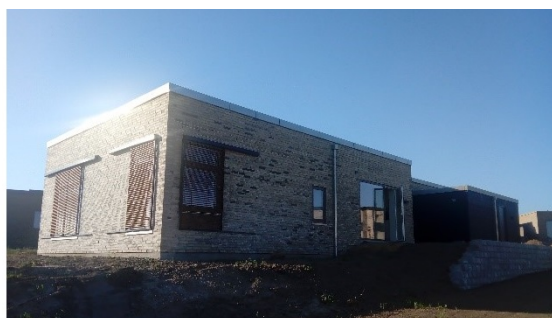
**Figure 3.** External south view.

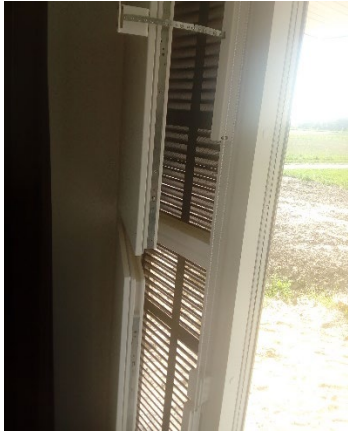
**Figure 4.** Ventilation louvers.

Natural ventilation and sun protection can be activated in order to create a pleasant indoor environment and minimize energy usage. Natural ventilation can be achieved through the skylights and a novel ventilation system with louvers incorporated in several windows in rooms with overheating risk. The external solar shadings are installed at the windows of the master bedroom and living room, with east, south and west orientations. In order to encourage the use of these systems, the solar shades are designed so that they allow good view to the outside, even when activated, while the ventilation louvers are providing theft and rain protection so that they can be used even when the dwelling is not occupied. In Figures 4 and 5 are shown the ventilation louvers and solar shades. At the end of November 2018, the natural ventilation and sun protection systems were connected to the control system, so that they can be

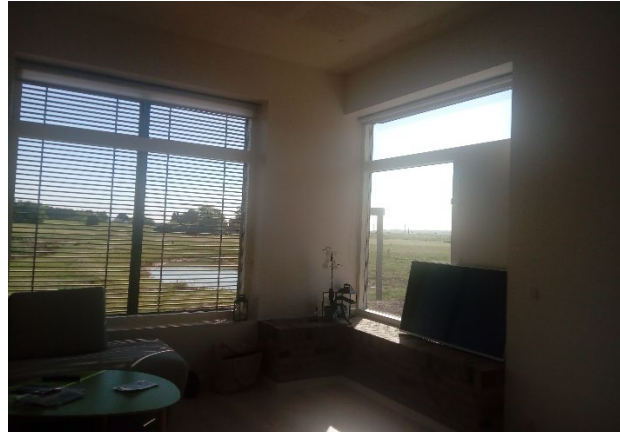
**Figure 5.** Solar shades and view to the outside.
