How Can a Cutting-Edge Gallium Nitride High-Electron-Mobility Transistor Encounter Catastrophic Failure Within the Acceptable Temperature Range?

Abstract—Commercial gallium nitride (GaN) high-electron-mobility transistors used for power electronics applications show superior performance compared to silicon (Si)-based transistors. Combined with an increased radiation hardening properties, they are key candidates for high-performance power systems in a harsh environment, such as space. However, for this purpose, it is key to know the potential failure mechanisms (FMs) of the devices in depth. Here, we demonstrate how the repeated thermomechanical stress in a power cycling (PC) test within specified operating conditions destroys the GaN device. Based on leakage current localization analysis, we identify an FM with a yet unknown root cause. Utilizing emission microscopy, focused ion beam cutting, and scanning electron microscope techniques, it is revealed that multilayer cracks of a GaN die are triggered by a commercial leading package structure, which shows excellent capability under frequent thermomechanical stress. Through multiphysics simulations, it is shown that the structural f

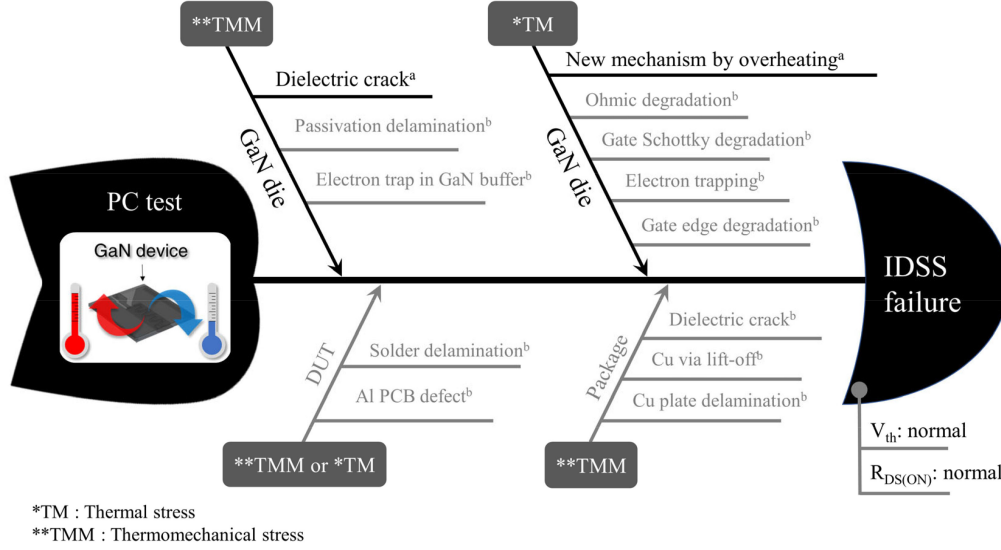
Fig. 1. Fishbone diagram for hypotheses to be able to induce the IDSS failure in a PC test classified by locations and stress conditions [21]: When IDSS failure was confirmed, threshold voltage (V_{th}), and the on-state resistance ($R_{DS(ON)}$) were in the normal range. These three parameters were characterized in the room temperature. (Words^a: remaining possible failure mechanisms to lead to the IDSS failure in the PC test, words^b: proven failure mechanisms that cannot be the cause of the IDSS failure in the PC test.)

Among various potential root causes, only a few candidates were identified to be consistent with observation [27]. The mechanisms are summarized in Fig. 1 and the analysis points to as if yet unclarified FM, the overheating, or dielectric crack. The previous study had not been able to pinpoint the cause of the failure because of test conditions beyond the allowed maximum operating temperature range 150 °C and limit of analysis technique to be able to analyze deep defect location inside a complex package [28]. To find the root cause of this failure, we have here tried to conduct an additional PC test within acceptable temperature ranges and high-level analysis techniques that can visualize deep cracks inside the package without destruction.

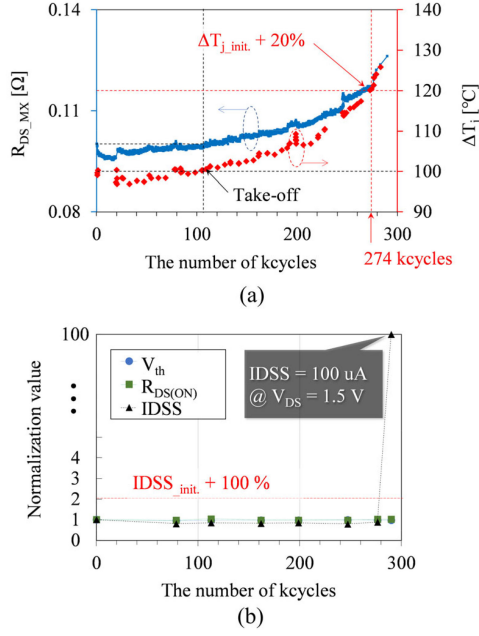
Fig. 2. Power cycling test results with $\Delta T_{meas} = 24.1 \sim 124.1 \text{ }^{\circ}\text{C}$. (a) Online parameters monitored during the PC test: R_{DS_MX} and ΔT_{meas} . Confirmed failure mode is the initial $T_{meas} + 20\%$. (b) Normalized offline parameters characterized in a curve tracer at the room temperature: V_{th} , $R_{DS(ON)}$, and $IDSS$. The failure criteria to determine the failure of the Device Under Test (DUT) are summarized in Fig. S3. The initial values of V_{th} , $R_{DS(ON)}$, and $IDSS$ are 1.3 V, 44.8 m Ω , and 0.77 μA . Offline parameter curves and parameter definition conditions are displayed in Fig. S4.

In the result, two failure phenomena are observed; thermal conductivity degradation and IDSS failure. Fig. 2(a) and (b) exhibits two online parameters (R_{DS_MX} and ΔT_{meas}) monitored in a PC circuit and offline parameters (V_{th} , $R_{DS(ON)}$, and IDSS) measured by a curve tracer at the room temperature, respectively. The details of the measurement are elaborated in Fig. S2. The first failure phenomenon can be explained by the ΔT_{meas} and R_{DS_MX} increase after the take-off point in Fig. 2(a) and no change of $R_{DS(ON)}$ in Fig. 2(b) [25], [26] at the end of test. In line with previous studies, the cause of this failure is the solder joint fatigue. Fig. 3(b) and (c) shows the solder joint images confirmed by scanning acoustic microscope (Model: KSI V-8 from IP Holding). In a comparison of them, it can be seen there is solder delamination underneath TPAD where the most heat is concentrated during the test. It is worth noticing, that the temperature swings employed are well within the acceptable operating conditions but still, the leakage current failure develops, which corroborates that the overheating scenario in Fig. 1 cannot explain the IDSS failure. Thus, the remaining dielectric crack hypothesis in Fig. 1 will be investigated extensively with additional structural FA.

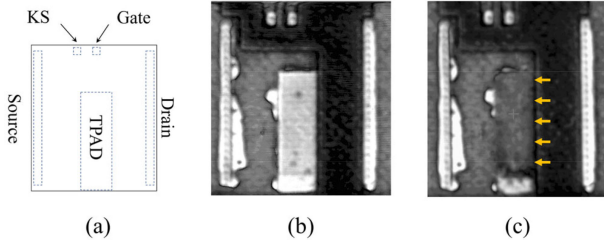
Fig. 3. SAM analysis result. (a) Footprints of a discrete GaN device: drain, source, gate, kelvin source, and thermal pad. (b) SAM image of a solder layer between a GaN device and Al PCB before PC test. (c) SAM image of the solder layer after PC test. Arrows point to the delamination area. Accurate structure information of a DUT is exhibited with a cross-sectional image in Fig. S5.

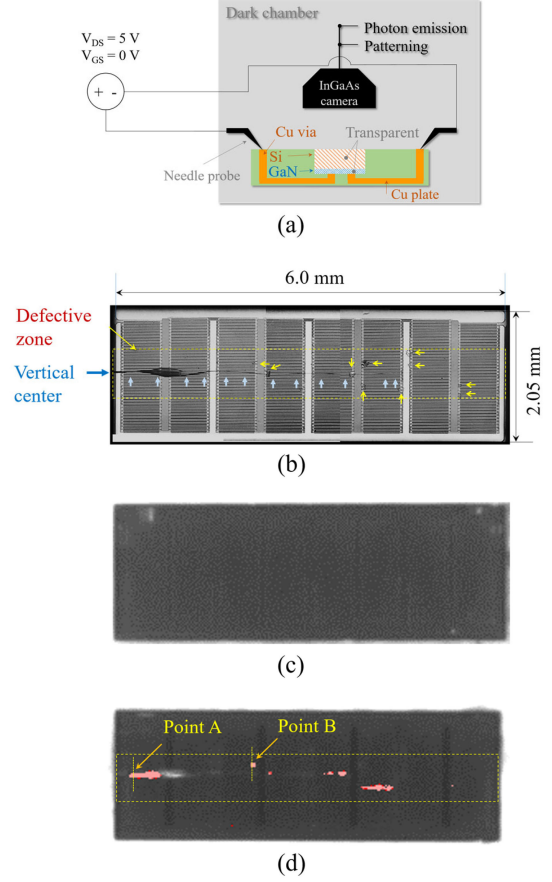
Fig. 4. Defect localization analysis. (a) Backside EMMI analysis environment with partially decapsulated GaN device. Three probe needles (gate, source, and drain) are used for electrical connection between the sample and measurement equipment. The analysis is conducted with an InGaAs camera in a dark chamber. (b) Patterning image of the failure GaN device in backside EMMI analysis with a die size, a long horizontal defect marked by blue arrows (\uparrow), and dot-like defects marked by yellow arrows (\uparrow). (c) Photon emission analysis of a normal GaN device without PC test under $V_{DS} = 5 \text{ V}$, and $V_{GS} = 0 \text{ V}$. (d) Photon emission analysis with two cross-sectional points of the failure GaN device by the PC test under $V_{DS} = 5 \text{ V}$, $V_{GS} = 0 \text{ V}$. $IDSS$ curves of both Fig. 4(c) and (d) are displayed in Fig. S7.

Fig. 4(b) shows a patterning image of the defective device analyzed in the backside EMMI. The various abnormal patterns suspected as defects are observed in this image. The abnormal patterns are classified into two types. The first conspicuous defective pattern is a long horizontal crack marked with blue arrows in Fig. 4(b). This crack at the vertical center of the GaN die is continued from the center of the die to left edge. Moreover, several of dot-like defect patterns marked with yellow arrows on Fig. 4(b) are observed around the horizontal crack. They are also placed in around the vertical center of the die. All defects

found in the patterning process are placed in the defective zone marked in Fig. 4(b). They might be directly related to the IDSS failure. The results will be argued with photon emission analysis conducted under IDSS measurement conditions.

Fig. 4(b) visualizes the defective positions directly contributing to the IDSS failure. Generally, the photon emission may occur even in normal operation so that the analysis of the defective device should be compared to a normal device without a PC test. Fig. 4(c) and (d) shows the photon emission images of the normal and the defective devices, respectively. In Fig. 4(c), there is no photon emission and $\text{IDSS} = 0.45 \text{ nA}$ at $V_{\text{DS}} = 5 \text{ V}$, whereas in Fig. 4(d) (the defective device), certain photon emission and $\text{IDSS} = 0.122 \text{ mA}$ were observed. Moreover, it is shown that the lighting positions are matched with the abnormal cracks in the patterning image [Fig. 4(b)]. The overlapping positions of the crack patterns and photon emission in these two images inform where the direct cause of the IDSS failure is. Cross-section analysis will then be performed at in Points A and B marked in Fig. 4(d) to understand the mechanism of IDSS failure in the following sections.

The locations of cracks found in the previous FA can be discussed with the FEM simulation. We can divide the cracks found in Fig. 4(b) into two groups: the long crack propagated from the center of the chip to the left edge and dot-type cracks scattered around the center. For the long crack, first we can inversely predict there was a strong vertical mechanical stress in the PC test. Fig. 7(a) shows the distribution of temperature swings at the die top surface height during PC. The different temperature distribution by the area of a homogeneous body can generate mechanical stress [45]. In Fig. 7(a), the center of the die has the highest temperature swing, while the upper left end has the lowest temperature swing. This imbalance can produce the overall thermomechanical stress of the die during the PC test. The Cu vias are not symmetrical at the left and right edges of the die in Fig. 7(b), which leads to a temperature imbalance between the upper and bottom at the edges of both sides. This imbalance induces stress on the surface of the die, which can lead to defects such as the first long crack.

The second crack group dot type defects in Fig. 4(b) can be analyzed by combining the EMMI patterning image [Fig. 4(b)],

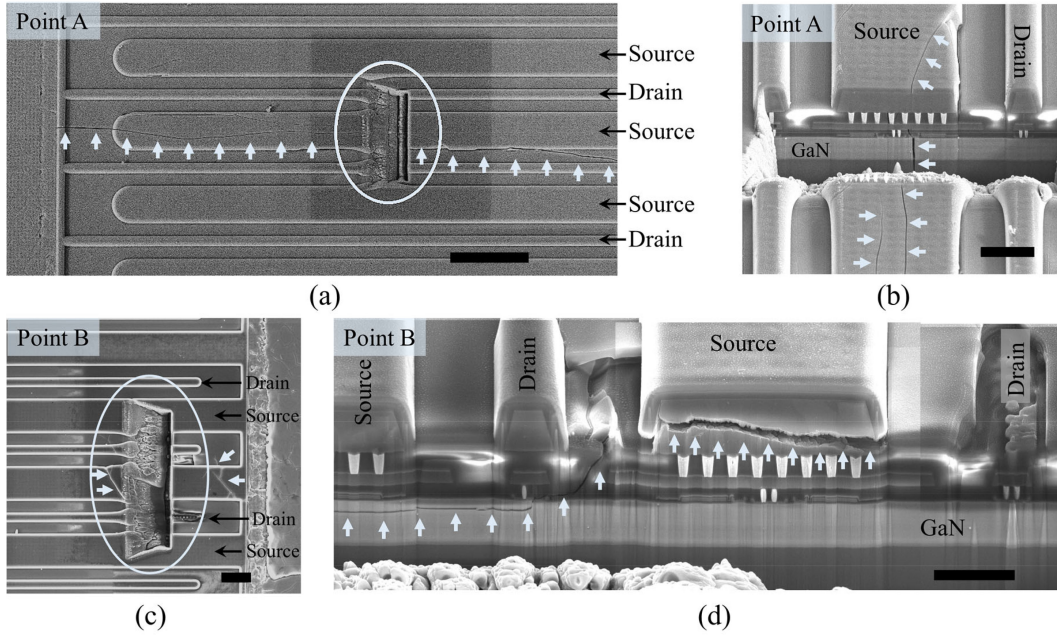
Fig. 5. Cross-sectional analysis results. (a) Top view with the FIB cutting of Point A (the cracks marked with blue arrows). (b) Cross-section image of Point A (the cracks marked with blue arrows). (c) Top view with the FIB cutting of Point B (the cracks marked with blue arrows). (d) Cross-section image of Point B (the cracks marked with blue arrows). Black scale bars: (a) 50 μm ; (b) 10 μm ; (c) 20 μm ; (d) 8 μm .

In the results of the cross-sectional analysis, defects relevant to the IDSS failure had been found in both selected points. Fig. 5(a) and (b) displays a top view image and a cross-sectional image around FIB-cut Point A, respectively. The horizontal long crack observed in Fig. 4(b) is also seen in Fig. 5(a). In Fig. 5(b), we can identify the vertical crack extended from a GaN HEMT core structure to multiple dielectric layers. Fig. 5(c) and (d) shows a top view image and a cross-sectional image at FIB-cut Point B, respectively. This location was a dot-like pattern observed in the EMMI patterning image [Fig. 4(b)]. In Fig. 5(d), we can see also the severe cracks horizontally extended from multiple metallization layers to a GaN HEMT structure. Even though the propagation direction of the Point B crack is horizontal in the cross-section image unlike the crack in Point A, both cracks are directly crossing from drain to source of GaN HEMTs. These severe cracks can be a critical leakage path in IDSS measuring.

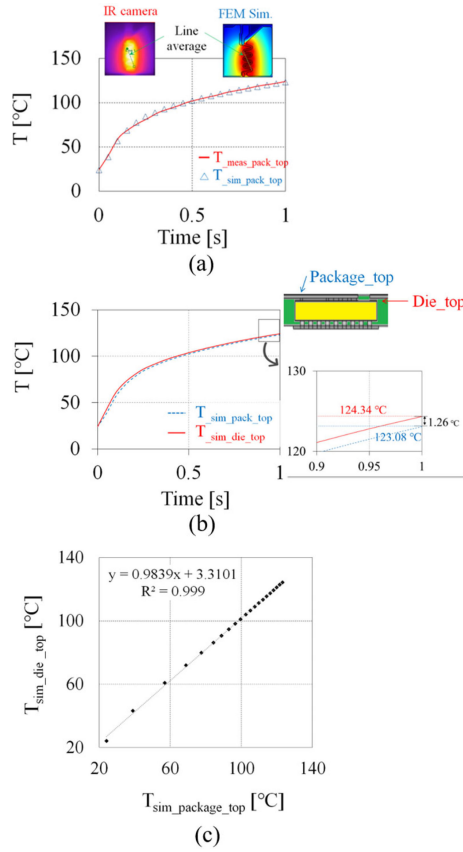
Fig. 6. Temperature analysis in a PC test based on FEM simulation (COMSOL Multiphysics software). (a) Line temperature average curve during 1 s heating period between IR camera measurement of the DUT and FEM simulation on the top surface of the package. (b) Temperature profile comparison in FEM simulation between package top surface and die top surface. (c) Correlation of temperatures between on the package top surface and on the package top surface. The temperatures mentioned Fig. 6(a) and (b) are equally defined as the average value of a line across the upper left to lower right of the die on the top surface of the package, which is the same as the way to monitor device temperature in the PC test [26, 27]. The lines for temperature measurement are shown in Fig. 6(a).

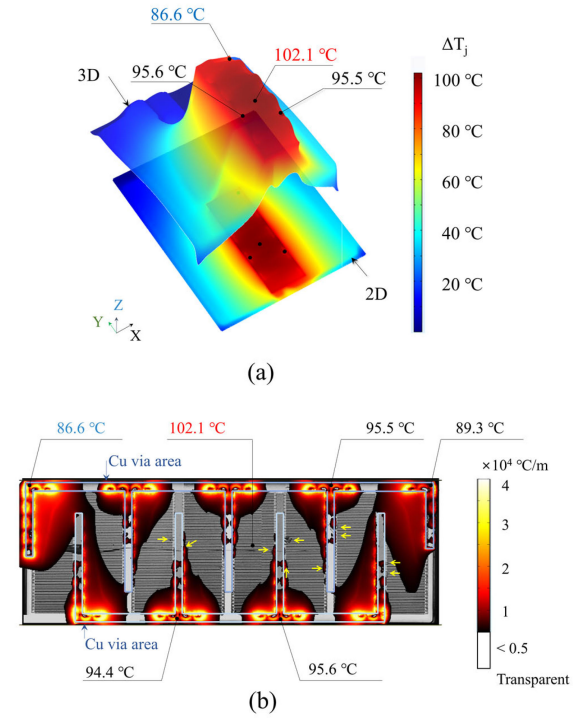
Fig. 7. FEM simulation analysis with defective patterns in the EMMI analysis. (a) 2-D and 3-D $\Delta T_{\text{die_sim}}$ distribution of the entire GaN device at the height of die top surface in FEM simulation during the PC. (b) Overlap image among the EMMI patterning image [Fig. 4(b)], Cu via areas directly bonded to the die, $T_{\text{die_sim}}$ at 1 s in six points and $T_{\text{die_sim}}$ gradient (°C/m) plot in the die top surface area.
