How Can a Cutting-Edge Gallium Nitride High-Electron-Mobility Transistor Encounter Catastrophic Failure Within the Acceptable Temperature Range?

Abstract—Commercial gallium nitride (GaN) high-electron-mobility transistors used for power electronics applications show superior performance compared to silicon (Si)-based transistors. Combined with an increased radiation hardening properties, they are key candidates for high-performance power systems in a harsh environment, such as space. However, for this purpose, it is key to know the potential failure mechanisms (FMs) of the devices in depth. Here, we demonstrate how the repeated thermomechanical stress in a power cycling (PC) test within specified operating conditions destroys the GaN device. Based on leakage current localization analysis, we identify an FM with a yet unknown root cause. Utilizing emission microscopy, focused ion beam cutting, and scanning electron microscope techniques, it is revealed that multilayer cracks of a GaN die are triggered by a commercial leading package structure, which shows excellent capability under frequent thermomechanical stress. Through multiphysics simulations, it is shown that the structural f

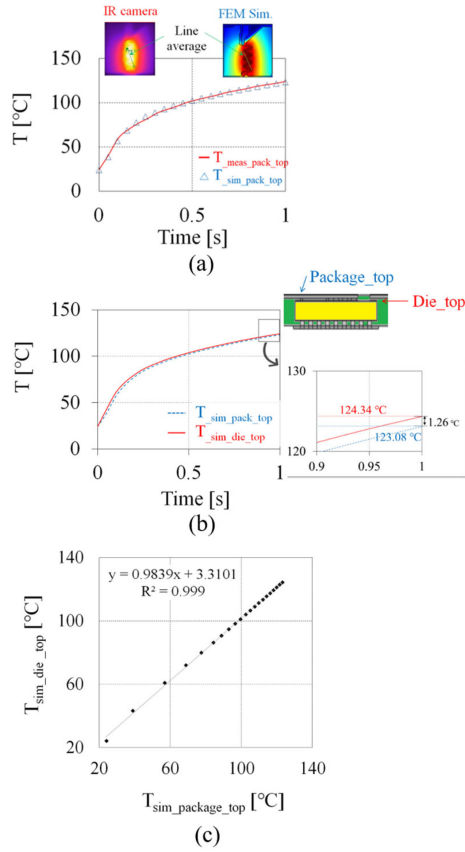
Fig. 6. Temperature analysis in a PC test based on FEM simulation (COMSOL Multiphysics software). (a) Line temperature average curve during 1 s heating period between IR camera measurement of the DUT and FEM simulation on the top surface of the package. (b) Temperature profile comparison in FEM simulation between package top surface and die top surface. (c) Correlation of temperatures between on the package top surface and on the package top surface. The temperatures mentioned Fig. 6(a) and (b) are equally defined as the average value of a line across the upper left to lower right of the die on the top surface of the package, which is the same as the way to monitor device temperature in the PC test [26, 27]. The lines for temperature measurement are shown in Fig. 6(a).

It is critical in simulation to find the heat flux condition that accurately reflects the experimental environment. For this, we first measured the temperature of the device at specific power consumption in a PC test environment and then derived heat boundary condition satisfying the temperatures corresponding to the power consumption conditions in the simulation. In the PC test environment, two temperatures 23.8°C and 25.8°C were measured under the two static power dissipation levels of 1.099 and 1.653 W, respectively. Through the FEM simulations, the heat flux condition $1.55 \times 10^4\ \text{W}/(\text{m}^2\cdot^\circ\text{C})$ satisfying the two results measure earlier had been extracted. The condition can be reverified in transient temperature comparison between the simulation and the real PC test. Fig. 6(a) displays the temperature ($T_{\text{maes_pack_top}}$) measured on the package top surface in the test and the temperature ($T_{\text{sim_pack_top}}$) on the package top surface in the simulation. As can be seen they have a very good quantitative agreement between both temperature curves in Fig. 6(a). Moreover, we compared the thermal spatial spreading in the simulation to the real PC test during a single PC recorded as a movie using a thermal camera monitoring the device surface this is supplied as supplementary video. In this comparison, the model parameter fitted was the heat boundary condition based on the simpler steady-state conditions, while we were able to confirm that this simulation is very close to the actual test result in terms of dynamic predictions. The proposed simulation, therefore, is confirmed to be very close to the real operation not only in constant condition but also in a transient condition, which ensure the credibility of this simulation.

Besides, this good agreement also proves that the simplified model proposed previously is acceptable. In the simplified die model, the interconnection layers and AlGaIn barriers between the junction and die top surface were ignored. If their thermal resistivity is significant, it can generate a meaningful difference between the measured temperature and the FEM simulation results. We cannot see any significant difference between them. And the conservatively calculated temperature difference between the junction and the die top was 0.13°C . The die model, hence, can be simplified excluding the interconnection layer and AlGaIn layer in the FEM simulation, and the die top temperature reflects the junction temperature very closely.

The measured temperature is the most direct stress parameter that we can monitor during the PC test. For this reason, the smaller the difference between this temperature and the actual junction temperature, the better. In the device using a no wire bond package, the difference between the junction temperature and the temperature measured by an IR camera has not been addressed for transient conditions in previous literature. Fig. 6(b) shows a difference of temperature on the top surface of between $T_{\text{sim_pack_top}}$ and on the die ($T_{\text{sim_die_top}}$) in the FEM simulation during a heating period 1 s of the PC test. Both temperatures were also defined as the average value of the line at the same position shown in Fig. 6(a). The change trends of them are very similar to each other, and the maximum temperature difference at the end of the period is only 1.26 °C. $T_{\text{sim_die_top}}$ represents the junction temperature in the simulation. Fig. 6(c) exhibits a strong correlation of both temperatures in the simulation. We can understand the temperature measured on a package top surface accurately reflects the junction temperature with a slight minus offset, indirectly through the simulation.

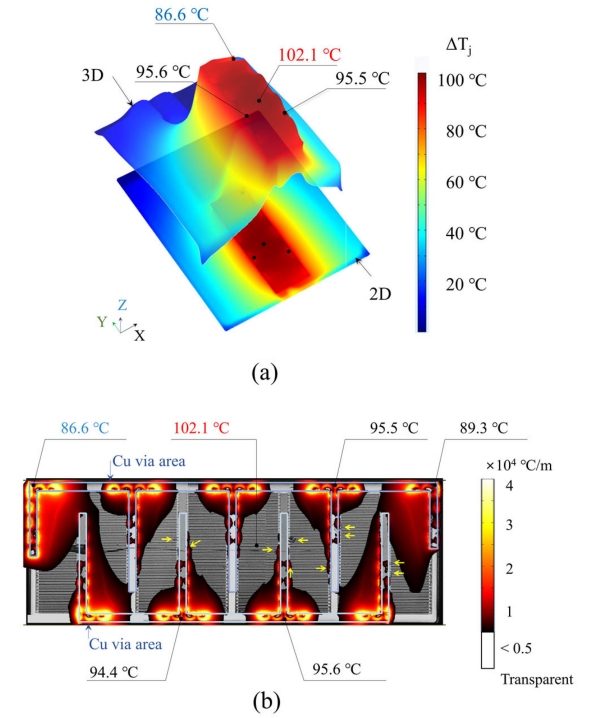
Fig. 7. FEM simulation analysis with defective patterns in the EMMI analysis. (a) 2-D and 3-D $\Delta T_{\text{die_sim}}$ distribution of the entire GaN device at the height of die top surface in FEM simulation during the PC. (b) Overlap image among the EMMI patterning image [Fig. 4(b)], Cu via areas directly bonded to the die, $T_{\text{die_sim}}$ at 1 s in six points and $T_{\text{die_sim}}$ gradient (°C/m) plot in the die top surface area.

the knowledge of the Cu via design inside the package directly bonded to the die, and the temperature gradient of the die ($T_{\text{die_sim_grad}}$) extracted from the FEM simulation at the highest point during a PC. Fig. 7(b) exhibits an overlap image of these three items. $T_{\text{die_sim_grad}}$ is expressed as (1).

When referring to Figs. S9 and S10, it is seen that the temperature gradient on the die top surface is significantly influenced by the Cu structure inside the package. Particularly, $T_{\text{die_sim_grad}}$ is relatively high along the Cu vias in the center of the die surface. There might be a larger temperature gradient around the boundary between them because Cu has much better heat transfer capability than FR4 which is filling most of the package [38]. In Fig. 7(b), the cracks pointed by the yellow arrows are located mainly near the Cu vias within the center area of the die. In this area, it is expected that severe mechanical stress is generated by CTE differences among the materials (Cu, FR4, a GaN die) at these interfaces as well as the larger temperature gradient. Thus, it is revealed that the dot-type defects also correlate with the Cu vias design in the package.

In the FEM simulation, we investigated the FM of the cutting edge GaN under PC test more deeply following the previous physical FA. The simulation model, created by structure analysis of the GaN device, very close to the actual PC test environment was presented. In the simulation, it was indirectly predicted that the junction temperature of the GaN device has around only 1% difference compared to the temperature on the active surface monitored by an IR camera. Based upon FEM simulation, backside EMMI analysis, and structure analysis results, we discussed that multilayered cracks causing the IDSS failure in PC test greatly correlate to a design factor: the up-down asymmetry Cu vias layout of the advanced package.
