How Can a Cutting-Edge Gallium Nitride High-Electron-Mobility Transistor Encounter Catastrophic Failure Within the Acceptable Temperature Range?

Abstract—Commercial gallium nitride (GaN) high-electron-mobility transistors used for power electronics applications show superior performance compared to silicon (Si)-based transistors. Combined with an increased radiation hardening properties, they are key candidates for high-performance power systems in a harsh environment, such as space. However, for this purpose, it is key to know the potential failure mechanisms (FMs) of the devices in depth. Here, we demonstrate how the repeated thermomechanical stress in a power cycling (PC) test within specified operating conditions destroys the GaN device. Based on leakage current localization analysis, we identify an FM with a yet unknown root cause. Utilizing emission microscopy, focused ion beam cutting, and scanning electron microscope techniques, it is revealed that multilayer cracks of a GaN die are triggered by a commercial leading package structure, which shows excellent capability under frequent thermomechanical stress. Through multiphysics simulations, it is shown that the structural f

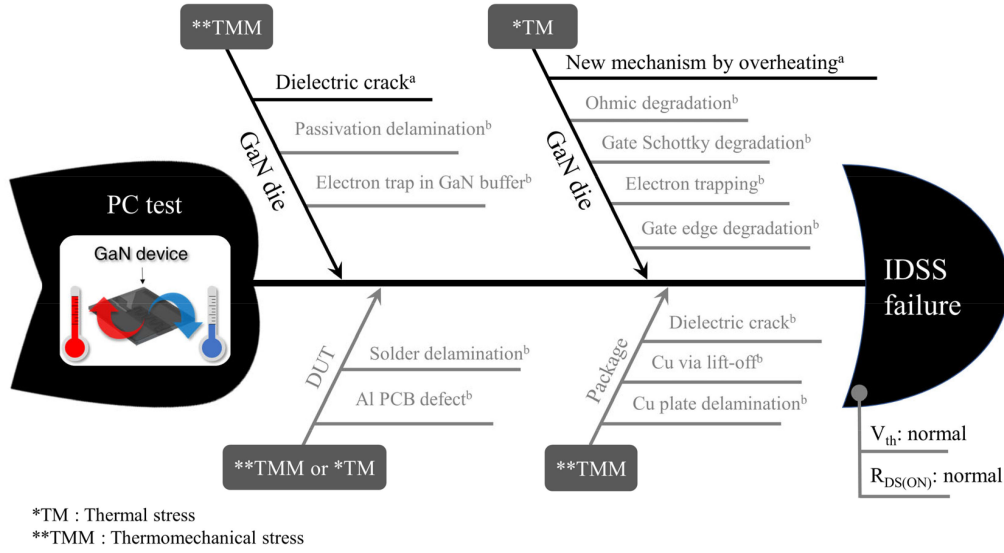
Fig. 1. Fishbone diagram for hypotheses to be able to induce the IDSS failure in a PC test classified by locations and stress conditions [21]: When IDSS failure was confirmed, threshold voltage (V_{th}), and the on-state resistance ($R_{DS(ON)}$) were in the normal range. These three parameters were characterized in the room temperature. (Words^a: remaining possible failure mechanisms to lead to the IDSS failure in the PC test, words^b: proven failure mechanisms that cannot be the cause of the IDSS failure in the PC test.)

Among various potential root causes, only a few candidates were identified to be consistent with observation [27]. The mechanisms are summarized in Fig. 1 and the analysis points to as if yet unclarified FM, the overheating, or dielectric crack. The previous study had not been able to pinpoint the cause of the failure because of test conditions beyond the allowed maximum operating temperature range 150 °C and limit of analysis technique to be able to analyze deep defect location inside a complex package [28]. To find the root cause of this failure, we have here tried to conduct an additional PC test within acceptable temperature ranges and high-level analysis techniques that can visualize deep cracks inside the package without destruction.

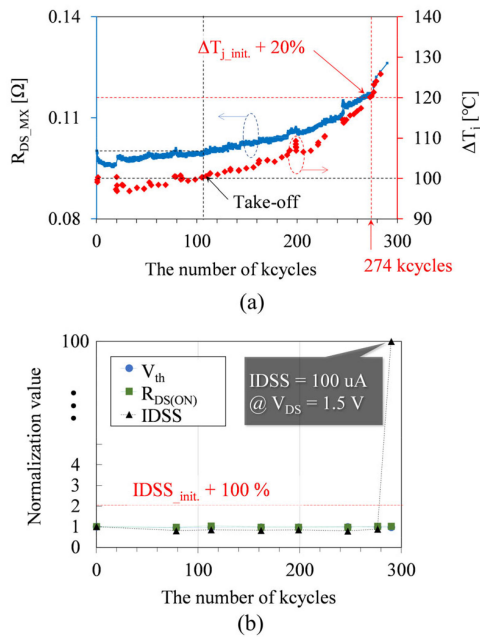
Fig. 2. Power cycling test results with $\Delta T_{\text{meas}} = 24.1 \sim 124.1$ °C. (a) Online parameters monitored during the PC test: $R_{\text{DS_MX}}$ and ΔT_{meas} . Confirmed failure mode is the initial $T_{\text{meas}} + 20\%$. (b) Normalized offline parameters characterized in a curve tracer at the room temperature: V_{th} , $R_{\text{DS(ON)}}$, and IDSS. The failure criteria to determine the failure of the Device Under Test (DUT) are summarized in Fig. S3. The initial values of V_{th} , $R_{\text{DS(ON)}}$, and IDSS are 1.3 V, 44.8 mΩ, and $0.77 \mu\text{A}$. Offline parameter curves and parameter definition conditions are displayed in Fig. S4.

In the result, two failure phenomena are observed; thermal conductivity degradation and IDSS failure. Fig. 2(a) and (b) exhibits two online parameters (R_{DS_MX} and ΔT_{meas}) monitored in a PC circuit and offline parameters (V_{th} , $R_{DS(ON)}$, and IDSS) measured by a curve tracer at the room temperature, respectively. The details of the measurement are elaborated in Fig. S2. The first failure phenomenon can be explained by the ΔT_{meas} and R_{DS_MX} increase after the take-off point in Fig. 2(a) and no change of $R_{DS(ON)}$ in Fig. 2(b) [25], [26] at the end of test. In line with previous studies, the cause of this failure is the solder joint fatigue. Fig. 3(b) and (c) shows the solder joint images confirmed by scanning acoustic microscope (Model: KSI V-8 from IP Holding). In a comparison of them, it can be seen there is solder delamination underneath TPAD where the most heat is concentrated during the test. It is worth noticing, that the temperature swings employed are well within the acceptable operating conditions but still, the leakage current failure develops, which corroborates that the overheating scenario in Fig. 1 cannot explain the IDSS failure. Thus, the remaining dielectric crack hypothesis in Fig. 1 will be investigated extensively with additional structural FA.

The IDSS failure mode without the change of $R_{\text{DS(ON)}}$ and V_{th} identified in Fig. 2 and Fig. S4 can be described with these local defects. This GaN die consists of multiple unit devices and the unit devices are connected to one gate, one drain, and one source electrodes in parallel. When $R_{\text{DS(ON)}}$ is defined in $V_{\text{GS}} = 6 \text{ V}$ and $I_{\text{DS}} = 9 \text{ A}$, this resistance represents a resistance of total source-to-drain channel width. It is hard to influence ON-state parameters such as $R_{\text{DS(ON)}}$ and V_{th} because defective channel width observed in Fig. 4(b) is too small compared with an entire channel width of the die. These local defects, on the other hand, are sufficient to serve as a leakage current path on the OFF state. Therefore, the IDSS failure phenomenon accompanied by normal $R_{\text{DS(ON)}}$ and V_{th} can be explained by this consideration.

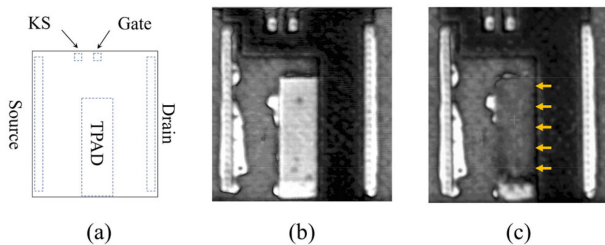
Fig. 3. SAM analysis result. (a) Footprints of a discrete GaN device: drain, source, gate, kelvin source, and thermal pad. (b) SAM image of a solder layer between a GaN device and Al PCB before PC test. (c) SAM image of the solder layer after PC test. Arrows point to the delamination area. Accurate structure information of a DUT is exhibited with a cross-sectional image in Fig. S5.

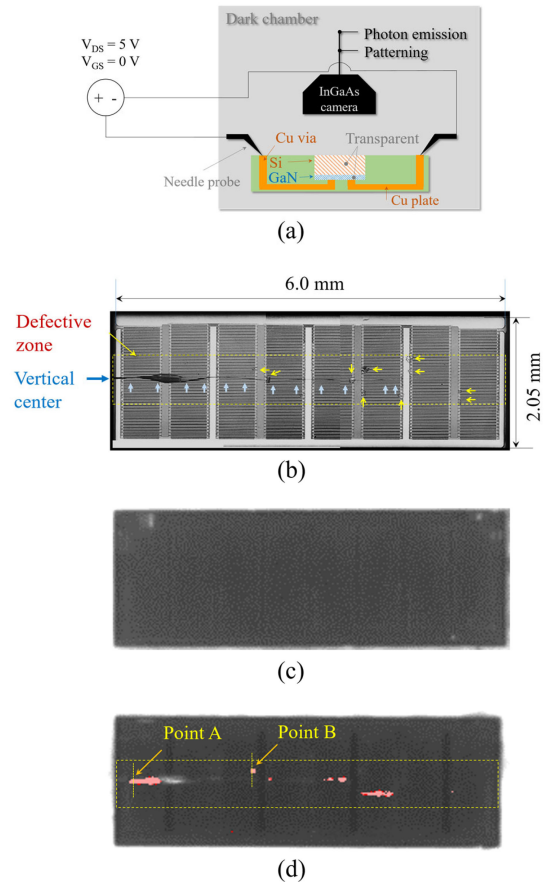
Fig. 4. Defect localization analysis. (a) Backside EMMI analysis environment with partially decapsulated GaN device. Three probe needles (gate, source, and drain) are used for electrical connection between the sample and measurement equipment. The analysis is conducted with an InGaAs camera in a dark chamber. (b) Patterning image of the failure GaN device in backside EMMI analysis with a die size, a long horizontal defect marked by blue arrows (\uparrow), and dot-like defects marked by yellow arrows (\uparrow). (c) Photon emission analysis of a normal GaN device without PC test under $V_{\text{DS}} = 5$ V, and $V_{\text{GS}} = 0$ V. (d) Photon emission analysis with two cross-sectional points of the failure GaN device by the PC test under $V_{\text{DS}} = 5$ V, $V_{\text{GS}} = 0$ V. IDSS curves of both Fig. 4(c) and (d) are displayed in Fig. S7.

Fig. 4(b) shows a patterning image of the defective device analyzed in the backside EMMI. The various abnormal patterns suspected as defects are observed in this image. The abnormal patterns are classified into two types. The first conspicuous defective pattern is a long horizontal crack marked with blue arrows in Fig. 4(b). This crack at the vertical center of the GaN die is continued from the center of the die to left edge. Moreover, several of dot-like defect patterns marked with yellow arrows on Fig. 4(b) are observed around the horizontal crack. They are also placed in around the vertical center of the die. All defects

found in the patterning process are placed in the defective zone marked in Fig. 4(b). They might be directly related to the IDSS failure. The results will be argued with photon emission analysis conducted under IDSS measurement conditions.

Fig. 4(b) visualizes the defective positions directly contributing to the IDSS failure. Generally, the photon emission may occur even in normal operation so that the analysis of the defective device should be compared to a normal device without a PC test. Fig. 4(c) and (d) shows the photon emission images of the normal and the defective devices, respectively. In Fig. 4(c), there is no photon emission and $\text{IDSS} = 0.45 \text{ nA}$ at $V_{\text{DS}} = 5 \text{ V}$, whereas in Fig. 4(d) (the defective device), certain photon emission and $\text{IDSS} = 0.122 \text{ mA}$ were observed. Moreover, it is shown that the lighting positions are matched with the abnormal cracks in the patterning image [Fig. 4(b)]. The overlapping positions of the crack patterns and photon emission in these two images inform where the direct cause of the IDSS failure is. Cross-section analysis will then be performed at in Points A and B marked in Fig. 4(d) to understand the mechanism of IDSS failure in the following sections.

The locations of cracks found in the previous FA can be discussed with the FEM simulation. We can divide the cracks found in Fig. 4(b) into two groups: the long crack propagated from the center of the chip to the left edge and dot-type cracks scattered around the center. For the long crack, first we can inversely predict there was a strong vertical mechanical stress in the PC test. Fig. 7(a) shows the distribution of temperature swings at the die top surface height during PC. The different temperature distribution by the area of a homogeneous body can generate mechanical stress [45]. In Fig. 7(a), the center of the die has the highest temperature swing, while the upper left end has the lowest temperature swing. This imbalance can produce the overall thermomechanical stress of the die during the PC test. The Cu vias are not symmetrical at the left and right edges of the die in Fig. 7(b), which leads to a temperature imbalance between the upper and bottom at the edges of both sides. This imbalance induces stress on the surface of the die, which can lead to defects such as the first long crack.

The second crack group dot type defects in Fig. 4(b) can be analyzed by combining the EMMI patterning image [Fig. 4(b)],

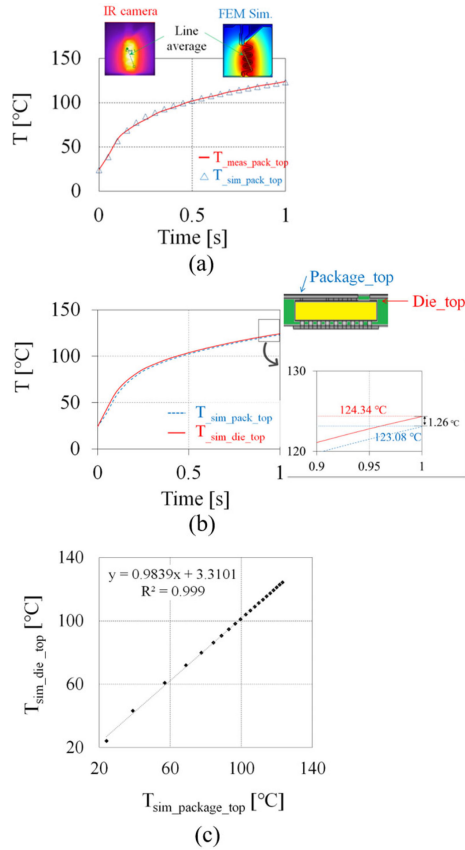
Fig. 6. Temperature analysis in a PC test based on FEM simulation (COMSOL Multiphysics software). (a) Line temperature average curve during 1 s heating period between IR camera measurement of the DUT and FEM simulation on the top surface of the package. (b) Temperature profile comparison in FEM simulation between package top surface and die top surface. (c) Correlation of temperatures between the package top surface and on the package top surface. The temperatures mentioned Fig. 6(a) and (b) are equally defined as the average value of a line across the upper left to lower right of the die on the top surface of the package, which is the same as the way to monitor device temperature in the PC test [26, 27]. The lines for temperature measurement are shown in Fig. 6(a).

It is critical in simulation to find the heat flux condition that accurately reflects the experimental environment. For this, we first measured the temperature of the device at specific power consumption in a PC test environment and then derived heat boundary condition satisfying the temperatures corresponding to the power consumption conditions in the simulation. In the PC test environment, two temperatures $23.8\ ^\circ\text{C}$ and $25.8\ ^\circ\text{C}$ were measured under the two static power dissipation levels of 1.099 and 1.653 W, respectively. Through the FEM simulations, the heat flux condition $1.55 \times 10^4\ \text{W}/(\text{m}^2\cdot\ ^\circ\text{C})$ satisfying the two results measure earlier had been extracted. The condition can be reverified in transient temperature comparison between the simulation and the real PC test. Fig. 6(a) displays the temperature ($T_{\text{maes_pack_top}}$) measured on the package top surface in the test and the temperature ($T_{\text{sim_pack_top}}$) on the package top surface in the simulation. As can be seen they have a very good quantitative agreement between both temperature curves in Fig. 6(a). Moreover, we compared the thermal spatial spreading in the simulation to the real PC test during a single PC recorded as a movie using a thermal camera monitoring the device surface this is supplied as supplementary video. In this comparison, the model parameter fitted was the heat boundary condition based on the simpler steady-state conditions, while we were able to confirm that this simulation is very close to the actual test result in terms of dynamic predictions. The proposed simulation, therefore, is confirmed to be very close to the real operation not only in constant condition but also in a transient condition, which ensure the credibility of this simulation.

Besides, this good agreement also proves that the simplified model proposed previously is acceptable. In the simplified die model, the interconnection layers and AlGaIn barriers between the junction and die top surface were ignored. If their thermal resistivity is significant, it can generate a meaningful difference between the measured temperature and the FEM simulation results. We cannot see any significant difference between them. And the conservatively calculated temperature difference between the junction and the die top was $0.13\ ^\circ\text{C}$. The die model, hence, can be simplified excluding the interconnection layer and AlGaIn layer in the FEM simulation, and the die top temperature reflects the junction temperature very closely.

The measured temperature is the most direct stress parameter that we can monitor during the PC test. For this reason, the smaller the difference between this temperature and the actual junction temperature, the better. In the device using a no wire bond package, the difference between the junction temperature and the temperature measured by an IR camera has not been addressed for transient conditions in previous literature. Fig. 6(b) shows a difference of temperature on the top surface of between $T_{sim_pack_top}$ and on the die ($T_{sim_die_top}$) in the FEM simulation during a heating period 1 s of the PC test. Both temperatures were also defined as the average value of the line at the same position shown in Fig. 6(a). The change trends of them are very similar to each other, and the maximum temperature difference at the end of the period is only 1.26 °C. $T_{sim_die_top}$ represents the junction temperature in the simulation. Fig. 6(c) exhibits a strong correlation of both temperatures in the simulation. We can understand the temperature measured on a package top surface accurately reflects the junction temperature with a slight minus offset, indirectly through the simulation.

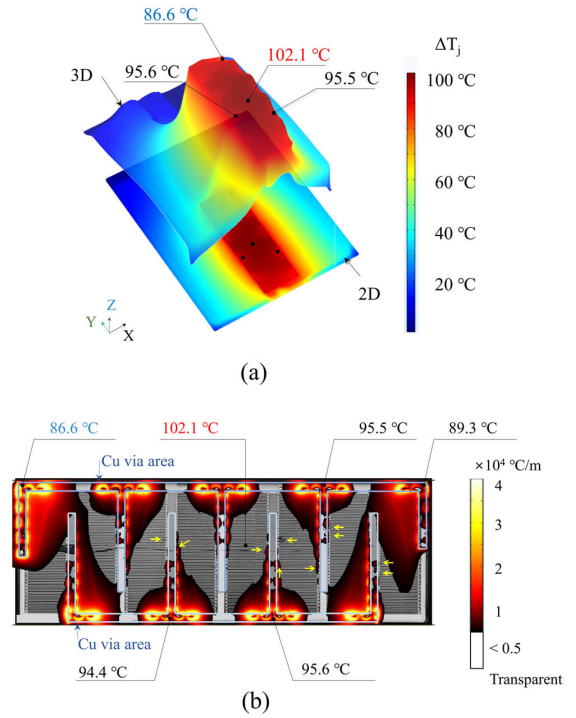
Fig. 7. FEM simulation analysis with defective patterns in the EMMI analysis. (a) 2-D and 3-D ΔT_{die_sim} distribution of the entire GaN device at the height of die top surface in FEM simulation during the PC. (b) Overlap image among the EMMI patterning image [Fig. 4(b)], Cu via areas directly bonded to the die, T_{die_sim} at 1 s in six points and T_{die_sim} gradient (°C/m) plot in the die top surface area.

the knowledge of the Cu via design inside the package directly bonded to the die, and the temperature gradient of the die ($T_{\text{die_sim_grad}}$) extracted from the FEM simulation at the highest point during a PC. Fig. 7(b) exhibits an overlap image of these three items. $T_{\text{die_sim_grad}}$ is expressed as (1).

When referring to Figs. S9 and S10, it is seen that the temperature gradient on the die top surface is significantly influenced by the Cu structure inside the package. Particularly, $T_{\text{die_sim_grad}}$ is relatively high along the Cu vias in the center of the die surface. There might be a larger temperature gradient around the boundary between them because Cu has much better heat transfer capability than FR4 which is filling most of the package [38]. In Fig. 7(b), the cracks pointed by the yellow arrows are located mainly near the Cu vias within the center area of the die. In this area, it is expected that severe mechanical stress is generated by CTE differences among the materials (Cu, FR4, a GaN die) at these interfaces as well as the larger temperature gradient. Thus, it is revealed that the dot-type defects also correlate with the Cu vias design in the package.
