*Published in:*  
12th Nordic Symposium on Building Physics (NSB 2020)

# Monitored conditions in wooden wall plates in relation to mold and wood decaying fungi

Tessa Kvist Hansen<sup>1\*</sup>, Nickolaj Feldt Jensen<sup>2</sup>, Eva Møller<sup>2</sup>, Ernst Jan de Place Hansen<sup>1</sup>, and Ruut Peuhkuri<sup>1</sup>

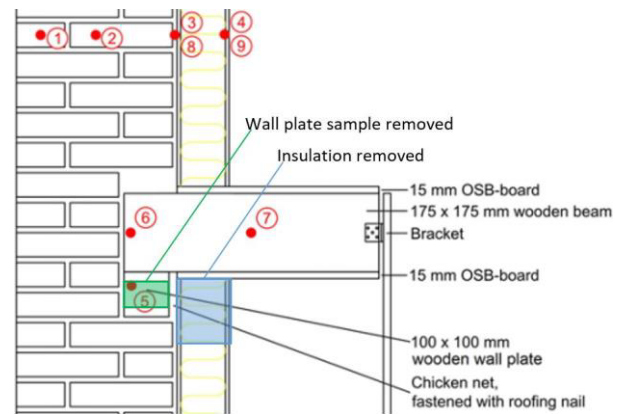
**Fig. 1.** Section view of the walls from the experimental setup, and indication of measurement points in the construction

A large-scale experimental setup at the Technical University of Denmark consisted of 24 internally insulated solid masonry wall sections with embedded wooden beams and supportive wall plates (pine). A section view of the wall configurations is given in Fig. 1; red dots and numbers represent monitoring points for temperature and relative humidity (digital HYT 221 sensors;  $\pm 1.8\%RH$  ( $23^\circ C$ , 0-90%RH)). The experimental setup was first and foremost conducted for evaluating the performance of several different internal insulation systems, which have been further described, analyzed and reported in [12–14]. For the present study, samples from the wooden supportive wall plate were taken from six of these walls. By means of sorption isotherms for pine [15], the moisture content was determined. In this study, only results from measuring point no. 5, in the wall plate, have been included.

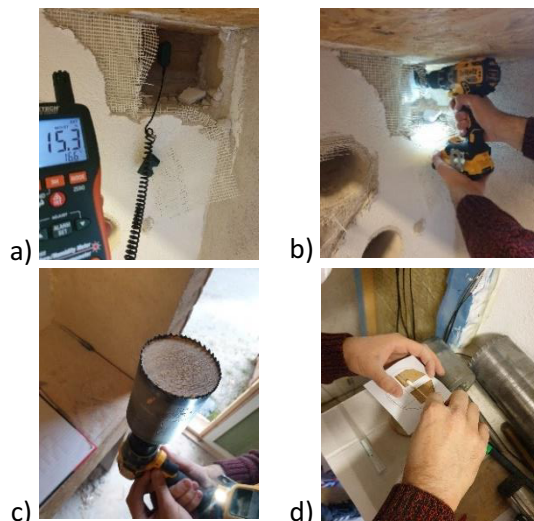
**Fig. 2.** Process of removing samples from the supportive wall plate. Measurements of moisture content (a) and Mycometer swabs (d) were performed on both ends of the samples.

Finally, two Mycometer swab tests [17–19] were made on each end of the drilled-out sample. Mycometer (surface) is a method for detection and quantification of mold growth on surfaces. The method is based on fluorometric detection and quantification of an enzyme found in mold spores and the mycelium. The Mycometer test generates a number that indicates the density of fungal biomass on the surface, corresponding to one of the following categories; A:  $\leq 25$  (mold level is not above regular background level); B: 25-450 (mold level is above regular background level. This mold level can be caused by high concentrations in dust, or indicate the presence of dried-out mold), and; C:  $>450$  (mold level is much higher than regular background level due to mold growth). The process of removing insulation, measuring moisture content, drilling the samples and Mycometer swabs, is illustrated in Fig. 2.

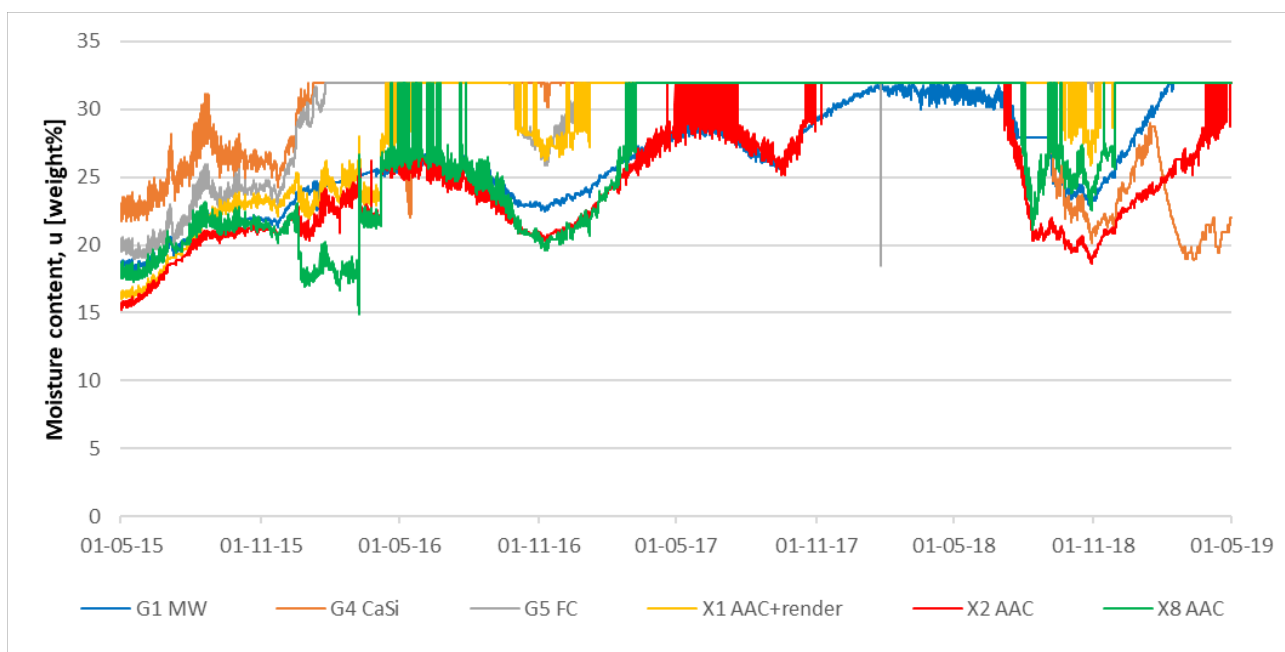
**Fig. 3.** Moisture content in the supportive wall plates, based on measurements of temperature and relative humidity, and sorption isotherms from pine [15]

The moisture content in the supportive wall plates over a 4-year time period of this study, are depicted in Fig. 3. An average between adsorption and desorption has been used under the assumption of equilibrium to surrounding air. It is seen, that the moisture content has an upper limit in this case, due to the limits of the sorption isotherm as was implemented [15], however the magnitude of the values are compatible with on-site measurements (see Fig. 7). It is seen, that after the first year of measurements, all the wall plates exhibit moisture contents between 20 and 33 % (wt.) for the entire period. Wall plates G4, X2 and X8 have few, shorter periods with moisture contents less than 20 % (wt.). The conditions are thus above the threshold value for decay, and for this reason, these wall plates appear to be in high risk of occurrence of wood decaying fungi.

With regard to the six investigated samples, the hygrothermal performance can be ranked in the following sequence according to monitored conditions, see Fig. 3; X2, G1, X8, X1, G4, and G5. The wood decay models yield very similar results with regard to the performance and mass loss achieved, which is not surprising as these prediction models are based on the hygrothermal conditions provided. The mold model gave a mold index value above 5 for all the wall plates investigated, which were differentiated only by the time it took to reach the maximum value of mold index.

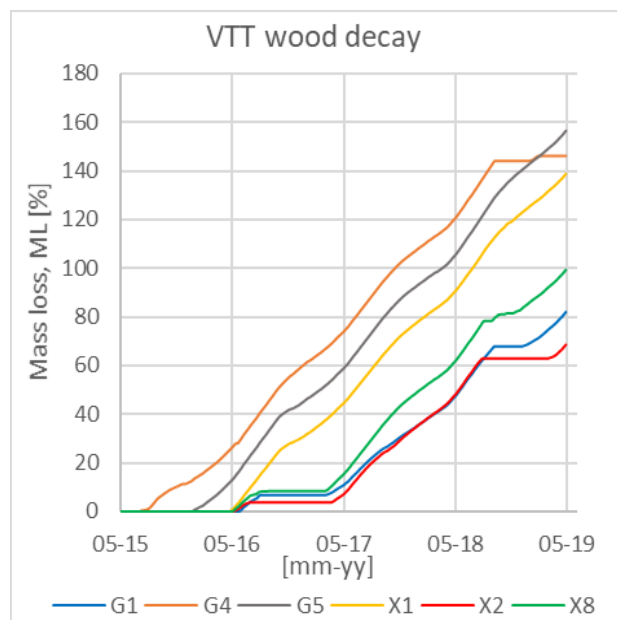
**Fig. 4.** Generated mass loss in the supportive wall plates for 6 wall configurations, with the VTT wood decay model, based on monitored temperature and relative humidity data

The monitored hygrothermal conditions for the six wall configurations presented in Table 2 were implemented in the wood decay models and the mold model respectively. The progression in values of wood decay and mold index over the 4 years of measurement data, are presented in Fig. 4, Fig. 5 and Fig. 6.

In the VTT model, three of the wall configurations (G4, G5 and X1) exhibit mass loss above 120% before 4 years. The remaining three wall configurations (X8, G1, X2) generated mass loss above 60% within 4 years. In terms of the Japanese model, the generated mass loss is less in terms of magnitude compared to the VTT model. The Japanese model yields mass loss above 60% in G4, G5 and X1. Wall X8 generated 40% mass loss in 4 years, whereas G1 and X2 resulted in around 20% mass loss. With regard to the value of the mold index, all the wall configurations show maximum value of mold index of 5.29 within 3 years. This is the maximum mold index value to be achieved for sensitivity class 2. The worst cases (G4, G5, X1) yielded the maximum value of mold index within the first year. Furthermore, it can be seen from the graphs of predicted wood decay and mold index (Fig. 4, Fig. 5, Fig. 6), that the initiation of mold growth occurs prior to the initiation of wood decay, which was also found to be the case in [11].

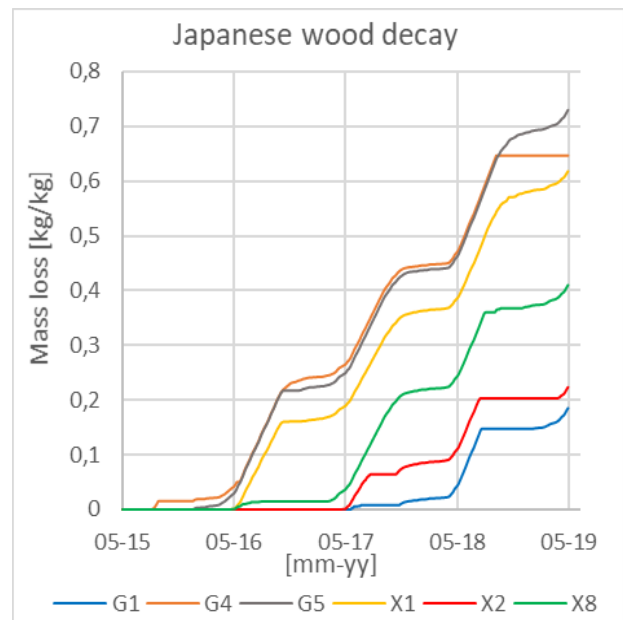
**Fig. 5.** Generated mass loss in the supportive wall plates for 6 wall configurations, with the Japanese wood decay model, based on monitored temperature and relative humidity data

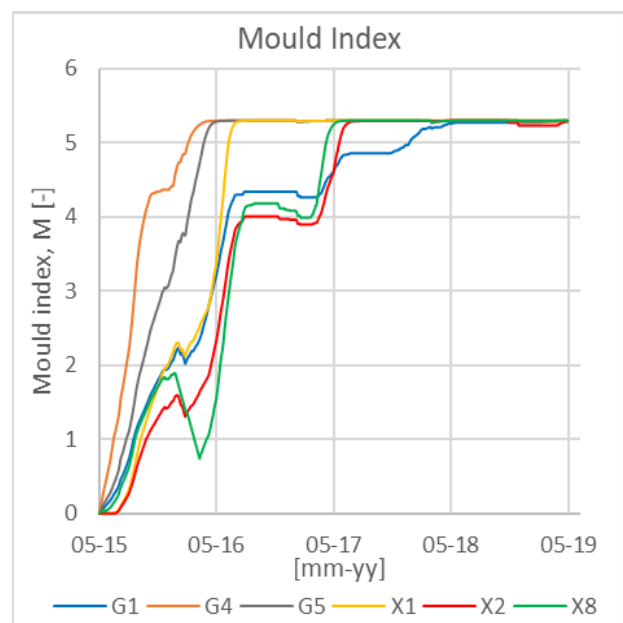
**Fig. 6.** Generated mold index in the supportive wall plates for 6 wall configurations, with the mold model, based on monitored temperature and relative humidity data

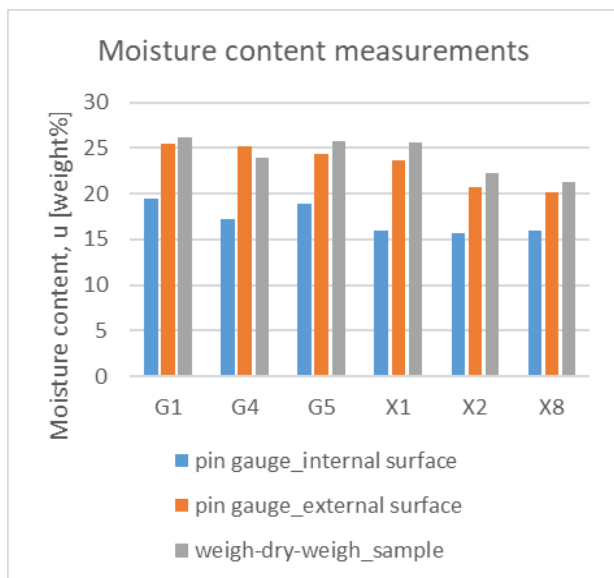
**Fig. 7.** Measurements of moisture content performed on site with pin gauge on internal and external surface, as well as the whole specimen

The measurements of moisture content performed on-site, during the removal of samples from the wall plate, are presented in Fig. 7; this was performed in October 2019. The in-situ measurements reported in Fig. 3 are presented for up to 1<sup>st</sup> of May 2019, and show a clear general tendency of nadirs in the autumn seasons.

From the in-situ pin gauge measurements on the external surface of the sample, and the weigh-dry-weight experiments on the samples, in Fig. 7 it is seen that the moisture content in the supportive wall plates is in the range of 20-27 % (wt.). The moisture content on the internal surface is recorded as lower in all cases. This observation is in line with the expected results: Due to the temperature gradient, the relative humidity on the exterior side of the construction is higher and therefore also the moisture content. The effect from external moisture loads (e.g. wind-driven rain) may also influence the conditions on the external side of the wall plates, as the masonry covering the wall plate is only one brick unit in depth (228mm). Furthermore, the anisotropic properties of wood promote moisture transport in the longitudinal direction and thus not tangentially through the wall plate. It is seen in Fig. 7, that samples from walls X2 and X8 yield the lowest moisture contents, consistent with Fig. 3. The measurements depicted in Fig. 3 also show, that G4 declined in moisture content by the spring of 2019, however the measurements from October 2019 indicate that the moisture content has again increased. The procedure of drilling out the samples generated high temperatures, and this is why it can be assumed that the pin gauge measurements on the external surface, as well as the weigh-dry-weight measurements could be affected by this process. The moisture content registered on the

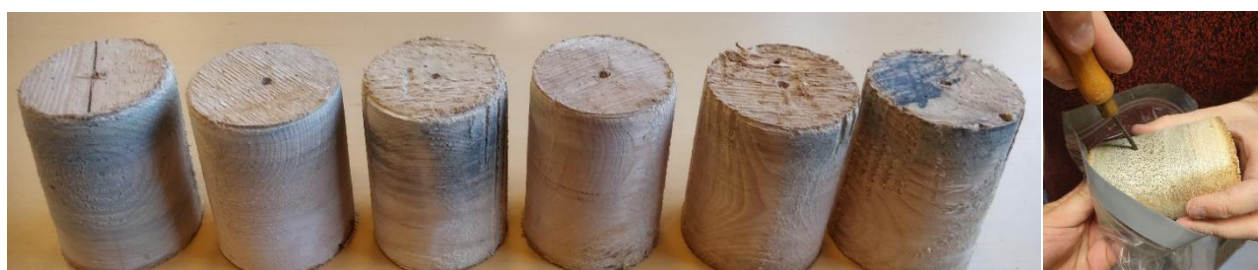
**Fig. 8.** Left: The 6 specimens drilled out from the supportive wall plates from the 6 wall configurations; left to right: X1, X2, X8, G1, G4, G5. Right: awl test of a specimen.

The state of the wooden core samples from the wall plates is seen in Fig. 8, as well as an example of the awl test. None of the wood samples exhibited any indication of mass loss nor rot or mold. Neither did the awl test, visual inspection or smelling indicate anything other than sound and healthy wood. The discolorations seen in the wood samples, were due to the drilling procedure, and from the wall construction and adjacent materials.
