Durability of the hydrophobic treatment on brick and mortar

Published in: **Building and Environment**

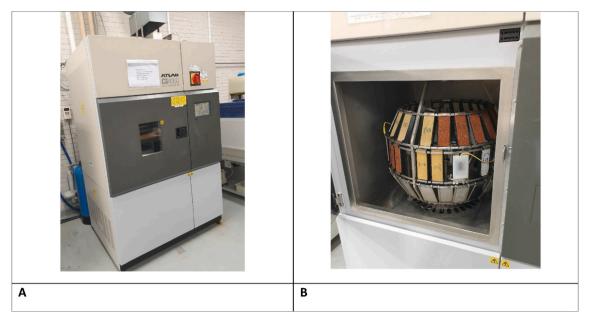
Fig. 1. Test setup for artificial aging. A) Atlas Ci4000 weather-ometer and B) test specimens on carousel sample holder inside the chamber.

To evaluate the durability of the hydrophobic surface treatment on brick and mortar, artificial aging was conducted, according to ISO 4892-2 [42], with Atlas Ci 4000 weather-ometer, at the Danish Technological Institute, Taastrup (Fig. 1). ISO 4892 [42] is targeted at the durability of plastics but its key features (UV radiation and water spray) are in line with [29], also performing artificial weathering of hydrophobized porous building materials in Atlas weather ometer. The samples were placed in plastic holders that cover the edges (from the 75 cm² of the samples' face surface, only 57.8 cm² are exposed to water spray and UV radiation). The plastic holders were placed on a carousel, inside a climatic chamber. The samples were exposed to sprayed water and UV radiation only from the interior of the carousel. The water repellency performance is evaluated by the water absorption coefficient (Acap) of the samples, obtained via water uptake tests in accordance with [43], as described in Refs. [44,45]. The samples were placed in a plastic container with deionized water that covered less than one cm of the sample, over plastic net support, for 1-D free capillary water uptake. The mass of the sample was determined with a balance reading 0.001 g and the samples were wiped with wet paper before each measurement. Since impregnation decreases the rate of capillary water uptake, the water uptake tests for the impregnated samples lasted for 24 h and the time intervals for the measurements were: 10', 30', 1h, 1h 30', 2h, 3h, 4h, 7h, 9h, and 24h. When displaying water uptake in kg/m² towards $\sqrt{\text{seconds}}$ does not produce a straight line but a curve of some form, A_{cap} is defined as the increase in weight (Δm) in kg/m² at 24h divided by $\sqrt{86400}$ [43].

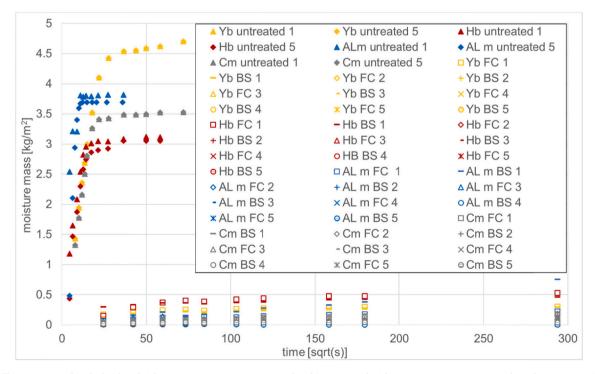
Fig. 2. Capillary water uptake of Y brick, H brick, C mortar, AL mortar, untreated and impregnated with Remmers FC cream 40% and Wacker BS cream C 80%. 1: 1st water uptake before artificial aging, 2: 2nd water uptake after 165 cycles of artificial aging, 3: 3rd water uptake test after 335 cycles of artificial aging, 4: 4th water uptake after 482 cycles of artificial aging, 5: 5th water uptake after 635 cycles of artificial aging. Each point of each curve is the average value of the respective measurements of three different samples.

Fig. 2 illustrate the capillary water uptake curves both of untreated and treated samples during the artificial weathering while Fig. 3 shows

only the treated samples. The water uptake curves of all the treated samples were significantly reduced compared to untreated. The moisture mass difference against sqrt(s) did not give a straight line, but could follow a curve of some form (Fig. 3).

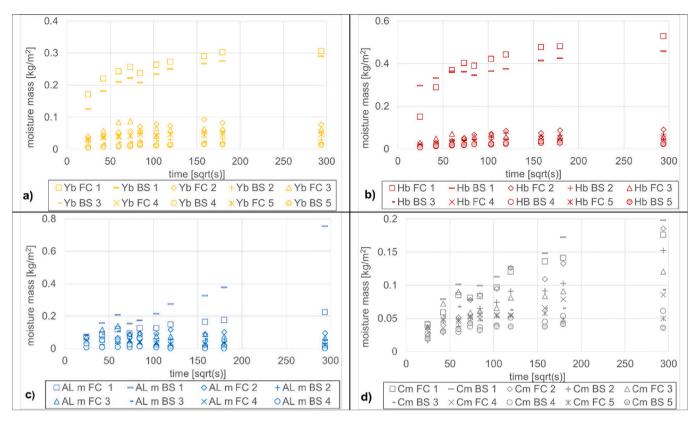
Fig. 3. Capillary water uptake of a) Y brick, b) H brick, c) AL mortar, d) C mortar, impregnated with Remmers FC cream 40% and Wacker BS cream C 80%.1: 1st water uptake before artificial aging, 2: 2nd water uptake after 165 cycles of artificial aging, 3: 3rd water uptake test after 335 cycles of artificial aging, 4: 4th water uptake after 482 cycles of artificial aging, 5: 5th water uptake after 635 cycles of artificial aging. Each point of each curve is the average value of the respective measurements of three different samples.

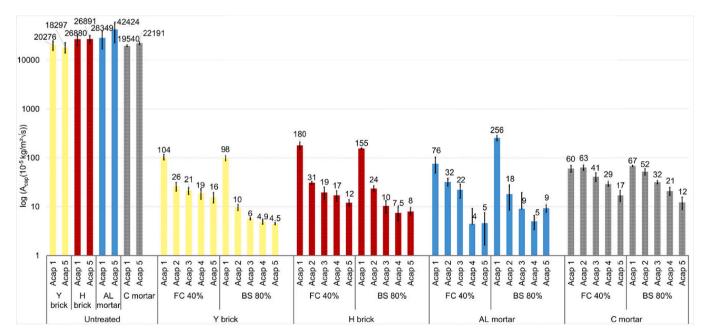
Fig. 4. Water absorption coefficient by capillary water uptake test of Y brick, H brick, AL mortar, C mortar, untreated and impregnated with Remmers FC cream 40% and Wacker BS cream C 80%. Acap 1: absorption coefficient before artificial aging, Acap 2: after 165 cycles of artificial aging, Acap 3: after 335 cycles of artificial aging, Acap 4: after 482 cycles of artificial aging, Acap 5: after 635 cycles of artificial aging. Each result is an average based on three samples, error bars correspond to standard deviation.

Fig. 4 focuses on the water absorption coefficient of the different samples during the testing period. The untreated samples did not show

significant changes in the water uptake after 635 cycles of aging. All treated samples showed reduced water uptake after treatment, and the water uptake was further reduced during the aging period.

The absorption coefficient on the first test before aging was reduced approximately by a factor of 200 due to hydrophobization (e.g Y brick treated with FC 40%, $A_{cap1}\colon 0.00104 \, kg/m^2 s^{1/2}$ from untreated $A_{cap}\colon 0.2 \, kg/m^2 s^{1/2})$ and was further reduced by a factor of more than 1000 ($A_{cap5}\colon 0.00016 \, kg/m^2 s^{1/2})$ after aging for all the tested materials, compared to untreated. Consequently, the ability of the hydrophobization to reduce water uptake is not diminished by the performed artificial aging. The absorption coefficient seems to be positively influenced by artificial aging since it is further reduced during the process of repeated cycles.

Two different types of brick, one type of air lime mortar and one type of cement mortar, all representing materials present in historic Danish buildings, illustrated the same behavior in terms of water repellency during aging resulting in very low absorption coefficients. Although air lime does not contain hydroxylated surfaces, the active ingredient was able to form irreversible bonds with the pore walls of the air lime mortar, since mortar also contains sand that has hydroxylated surfaces and thus kept the very low absorption coefficient after accelerated weathering similar to hydraulic lime mortar [21] and cement mortar (Fig. 4).

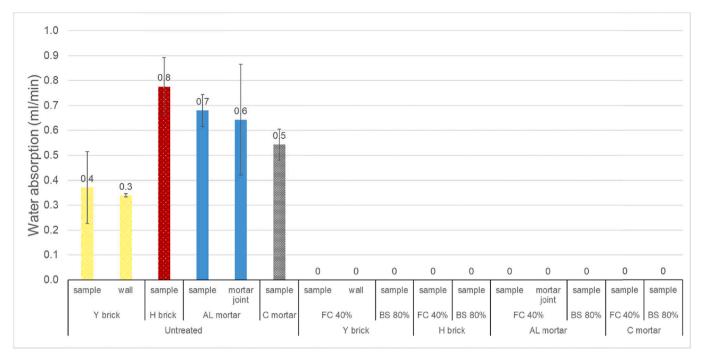
Fig. 5. Water absorption by Karsten tube test, Y brick, H brick, AL mortar, C mortar, and mock-up wall, untreated and impregnated with Remmers FC cream 40% and Wacker BS cream C 80%. "Sample" refers to samples from artificial aging, "wall" and "mortar joint" refer to mock-up wall measurements on brick and mortar joints respectively. Each result is an average based on three measurements, error bars correspond to standard deviation.

The Karsten tube test, as an additional indicator, supported the observation that hydrophobization blocked liquid water transport even after aging in brick and mortar since the water penetrated neither samples nor brick and mortar joints of the mock-up wall hydrophobized six years ago (see Fig. 5). Also, the water absorption of untreated brick and mortar samples was similar to untreated bricks and mortar joints of the mock-up walls, as seen in Fig. 5.

Mortar joints are regarded as the weak point of a masonry facade [28], however, they are not easy to characterize with a Karsten tube test. During Karsten tube tests on the mock-up wall (Fig. 5) it was challenging to adjust the glass tube on the mortar joints without having leakages. Especially, in buildings with concave mortar joints, it would be very difficult to test the water uptake with the Karsten tube test. Karsten tube is an accurate method for testing water uptake on bricks but it is more difficult to give accurate results on mortar joints [54]. Additional in-situ measurement equipment, not available for this study, covers wider wall areas [55]. However, the impregnation depth is reported to be lower in mortar samples and mortar joints than in bricks [21,28], and the possibility of cracks after treatment is higher in mortar joints, as well as in the interface between bricks and mortar joints. Moreover, brick absorbs the water repellent agent much faster than mortar [21]. During the application process of the cream products, a percentage of the cream placed in the mortar joints would be absorbed by the brick, leaving less active ingredient for the mortar joints. Furthermore, since the beading effect is reduced due to UV radiation exposure, the water is being absorbed into the first mm of the substrate and during winter this water may freeze, expanding its volume and induce spalling. If this continues to occur and mortar joints start to crumble, cracks may reach untreated areas after years. This could also happen to brick although less possible as the impregnation depth is larger [21]. These observations indicate that mortar joints should be studied further.
