Flexural behavior of hybrid fibre-reinforced geopolymer composites (FRGC)-jacketed RC beams

Published in:
Engineering Structures

Fibre-reinforced geopolymer composites (FRGC) are drawing interest as potential repairing and strengthening materials for concrete elements due to their desirable properties. They are known to have good mechanical bond with the concrete substrate and steel reinforcement, good fire resistance, greater durability in corrosive environments, and lower creep and shrinkage characteristics. However, the main challenge in their practical application is the lack of design standards and the structural performance of FRGC-rehabilitated concrete elements has not been fully investigated. In this paper, the result obtained from an experimental study on the flexural behavior of reinforced concrete (RC) beams jacketed by hybrid FRGC is reported. Six repair and strengthening configurations were adopted in this study including jacketing at the bottom, two and three sides of the beam with at least 25 mm thick FRGC layer. Twelve FRGC-jacketed and two control beams were subjected to four-point bending test to determine their loading performance, cracking response, ductility

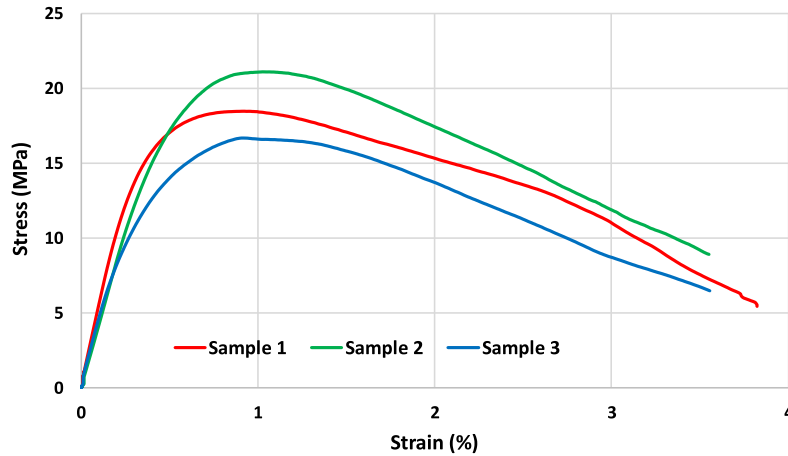
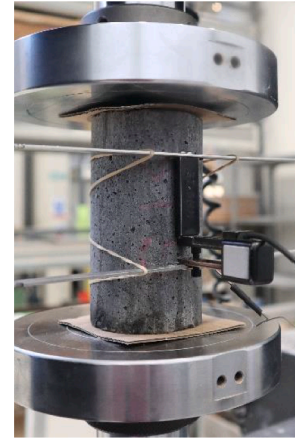
**Fig. 1.** Compressive stress-strain curve and testing set-up for FRGC specimen.

resulting to a total FRGC mixing time of 18 min. To determine the mechanical properties of hardened FRGC (compressive and tensile strengths), the prepared FRGC wet mixture was poured in a desired mould and cured before the actual tests. The specimens were initially cured in a 50 °C temperature-controlled chamber with 98% relative humidity for 48 h, after which they are demoulded and stored in an ambient temperature room and tested after 28 days. The compressive properties of the used FRGC was characterized by testing of 5 cylindrical specimens having a size of 60 × 120 mm in a compressive testing machine. On the other hand, the tensile properties of FRGC were determined by testing 3 dumbbell-shaped specimen with a test cross section of 40 × 40 mm in a uniaxial testing machine. Compressive and tensile test specimens were all instrumented by extensometer to record their respective strain values. Figs. 1 and 2 shows the testing set-up and the samples of stress-strain curves from compressive and uniaxial tensile tests. The average compressive and tensile strength values, as well as the modulus of elasticity of the FRGC obtained from the test is 18.9 MPa, 3.5 MPa and 21 GPa, respectively. The result obtained from the tests indicates that the specimen subjected to tensile load underwent softening behavior after reaching its peak load capacity. Due to this behavior, multiple-crackings on the surface of the specimen was not observed in all of the tested specimens.

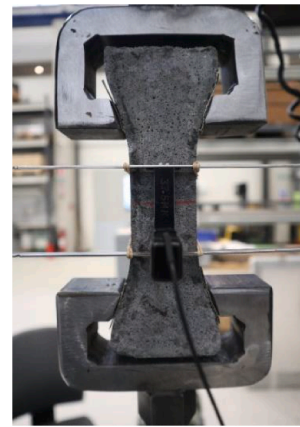
**Fig. 2.** Tensile stress-strain curve and testing set-up for FRGC specimen.

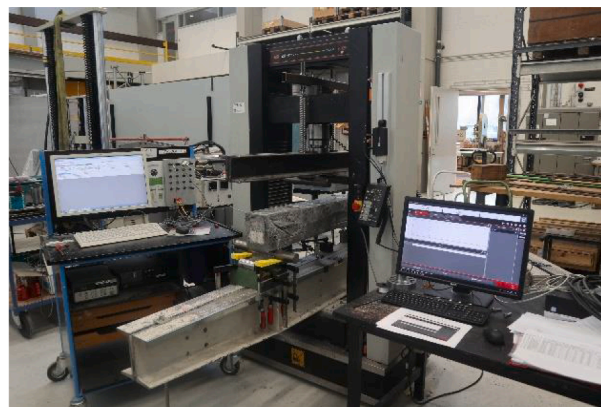
Fig. 5. Experimental set-up of 4-point loading test.

Fig. 5 presents the typical test set-up and instrumentation details of the study. All beams were loaded in a four-point bending using a 100kN-capacity testing machine under displacement control rate of 2 mm/min. The effective test length of all specimens is 950 mm and was loaded symmetrically at two points 200 mm apart about its centerline. For this set-up, the size of the test beams (at least the control specimen) is adequate for pure flexural behavior since it fulfilled the condition of shear span to depth ratio ≥ 2 . A 20 mm length strain gauge was glued on the bottom surface of each specimen at mid-span while one linear variable displacement transducers (LVDT) was placed at the bottom mid-span to record the specimen deflection. An automatic data acquisition system was used to record the loading, deflections and strain values. Visual inspection was performed on the specimens while the test progresses to document initiation and propagation of cracks until the beam reached failure. In all of the bending tests, the complete beam failure (i. e. rupture of reinforcement steel) were not obtained and tests were stopped once the concrete in the compression zone started crushing to protect the mounted LVDT from potential damage.

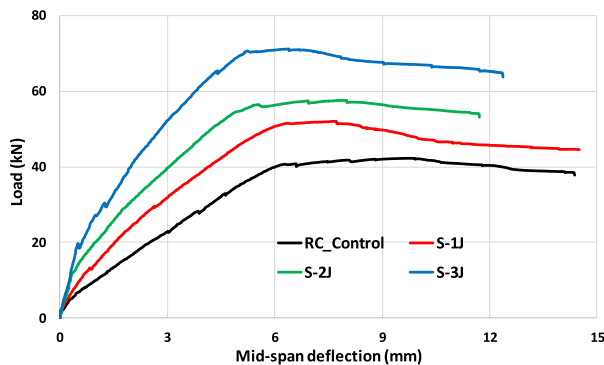
Fig. 7. Load-deflection relationship of strengthened RC beams.

The load-deflection relationship of the strengthened beams (i.e., S-1 J, S2J and S-3 J) likewise follows a trilinear curve as shown in Fig. 7. One can observe that generally the stiffness in the first elastic region of the strengthened beams is higher than the control specimen. It is also apparent that the length of the first elastic region for strengthened beams is longer than the control specimen. S-1 J exhibited slight increase in both slope and length in this region relative to RC control with crushing of concrete as the actual failure at peak loading condition. This enhancement is primarily attributed by the addition of FRGC section that consequently increased the un-cracked gross moment of inertia. At the first elastic zone (i.e., load level of 12.9 kN), S-1 J remained intact and act monolithically, which is the same response exhibited by R-t66. One major difference that can be established between these two specimens is that the length of the first cracking region for S-1 J is shorter than RS-t66. Although these specimens have equal nominal cross sectional areas, the amount of FRGC incorporated for S-1 J is relatively smaller than RS-t66, thus the contribution in increasing the load-deflection values is minimal. On the other hand, the length and slope of S-2 J in the first cracking region have an intermediate values between S-1 J and S-3 J. Relative to the control specimen, the enhancement was provided by the stiffening effect of the added FRGC on the two sides of the RC beam. Just like S-1 J, S-2 J responded monolithically and no delamination between FRGC and the concrete substrate was observed in the first cracking region. The typical failure at ultimate condition for S-2 J was either crushing of concrete or FRGC at the compression zone. S-3 J exhibited the highest increase in slope and length in this zone due to the maximum equivalent addition of FRGC, hence highest relative un-cracked moment of inertia. An utmost value of slope is also noticeable for S-3 J than the other strengthened beams with more significantly relative to the RC control. This is certainly demonstrating the effectiveness of jacketing the three sides of the beam using FRGC in not reducing the load rapidly after the occurrence of first cracking. In contrast, the transition in the inelastic region for S-3 J is generally shorter with a sudden softening mode, indicating a less ductile failure compared to S-1 J, S-2 J and conventional RC beam. This shows that addition of tension reinforcement by means of jacketing at the three sides using FRGC can essentially transform the behavior of the originally under-reinforced section to that of an over-reinforced one. Increasing the amount of effective tension FRGC lowers the location of the neutral axis that triggers either FRGC and concrete approached their compressive crushing strain. The crushing of these two component materials prior to any significant post-yielding of the steel will lead to the undesirable brittle mode of failure. Nevertheless, S-3 J exhibited a monolithic response with no observed debonding between FRGC and concrete substrate during the entire flexural test. Similar with S-2 J, the failure

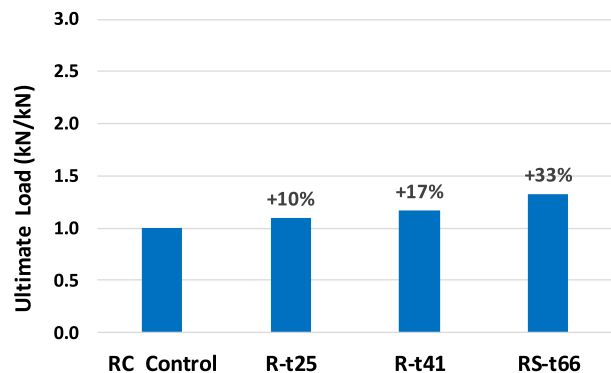
a. First cracking condition

b. Yielding condition

c. Ultimate condition

Fig. 8. Normalized load values at different stages for repaired beams.

Table 5 summarizes the load values (average of 2 replicates) of beam specimens at different loading stages and its normalized values are graphically presented in Figs. 8–9 for ease of comparison. Results shown in Table 5 indicated that the first cracking load of repaired RC beams is in the range of 8–10 kN, depending on the thickness of FRGC material and its interface location with the concrete substrate. The first cracking in the repaired beam may occurred theoretically at the FRGC section and/or the concrete in tension, although it has been observed in the tests that cracking usually started at the FRGC layer (previously highlighted). As illustrated in Fig. 8, cracking for R-t25 initiated at a load level of 8.06 kN, a value that is 28% higher than the control specimen. The increase is attributed from a relatively high tensile strength of FRGC. At same cross-sectional area, a thicker 41 mm FRGC added on the bottom of the control beam (i.e., beam R-t41) resulted in an 8.27 kN first cracking load capacity. This repair configuration magnified the cracking performance of the beam by 31% relative to the control and slightly higher by 3% on R-t25. Increasing the thickness of the repair material to monolithic 66 mm (beam RS-t66) lead to a first cracking load of 9.96 kN that somehow increased the capacity by 60% compared to the controlled specimen. Unlike R-t25 and R-t41, this time the initial cracking resistance of RS-t66 is attributed by the dual contribution of the excellent tensile properties of FRGC and the increased moment of inertia effect with its addition on the beam soffit. The increase of cracking load is also evident by observing the cracking strain value whereby the value of repaired beams is approximately 3–4 times that of RC_Control.

On the other hand, the yielding load of the repaired beams is in the interval of 45–56 kN, R-t25 expectedly showing the least exhibition of yielding load having a marginal 8% increase relative to the RC_Control. Comparing the load interval difference from cracking to yielding point of R-t25 and control beam (i.e., 36.9 and 35.3 kN, respectively) provided a value of 5% which can be considered as a negligible difference. Ergo this indicates that the increase of yielding load of the former is only primarily due to the initial cracking resistance provided by FRGC and the replacement of ordinary concrete with same cross section of FRGC will not significantly alter the yielding load response of the bottom reinforcement bar. Thickening the FRGC section to 41 mm in a repaired beam (i.e., R-t41) outperformed the yielding load response of the control beam and R-t25 by 14% and 6%, respectively. Unlike R-t25, the load increment from cracking to yielding point of R-t41 is 17% higher than the control specimen. Noted that in this particular repairing method the originally normal concrete-rebar bond has been replaced by FRGC-rebar interface as a result of repair material thickening. Certainly the excellent FRGC-rebar bonding performance modified the favorable yielding load response of the bottom steel reinforcement. The reason is because FRGC reduced the applied tensile strain in the rebar through strain localization at the interface resulting to a much higher load value for the rebar to yield, as discussed earlier. This finding is noteworthy in the sense that not only for this specific repair configuration the bottom rebar can be

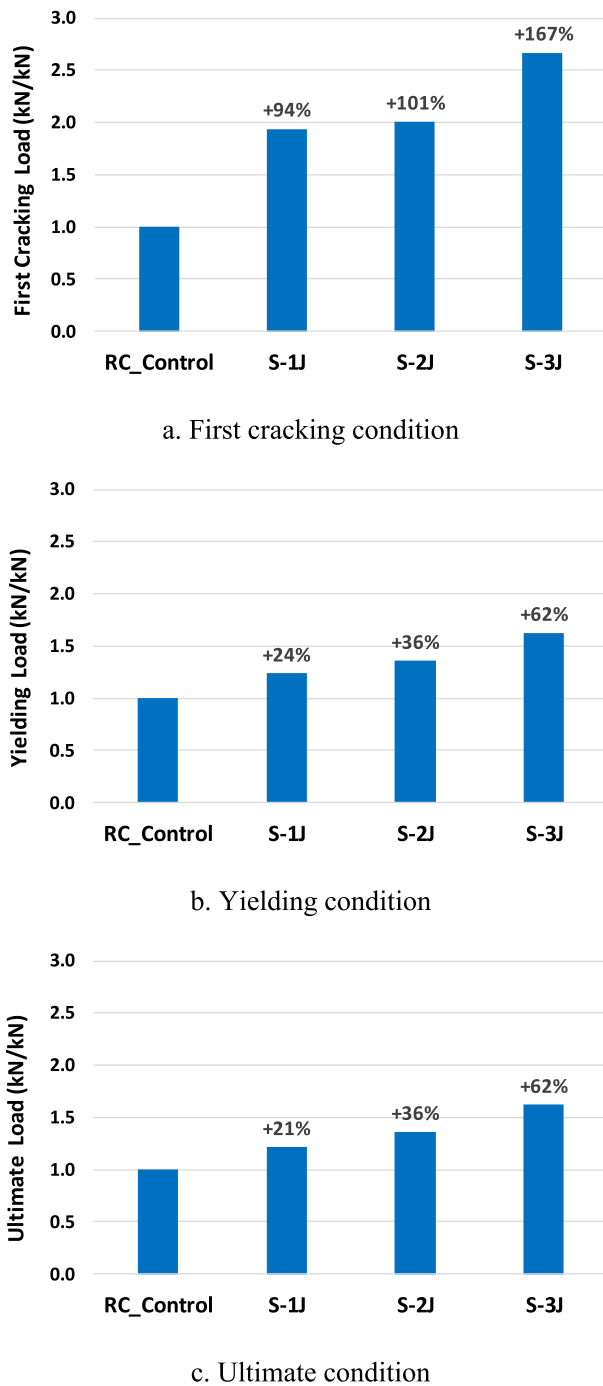
Fig. 9. Normalized load values at different stages for strengthened beams.

The effects of the three jacketing techniques applied at different sides of the beam on the loading performance of the strengthened specimens are displayed in Fig. 9. As expected, the experimental results shown in Fig. 9 indicate an increase of varying degrees in the load performance for all of the strengthened beams relative to the control beam as a result of an enhanced stiffening action provided by FRGC strengthening layer. These techniques were able to demonstrate an initial cracking load capacity at a load level between 12 and 17 kN, depending on the number of

jacketed sides. In the case of jacketing at the bottom side, this technique was able to increase the load to initially crack the beam by 94% higher than the control beam, whereas jacketing at the two sides of the beam yielded 101% enhancement. While the improvement on the cracking load of S-1 J was attributed due to the increased un-cracked moment of inertia solely in the tension zone, the un-cracked moment of inertia of beam S-2 J generally is obtained from both compression and tension regions. Consequently, the first cracking load of S-2 J may exhibit higher value than S-1 J, just like the case in the present study whereby the result of the former showed marginally higher value of 7% than the latter. Similarly, beam strengthened by 3-sides jacketing technique has improved first cracking performance showing the highest increase of 167% compared to the control beam. The highest increase in this aspect for S-3 J is anticipated as a result of adding FRGC on the three sides of the beam causing a remarkable growth of the un-cracked moment of inertia in both compression and tension zones. It can be seen from Table 5 that strengthened beams generally cracked at relatively higher strains than that of RC_Control indicating that apparently the former was subjected by loads higher than the latter.

Beams strengthened using the three jacketing techniques demonstrated yielding load ranging from 51 to 69 kN, as can be seen in Table 5 and Fig. 9. Compared to the RC_Control, jacketing the beam only at the bottom increased the yielding load capacity by 24%. Once cracking initiated on either FRGC or concrete at the tensile zone and later extend to the bottom reinforcement bar, applied load to the beam S-1 J will only now be resisted by the yielding capacity of the rebar and the concrete section at the compression zone, that eventually will behave just like an ordinary RC beam. Changing the jacketing configuration from the bottom to the two sides of the specimen exhibited 36% increase of load to yield the strengthened beam. Unlike the post-cracking-to-yielding response of S-1 J were the yielding load is partially contributed by the concrete section at the compression zone, the yielding load of S-2 J is provided by both FRGC and concrete sections. This phenomenon can be supported by the result of the present study wherein S-2 J exhibited 12% higher yielding load than S-1 J. Referring from Table 5, the initial cracking load increment for S-1 J and S-2 J can be calculated as equal to 7% while their post-cracking-to-yielding load deviation is 12%. These values indicate that the contribution of the initial cracking load response to improve the yielding performance from 1-sided (bottom) to 2-sided jacketing technique seems to be less significant than the post-cracking-to-yielding load response. Meanwhile, applying a 3-side jacketing approach to strengthen the beam showed a relatively high yielding load increase of 62% than its un-strengthened counterpart. Regarding the ultimate load capacity of the strengthened beams, the trend is similar to that in the first cracking and yielding conditions in which S-1 J and S-3 J demonstrated the least and largest value, respectively. Strengthening RC beam using bottom jacket increased the ultimate loading value by 21% while jacketing the three sides resulted to 62% load rejuvenation. The ultimate loading capacity of the beam jacketed at the two sides remained intermediate relative to beams S-1 J and S-3 J, obtaining 36% higher value than the control specimen. The increase may be credited to the fact that the rigidity of the jacket, regardless the type of configuration used, makes it the significant part in carrying the load compared with the un-strengthened beam.

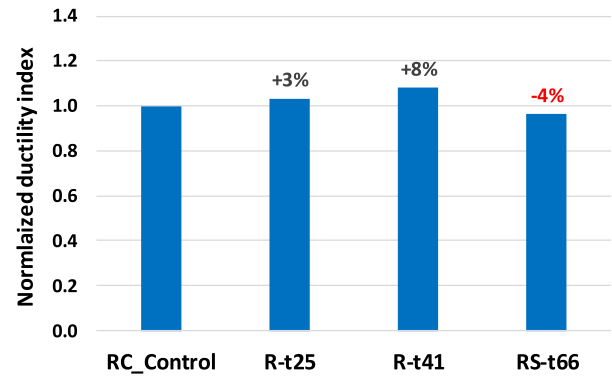
Fig. 10. Comparative curve of ductility performance for repaired beams.

Ductility in RC beam maybe defined as its ability to sustain deformation beyond the elastic limit while maintaining a reasonable load carrying capacity until total failure [24] and is one of the design parameters that needs to be identified to ensure desirable failure of the structural element. The addition of FRGC layer may not only provide positive impact on the RC beam in terms of increased the strength and stiffness but may also contribute in reducing its ductility. In the present study, ductility was described using an index in terms of deflection and quantitatively defined as the ratio between the deflection at peak load δ_{max} and the deflection at yielding load δ_y . Table 6 summarizes the ductility indices of the test specimens and the normalized values with respect to RC_Control are plotted in Figs. 10–11 for comparison. Fig. 10 illustrates that the ductility was increased when plain concrete was replaced by FRGC to restore its original cross section depending on the thickness repairing material. R-t25 demonstrated marginal ductility increase of 3% relative to the control beam. This indicates that a 25 mm FRGC replacement is not enough to significantly lower the neutral axis that leads to subsequent reaching of the compressive concrete crushing values soon after yielding of the beam tensile reinforcement. Assuming that total ruptures of the tensile FRGC happened before yielding of concrete, then the deflection response of R-t25 resembles that of the control beam indicating their respective ductility indices are getting comparable values, as evidenced by Fig. 10. Repairing the beam by a thicker 41 mm of the FRGC material resulted in a 1.46 displacement ductility that brought an increase of 5% and 8% relative to R-t25 and control specimen, respectively. Compared to R-t25, increasing the thickness from 25 mm to 41 mm tends to level up the effective tension FRGC that eventually lift the location of the neutral axis closer to the concrete extreme edge compression zone. The upward movement of the neutral axis has led to the reduction of the amount of strain introduced to the concrete in compression, thus allowing the beam to deflect more before attaining its crushing strain. It is suspected that the enhanced ductility was also provided due to the excellent FRGC-rebar bonding, that allows the yielded rebar to fully develop the plastic deformation before crushing of concrete in the compression zone. Among repaired specimens, RS-B66 showed the lowest ductility index corresponding to 7% and 12% lesser than R-t25 and R-t41, respectively. The addition of extra 25 mm thick FRGC in reference to R-t41 starts RS-t66 to resemble more that of an over-reinforced concrete beam. In general, beams repaired using these three patterns showed promising results of not only a providing a noticeable increase in ultimate capacity, but also without an appreciable compromise on the ductility of the structure.

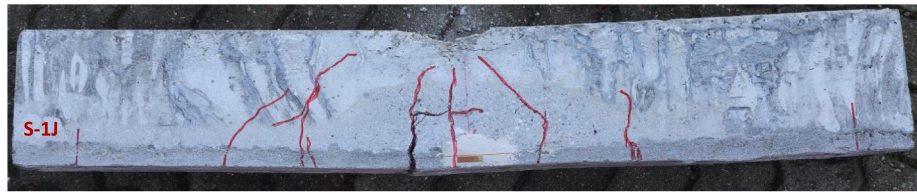
a. S-1J

c. S-3J

Fig. 16. Condition of strengthened beams at the end of the test.

Meanwhile, the cracking behavior of strengthened RC beams using bottom jacketing (S-1 J) looks similar with that of the repaired beams,

with relatively few visible cracks than the un-repaired beams (shown in Fig. 18). As displayed in Table 7, number of cracks on RC layer is reduced by 20% by FRGC bottom jacket indicating its effectiveness to suppress the crack development of the RC layer during the entire testing process. The cracking direction was also observed to propagate seamlessly from the bottom FRGC to the upper concrete portion, as can be seen in Fig. 16a. Unlike the repaired beams, a horizontal cracking was detected within the layers of concrete instead in the FRGC-to-concrete interconnections. In the case of S-2 J, cracks are purely vertical and concentrated at the mid-section of the beam as shown on Fig. 16b. It can be observed that the number of cracks for S-2 J is less compared to the control specimen of having only 3 fissures. Post-mortem examination of the strengthened beam revealed that no delamination was observed between the FRGC and concrete substrate regardless of its interface location (i.e., compressive and tensile regions). In addition, spalling of

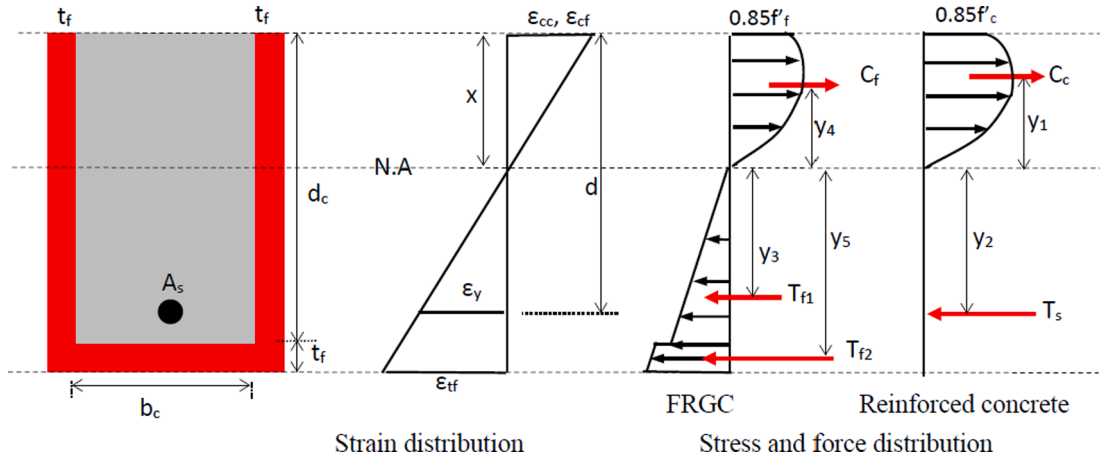
Fig. 20. Stress, strain and force distribution diagram for S-3 J.

and all calculations adopt that of the S-1 J. Figs. 18–20 demonstrates the superposition between the contributions of concrete in compression, steel reinforcement in tension and FRGC jacketing overlay in both compressive and tensile zones. At the ultimate condition, the steel reinforcement in the tensile zone yielded (F_y) while the concrete in the compressive region reaches its compressive strength, f'_c . Also, FRGC simultaneously reaches its ultimate tensile strength, (for S-1 J and other repaired beams) or reaching of both tensile strength, F_{fu} and compressive strength, f'_f (for S-2 J and S-3 J), with stress distribution along the beam section following from the FRGC material model shown in Fig. 17.
