Published in:
Infrastructures

Digital Image Correlation for Evaluation of Cracks in Reinforced Concrete Bridge Slabs

Abstract: In proof-loading of concrete slab bridges, advanced monitoring methods are required for identification of stop criteria. In this study, Two-Dimensional Digital Image Correlation (2D DIC) is investigated as one of the governing measurement methods for crack detection and evaluation. The investigations are deemed to provide valuable information about DIC capabilities under different environmental conditions and to evaluate the capabilities in relation to stop criterion verifications. Three Overturned T-beam (OT) Reinforced Concrete (RC) slabs are used for the assessment. Of these, two are in situ strips ($0.55 \times 3.6 \times 9.0$ m) cut from a full-scale OT-slab bridge with a span of 9 m and one is a downscaled slab tested under laboratory conditions ($0.37 \times 1.7 \times 8.4$ m). The 2D DIC results includes full-field plots, investigation of the time of crack detection and monitoring of crack widths. Grey-level transformation was used for the in situ tests to ensure sufficient readability and results comparable to the laboratory test. Crack initiatio

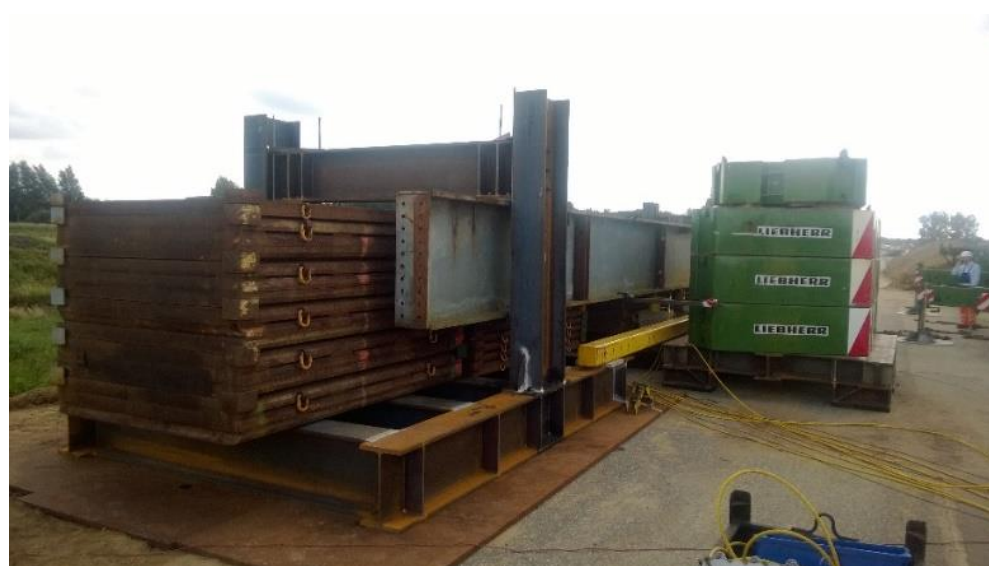
The two previously tested OT-slab bridges were tested in Jutland, Denmark, in summer of 2016 and winter of 2017 [3] (example photograph in Figure 2). The bridges were similar in composition and appearance with a difference in span only. Bridge 1 (422-0-005, Underpass of Foldagervej (road)) had a span of 11 m and Bridge 2 (422-0-009, Underpass of Rosmosevej (road)) had a span of 9 m. Both had a width of 12.2 m (37 beams). The in situ cast concrete was covered with a layer of protecting concrete, a thin bitumen membrane and finally a relatively thick asphalt layer.

Figure 2. Applied classification loads used for the in situ tests. Standard vehicle A adjacent to standard vehicle B.

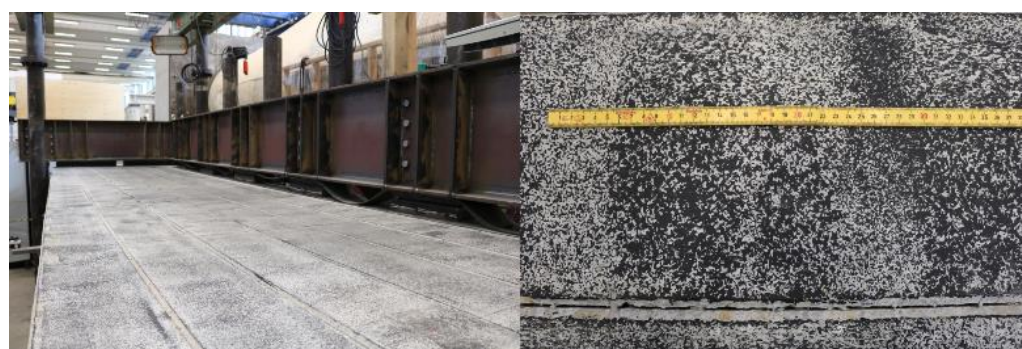
Figure 8. Contrast pattern on slab surface.

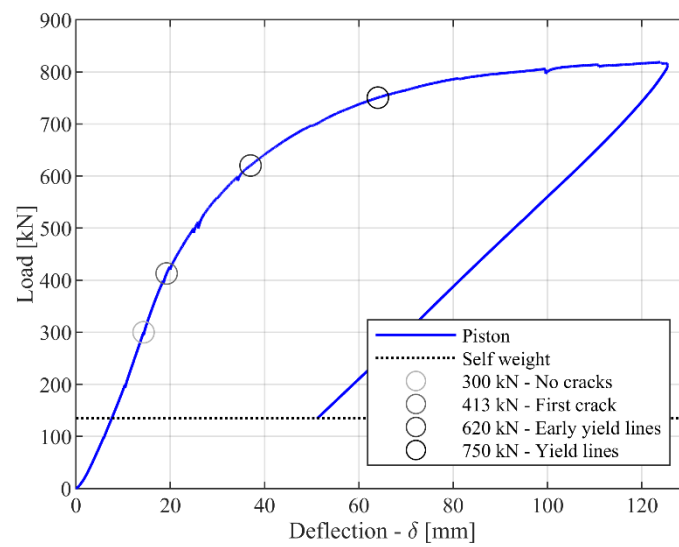
Figure 11 shows the load/deflection curve for the lab test with markers for four distinct crack development stages: (1) no detectable cracking, (2) crack detection, (3) developed cracks and beginning yield lines, (4) fully developed yield lines. It is clear that crack detection occurs in the linear elastic regime before any stiffness change. Crack patterns for the different stages are shown in Figure 12.

The more developed cracking stages might appear dramatic, but these should always be coupled to the magnitude of the applied load. For instance, at 620 kN, which on the load/deflection curve would indicate minor or no plastic deformation, the load level is already at a significant magnitude. Consequently, a lower load level may already have fulfilled a desired target load.

Figure 11. Load/deflection curve—lab test.

In the laboratory test, cracks were identified in the linear elastic regime before any significant stiffness change (Figure 11). The surface pattern (Figure 9) provided a noise level which was sufficiently low for smaller subset configurations (e.g., 15/5) to work well. Larger subset configurations smoothen the strain intensities and make definite crack detection more challenging (Figure 10). In the strip tests, cracking was detected at a later stage in the load/deflection curve; however, multiple factors influence this observation. The general setup of the lab test and strip tests have different supporting conditions. From the strip test results, it is seen that the first cracks form through all 11 beams in the slab and that the cracks form from one DIC image to the next (Figure 18) with no prior indications of cracking. In the load/deflection curve, this results in a sudden stiffness change. The load and boundary conditions in the lab test differ from the in situ strip tests. Consequently, the slab tested in the laboratory is constrained by the longitudinal support and cracking occurs more gradually. In the early crack stages, only the outer OT-beams are cracked and the stiffness change is not as sudden. In addition, the image capture interval in the strip tests (3 min/image) is larger than for the lab test (10 s/image). This means that cracks might have been identified earlier if more images had been captured. Nonetheless, clear cracking seems to happen from one DIC image to the next with no prior indications. Consequently, it appears that cracking occurs between the two images and not earlier.

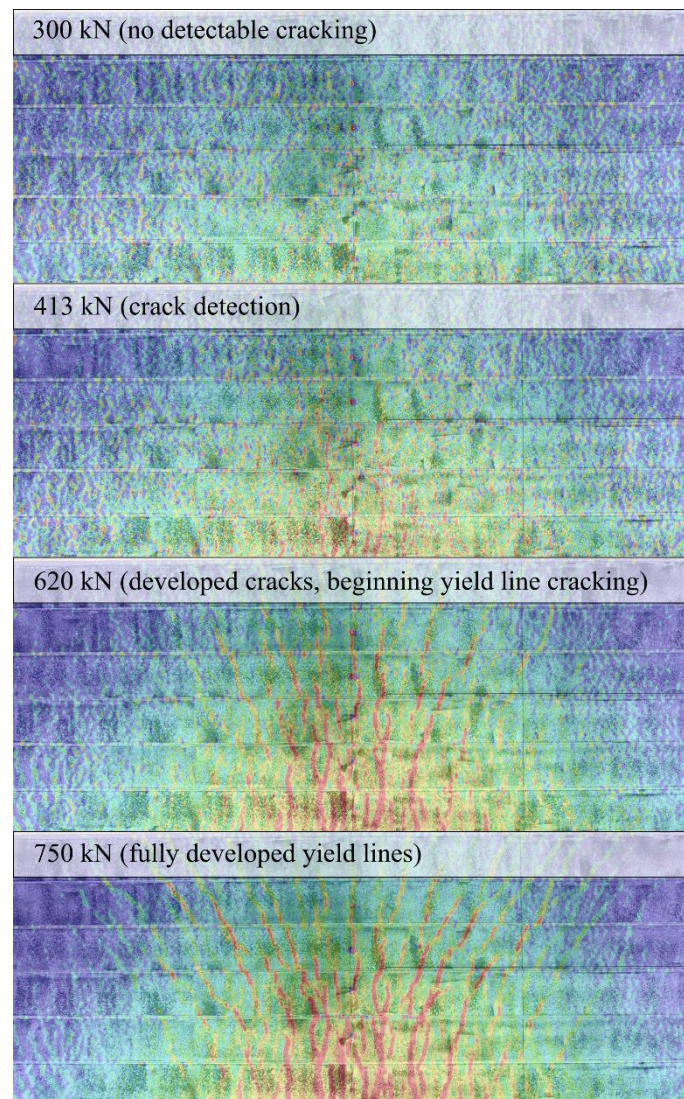
Figure 12. Lab test crack development stages.

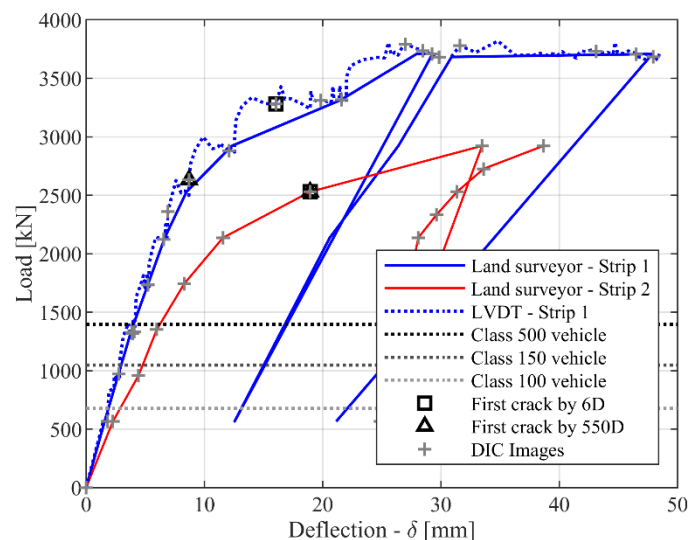
The results from Strip 1 includes continuous data logging throughout the test supplemented by manual results from a land surveyor. For Strip 2, an error occurred in the logger system and therefore only land surveyor data exist. In addition, Strip 2 was tested at a higher load rate than Strip 1 due to time limitations. The load/deflection curves can be seen in Figure 14. It is seen how the full data from LVDT show a more detailed loading acquisition, whereas the land surveyor data provide a smoother curve due to fewer data points. The figure also shows the frequency of DIC images (crosses) and first detection of

cracking with two different cameras. In addition, loading equivalent to Class 100, 150 and 500 vehicles are depicted for comparison. The Class 500 vehicle is the heaviest standard vehicle, whereas the Class 150 vehicle is usually applied for new bridges and Class 100 for existing bridges.

Figure 14. Load/deflection curve—strip tests.

The times of crack detection are marked in Figure 14 for both strip tests. It is seen how the cracks are detected a bit later on the load/deflection curve than for the lab test in Figure 11. The crack formation is observed as more sudden from one image to the next and it is involving all 11 beams in the slab along with a significant stiffness change.

An image capture interval of 3 min was used for the data sampling. If the interval had been lower, the cracks may have been detected earlier. For Strip 1, it is seen from Figure 14 that the cracks are not detected simultaneously with the two cameras. This is because only slight indications of cracking are visible with the Canon 6D camera on earlier images.

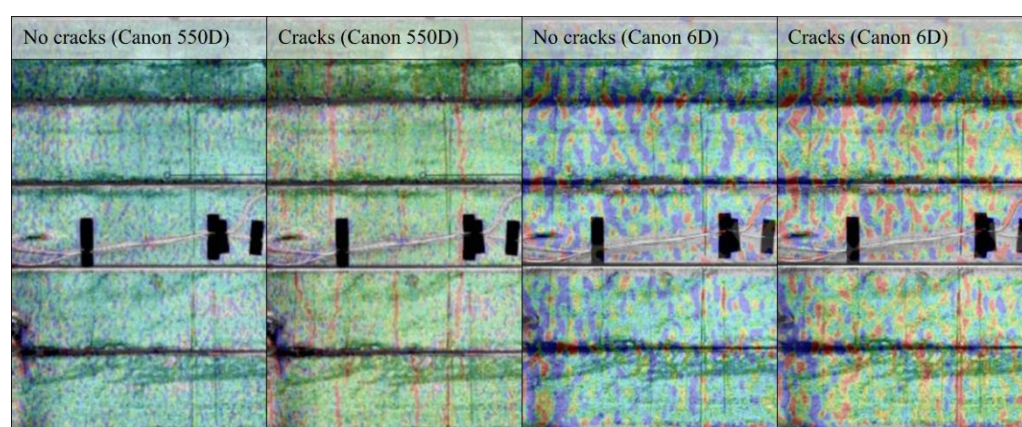
Images before and after crack detection are shown for both cameras for Strip 2 in Figure 18. It is seen how the images at a larger distance using the Canon 6D camera have noise to an extent that makes it difficult to see cracking. With the Canon 550D camera, the cracks are very well defined in comparison. The effect from camera distance on resolution is also clear when comparing that the images from the Canon 550D camera have 1.72 px/mm and the images from the Canon 6D camera have 0.69 px/mm. However, the use of two cameras ensures that both the full-field results are captured as well as more detailed data from the closer camera. The Strip 1 data show similar results, although with slightly lower quality for the Canon 550D camera due to the 8-bit JPEG images.

Figure 18. Crack Detection for Strip 2. All with Subset 30/10.

Given this sudden crack formation and viewing Figure 18, it seems that cracks are formed between two images (“No cracks” and “Cracks”) and that no indications of cracks are present prior to this. Additionally, the simultaneous cracking of the beams indicates a well distributed load on the prestressed OT-beams.

Compared to the lab test, a larger amount of noise is present in the strip test DIC results, especially for the Canon 6D camera at a distance of 3.8 m (Figure 18). This camera does, however, provide a good method to evaluate and verify the overall structural behavior during loading (load placing, symmetry, boundary condition, etc.). Accordingly, the use of two cameras shows how multiple independent monitoring systems can work in synergy in a desirable way. The enhancing of the images by linear grey level transformation enables the Canon 6D camera to provide full-field data, whereas the Canon 550D provides better crack monitoring in an area of interest. Intelligent positioning of the cameras is therefore one of the key elements to successful monitoring and ultimately identification of stop criteria.

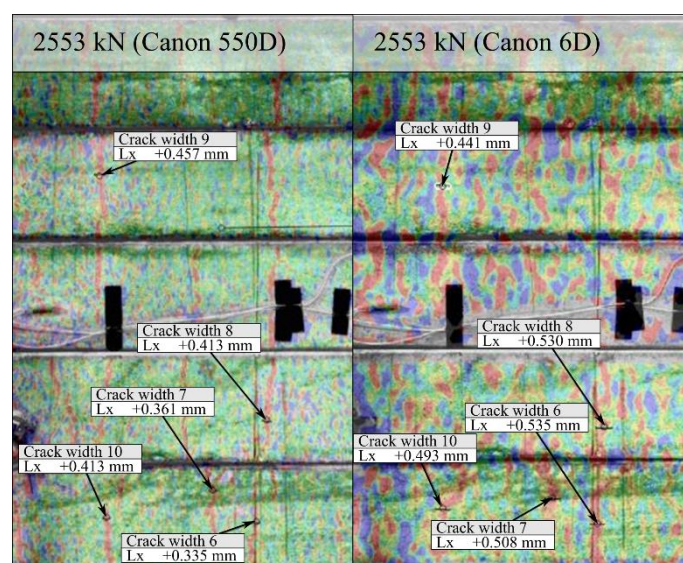
For Strip 2, the crack detection occurs simultaneously. Five cracks are monitored, as seen in Figure 20. Clear crack indications are visible for Canon 550D, while the plot for Canon 6D is dominated by noise.

Figure 20. Crack widths at crack detection for Strip 2.

The measured crack widths, corrections and corrected values are given in Table 4. Before correction, the crack widths measure between 0.335 mm and 0.457 mm for Canon 550D and between 0.431 mm and 0.535 mm for Canon 6D. After correction, they measure between 0.175 mm and 0.240 mm for Canon 550D and between 0.236 mm and 0.328 mm for Canon 6D. It is seen how the Canon 6D results generally measure larger crack widths, similarly to the Strip 1 results. Applying the stop criteria from the German guideline, all measured cracks are detected in time. However, only some of the measured crack widths for Strips 1 and 2 are below the EC2 threshold at the time of crack detection and none are from the Canon 6D results.
