Published in:
Journal of Cultural Heritage

The mysterious mould outbreak - A comprehensive fungal colonisation in a climate-controlled museum repository challenges the environmental guidelines for heritage collections

3.1. Study site and previous interventions

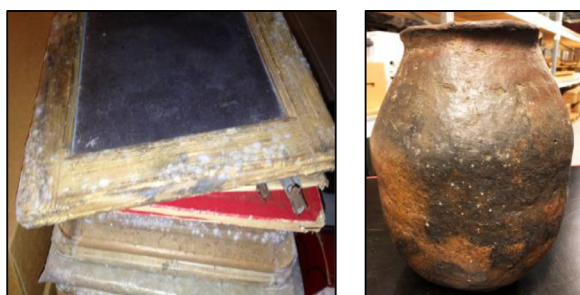
Fig. 2. Fungal contaminated blackboard and archaeological ceramic urn.

Penicillium sp., and *Stachybotrys chartarum* from the examined museum artefacts (Table 1). The colours of the species on V8® were brown, green/blue, black, and yellow, while the colour of the growth on the heritage artefacts was white (Fig. 2). The report concluded minor to moderate growth.

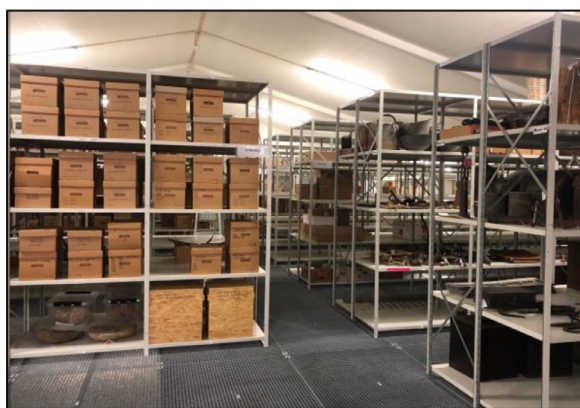
**Fig. 4.** The repository was well-maintained with no evidence of discolouration on walls/ceiling due to leaks or water damage.

The outdoor and indoor building inspection confirmed a well-maintained building envelope with no evidence of leaks causing water damage, no discolouration on walls/ceiling and no evidence of rising soil moisture (Fig. 4). Annual data loggings from 2010–2012 showed RH fluctuating between RH 50–57% and T 4–21°C (Fig. 3).
