Conservation compatible energy retrofit technologies

Part III: Documentation and assessment of materials and solutions for wall insulation in historic buildings

Part III - Documentation and
assessment of materials and
solutions for **wall insulation**
in historic buildings

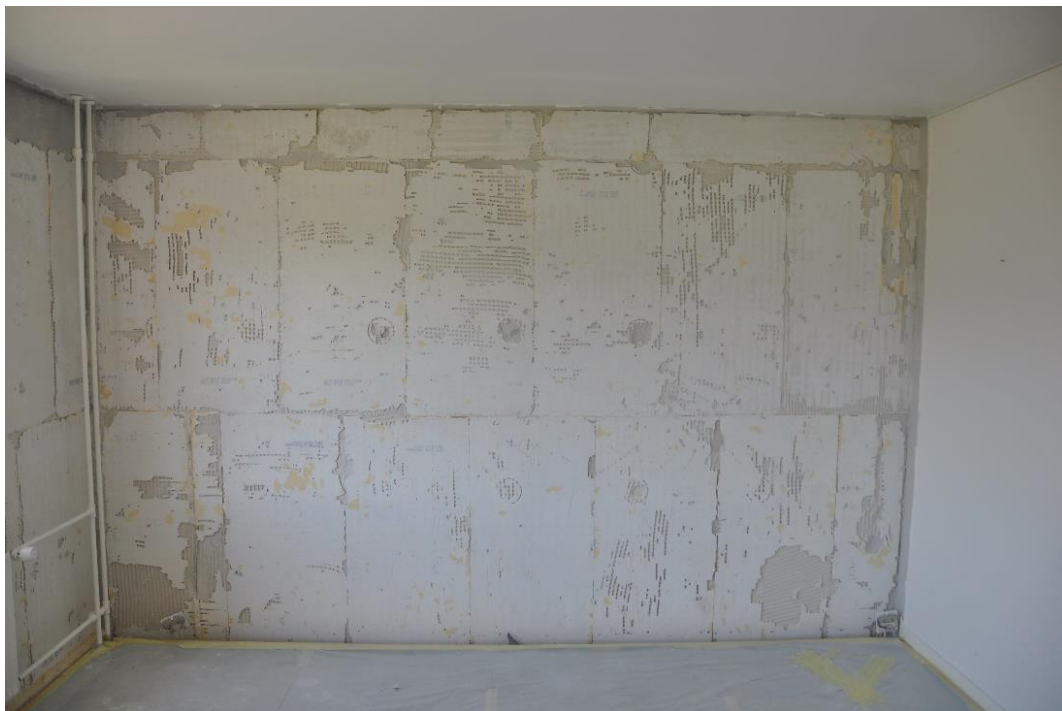
figure 13: View of gable wall after removing the internal insulation, to look for mould growth two years after installation. No mould growth was identified; however, the view shows that the insulation system did not fully bond to the existing wall. © AAU

some of the test apartments, the insulation was removed again after two years to see whether there was any mould growth at the interface between the insulation and the original wall.

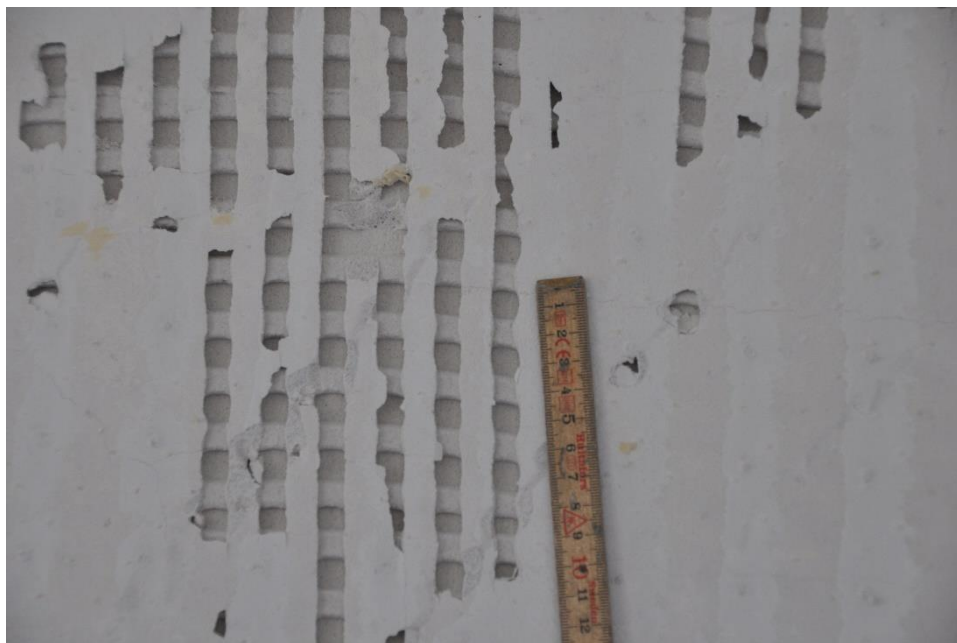
figure 14: Close up of the wall in figure 13 showing the size of the areas with no bonding. According to the producer, opening of max 4x4 cm are accepted © AAU

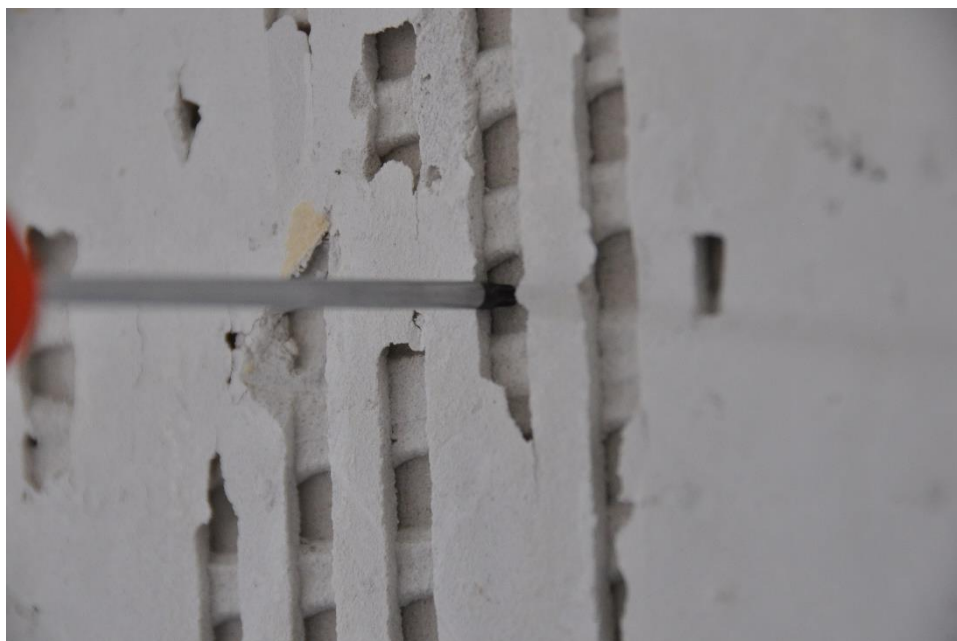
figure 15: Close up of the wall in figure 13 indicating the depth of the area without bonding. © AAU

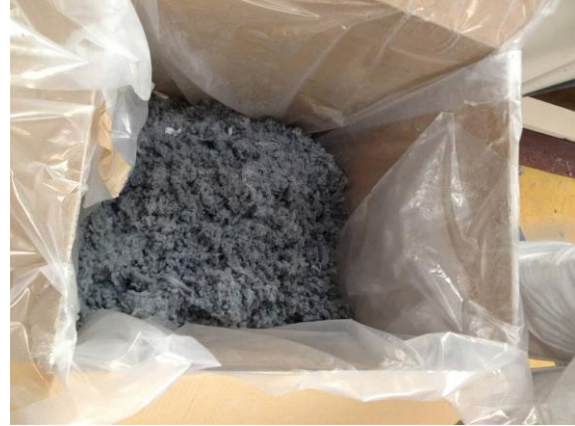
figure 83: Loose material, © Elena Lucchi (Eurac)

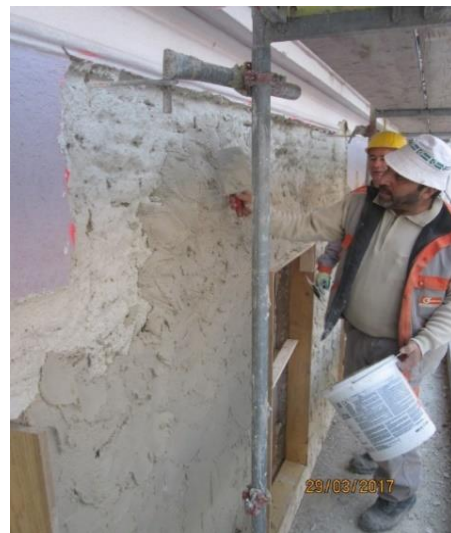
figure 125: Application of the aerogel plaster, © Trimmel Wall Architekten ZTGmbH

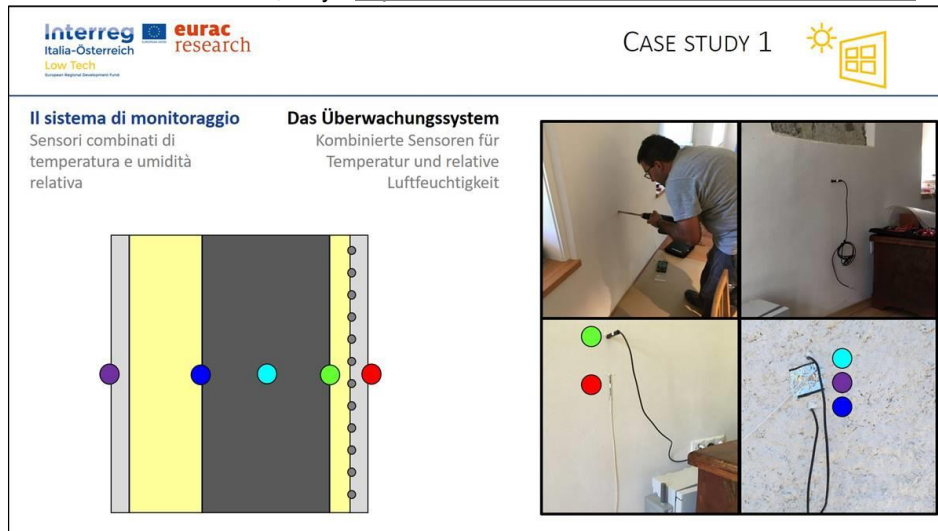
figure 139: Monitoring system of the construction, © Eurac

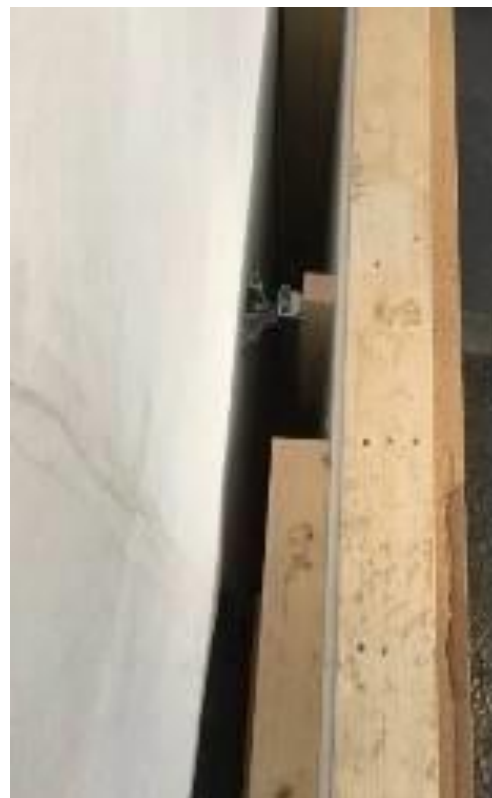
figure 154: Detail of the facade, © Michael Flach

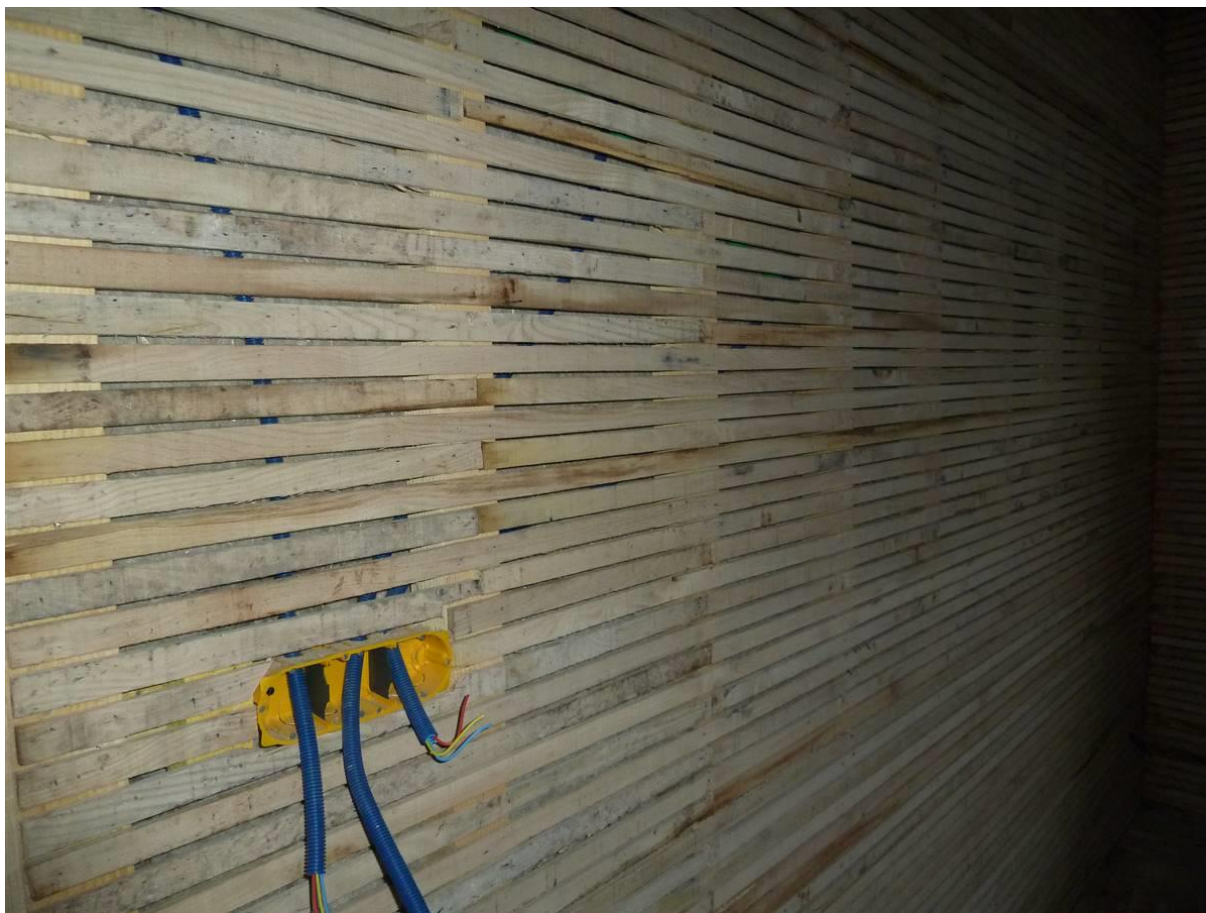
figure 164: Chestnut laths as a support for the earth render

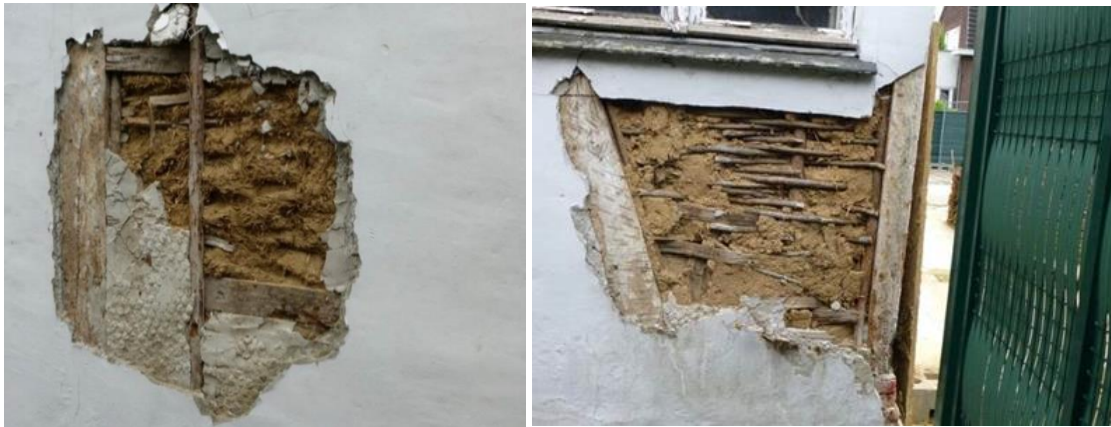
figure 177: Details of the original wall composition with wooden fence, visible wickerwork and loam (copyright Erfgoed en Visie bvba)
