A pilot study on the use of the heavy/soft impact source for building acoustic impact measurements in housing

Published in:
ICA 2022 Proceedings of the 24th International Congress on Acoustics

Birgit RASMUSSEN¹; Rasmus Stahlfest Holck SKOV²

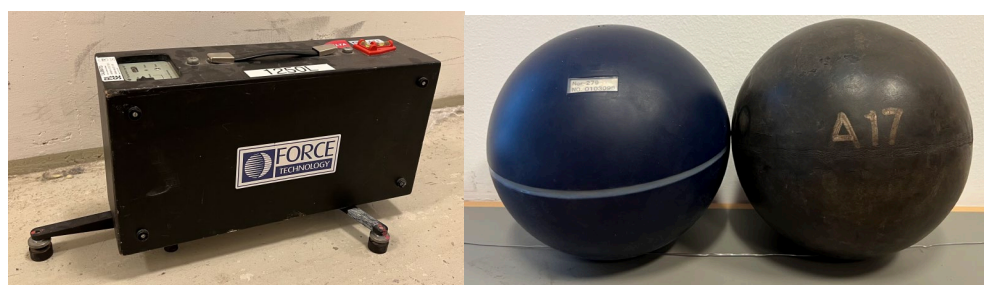
Figure 2 – Left: Tapping Machine B&K 3207; Middle: Impact Ball Nor279; Right: Impact Ball (Old Ball)

The following test equipment was applied: Sound level meter B&K 2270, tapping machine B&K 3207, B&K microphones, an old impact ball (Japanese prototype, probably from before year 2000) and a new rubber ball Nor279. The tapping machine and the impact balls are shown in Figure 2.

The reason for using two rubber balls was that we started out using FORCE’s old rubber ball, being unaware of the physical characteristics not complying with the new standards, and it was only in the middle of the test series, when discussing verification checks of equipment, we became suspicious, and rented (later bought) a new ball to check that the old ball could still be used. However, this turned out to be impossible for standardized measurements since the results for the two balls were very different. Nevertheless, we continued to use both impact balls, hoping to see systematic differences and to learn something about these two balls.

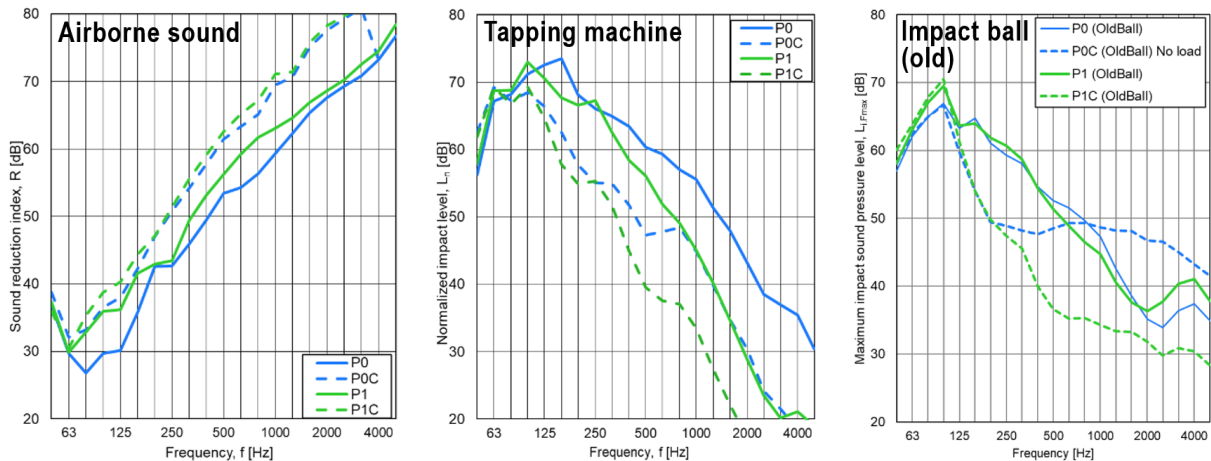
Figure 3 – Laboratory measurement results for timber floor with and without additional ceiling: (3a) Airborne sound insulation R; (3b) Impact sound level L_n ; (3c) Impact ball (Old Ball) $L_{i,Fmax}$. Legends: Solid lines for construction without ceiling; Dashed lines with ceiling.

In Figure 3 are shown laboratory measurement results for timber floor with and without additional ceiling. Table 3 and results in Figures 3a and 3b show improved results with the ceiling installed. In Fig. 3c for the rubberball measurement, it is not possible to interpret why the blue dashed line for P0C is higher (worse) than the others in the upper frequency range.

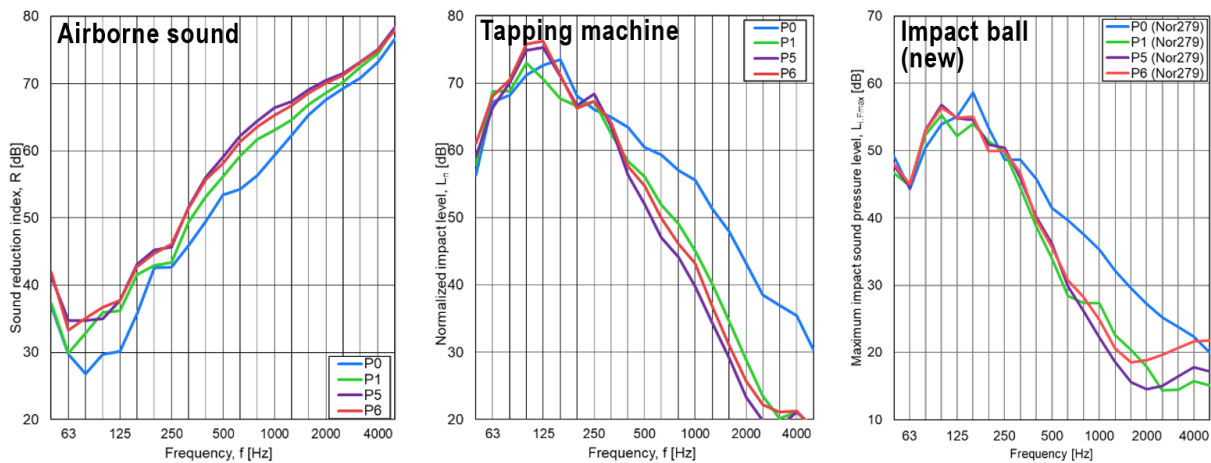
Figure 4 – Laboratory measurement results for timber floor with and without additional flooring: (4a) Airborne sound insulation R; (4b) Impact sound level L_n ; (4c) Impact ball (Nor279) $L_{i,Fmax}$.

In Figure 4 are shown results for P0 (basic timber floor) and the timber floor with three parquet floor solutions. Results for P5 and P6 are as expected almost identical, and results for P1 slightly different. The reason for P5 and P6 was to test very basic floor solutions as typically applied in practice, when replacing a worn out floor. Note different dB axes in (4a) and (4b).

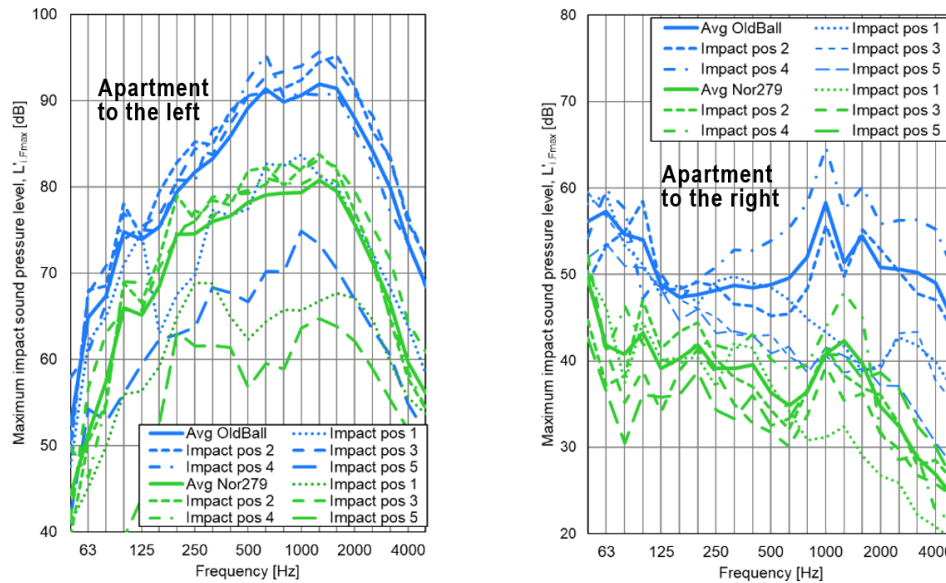
Figure 6 – Field test results $L'_{i,Fmax}$ for the impact ball method in two apartments: Individual impact positions and average results of the two impact balls, blue (old ball) and green (Nor279) respectively. (6a): Apartment to the left G121tvSS; (6b) Apartment to the right: G121thSS

Field test results for the individual rubberball impact positions in the apartments are found in Fig. 6a and 6b for the left and right apartment, respectively. Ideally, the two apartments should give similar overall results, but there are obviously huge differences between ball impact positions. Other things being equal, it seems as if much lower levels occur, when the ball hits the joists than when it hits between the joists. The apartments were occupied, and we did not have access for further measurements in the pilot study. Note different dB axes in (6a) and (6b).

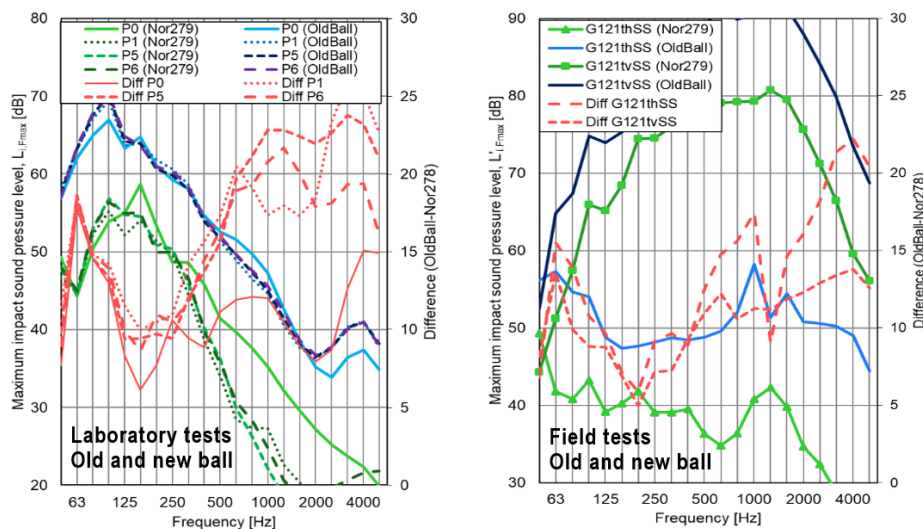
Figure 7 – Comparison of the two impact balls in laboratory $L_{i,Fmax}$ (left) and field $L'_{i,Fmax}$ (right). The red curves show the differences between the old and new ball.

Note: The two diagrams have different dB-scales (left axes). Differences between the old/new ball are in red (dB scale right axes)

Since there is a need to understand better the behaviour of the rubberball impact results, it was found appropriate to show all results from the laboratory and field in two diagrams, see Fig. 7 with laboratory results in the left diagram and field results in the diagram to the right.

For the laboratory results, the differences between the old and new ball are similar up to about 250 Hz. However, with an additional floor, there are large differences above 250 Hz. For field results, the largest differences between the balls are found for the “th” apartment. In summary, the results show that we cannot convert results from one type of ball to the other one.
