Published in:
Energy and Buildings

Long term in situ measurements of hygrothermal conditions at critical points in four cases of internally insulated historic solid masonry walls

Tessa Kvist Hansen , Søren Peter Bjarløv ,
Ruut Hannele Peuhkuri , Maria Harrestrup

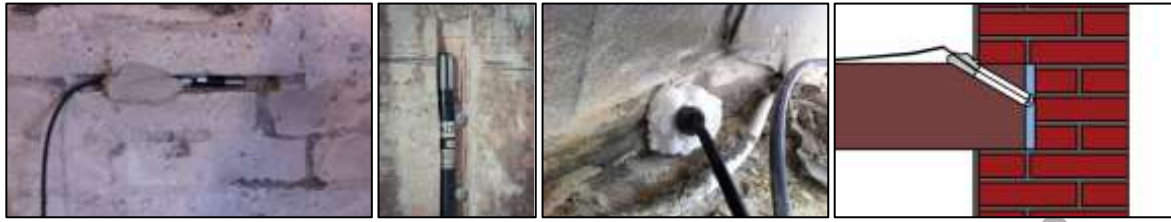
Figure 1: Sensor locations. From left to right; sensor in existing joint, purposely designed notch and in hole through beam end.

either existing joints, or purposely designed notches in the existing wall. Sensors behind beam ends are placed through holes drilled in the beam, and the holes then sealed with foam. Examples of sensor locations can be seen in Figure 1.

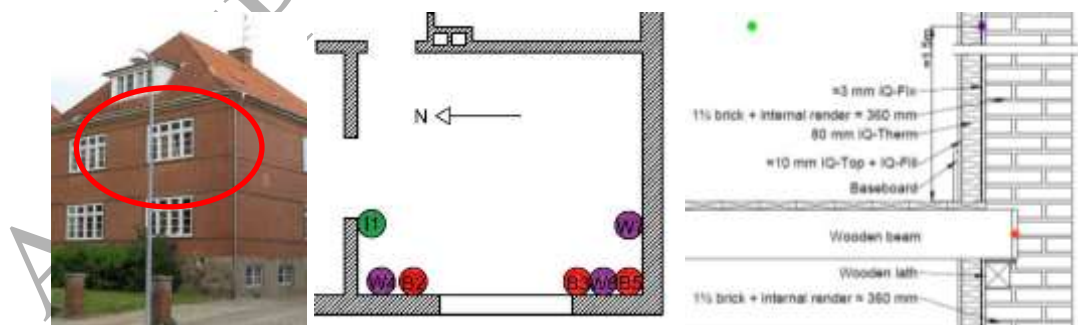
Figure 2: left to right; Ny Allegade facade with indication of insulated walls, sensor placement on floor plan, and construction with sensor placement.

The case building in Haderslev is a 2 story building from 1932, with a bare brick surface, as seen in Figure 2. In the spring of 2015, 80mm of system 2 (30mm at spandrels) was installed on the west and south facades of both the 1st and 2nd floor. Figure 2 also displays the sensor locations on the floor plan, and construction plan. Sensor I1 represents interior conditions, sensors W4, W6 and W7 represent conditions at the interface, and sensors B2, B3 and B5 represent conditions behind beam ends in the west orientated façade.

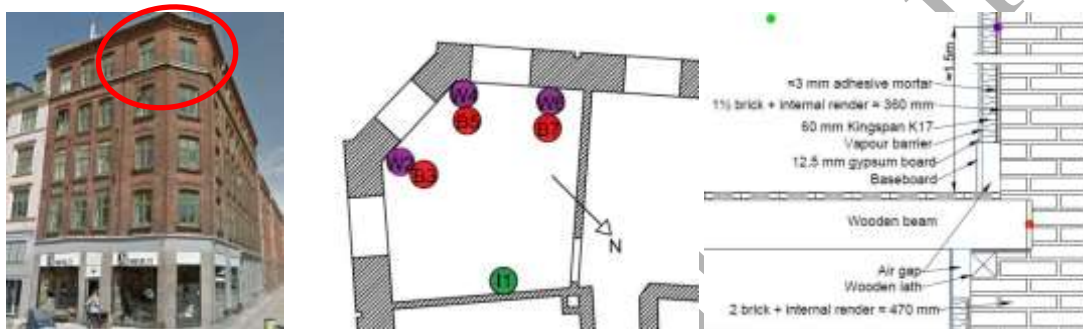
Figure 3: left to right; Meinungsgade facade with indication of insulated walls, sensor placement on floor plan, and construction with sensor placement.

This case building is from 1877, and the measurements are performed on the south and southwest walls on the 5th floor. During the winter of 2015 the walls on the 4th and 5th floor, were insulated with 60mm of system 1 (20mm for spandrels). Furthermore, a gap of 20cm was left above the floor, for the creation of an intentional thermal bridge; the construction is seen in Figure 3. A floor plan with indications of sensor locations is also seen in Figure 3; sensor I1 represents interior conditions, sensors W2, W4 and W6 are placed at the interface; and sensors B3, B5 and B7 are behind the beam ends. Figure 3 also displays the façade, and as it can be seen, there is no visible surface treatment.

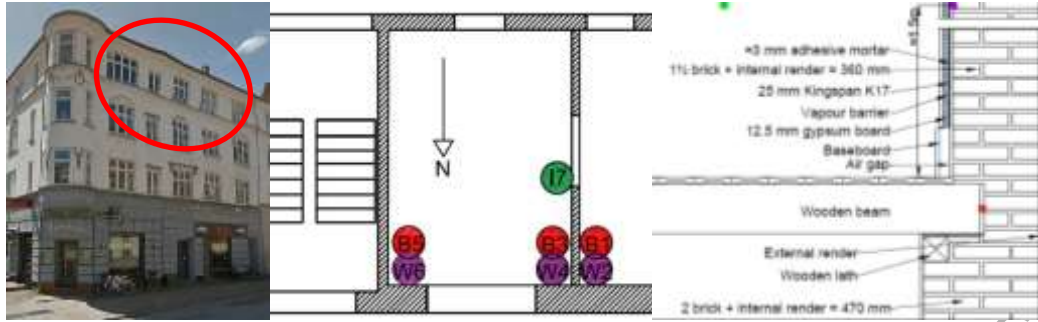
Figure 4: left to right; Kildevældsgade facade with indication of insulated walls, sensor placement on floor plan, and construction with sensor placement.

The case on Kildevældsgade is a building from 1905, and has a rendered façade, as can be seen in Figure 4. 25mm of system 1 (20mm for spandrels) was installed in March 2015 on the northern façade of the 3rd floor. As indicated in Figure 4, a 20cm air gap above the beam was included for the intention of creating a thermal bridge, thus increasing the temperatures at the beam end. Figure 4 also displays a floor plan with an indication of sensor locations. Sensor I7 represents interior conditions, while sensors W2, W4 and W6 represent conditions at the wall-insulation interface, and sensors B1, B3 and B5 represent conditions behind the beam ends. Note that the floor beneath has not been insulated, and thus higher temperatures at the beam ends are expected compared to if both walls were insulated.

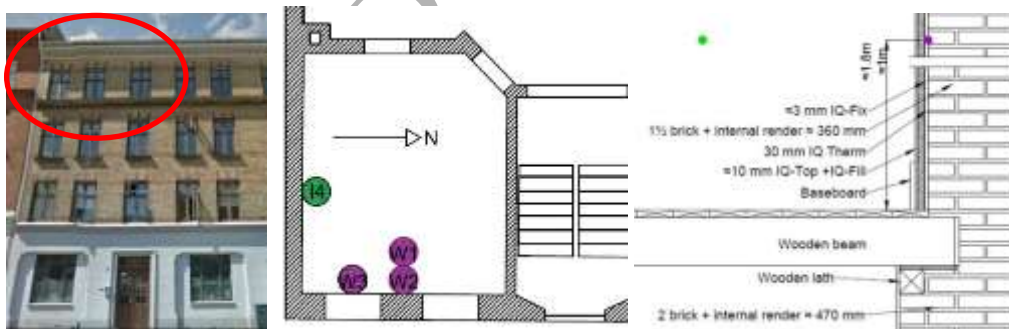
Figure 5: left to right; Thomas Laubs Gade facade with indication of insulated walls, sensor placement on floor plan, and construction with sensor placement.

The case on Thomas Laubs Gade is a building from 1899 with an exposed brick surface, as seen in Figure 5. The eastern façade on the 3rd floor was in the fall of 2015 insulated with 30 mm system 2 except the spandrels which were insulated with 50 mm calcium silicate (SLP CS 50). Figure 5 also illustrates the floor plan with indication of sensor placements, and the construction. In this case there are no sensors in the beam ends. Sensor I4 presents the interior climate readings; sensor W3 is placed behind the calcium silicate in the spandrels, whereas sensor W1 is placed above sensor W2 at the interface between the insulation and the external wall. Unfortunately sensor W3 lost all contact during the summer of 2016. And all sensors lost connection for a period of about 3 months, March 2017 - June 2017.

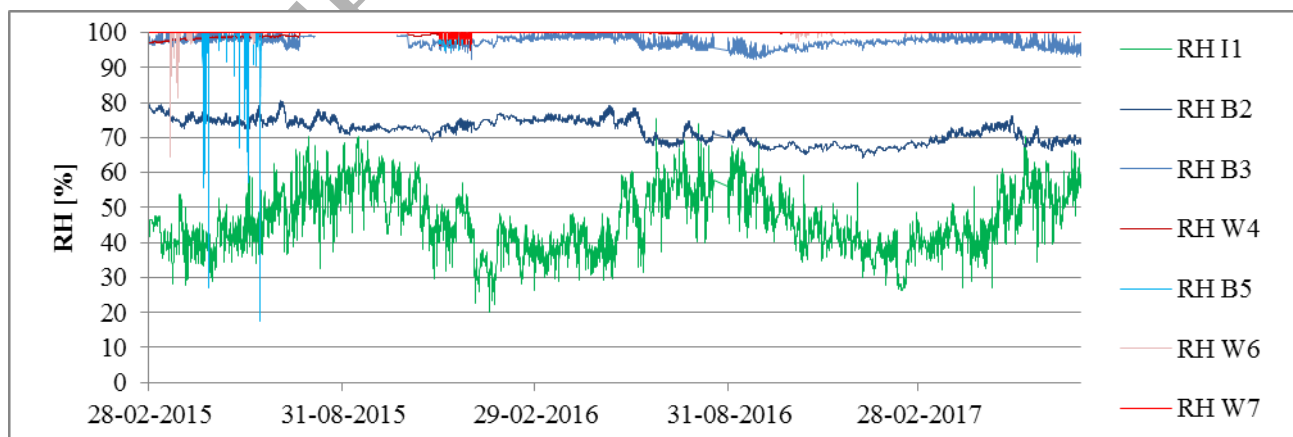
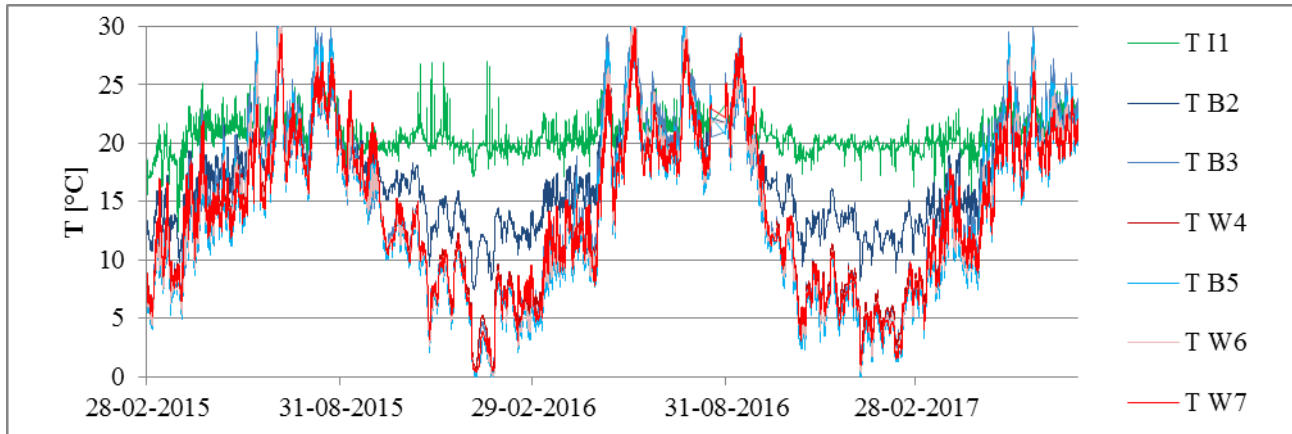
Figure 6: Measured hygrothermal conditions measured in Ny Allegade (80mm, system 2, western (W4, W6, B2, B3, B5) and southern (W7) façade). The blue nuances represent sensors behind the beam ends, whereas the red colors represent sensors at the wall-insulation interface.

Hourly averages of measurements performed are presented in **Error! Reference source not found..** The relative humidities at both wall interfaces and cavities behind the beam ends are above 95 % during the measurement period, with the exception of sensor B2. During the 2½ year measurement period, there is no indication of significantly reduced relative humidity in either the wall interfaces or behind the beam ends. It is a known fact that built-in moisture, due to the installation of internal insulation takes time to dry out, but after the first year the installation moisture from the glue mortar can be considered of no influence [29]. There is no observable difference in wall measurements on the west and south façades. The outlier, sensor B2 however, exhibits acceptable conditions below 80% relative humidity for the entire period. Sensor B2 is placed towards the middle of the wall, as opposed to B3 and B5, which may reduce the impact of driving rain in this position [32]. The temperature measurements however, also reveal higher temperatures at B2 during winter, thus increasing the drying potential. The higher temperature may indicate the placement of a hot water pipe or the like, or that the sensor is not placed at the end of the beam, but rather within the beam, and thus closer to the warmer interior conditions. Also, the beam end might be dryer than the cavity behind the beam, as the wood fibers of the beam end transport the moisture inwards. In these cases, the measurements in B2 are not representative and should be discarded. The measured interior conditions seem stable at 20°C and seasonal variation of 30-70% RH. The interior conditions do not seem to effect the hygrothermal conditions in sensor locations, although temperature measurements in sensors resemble the interior temperature during summer seasons.

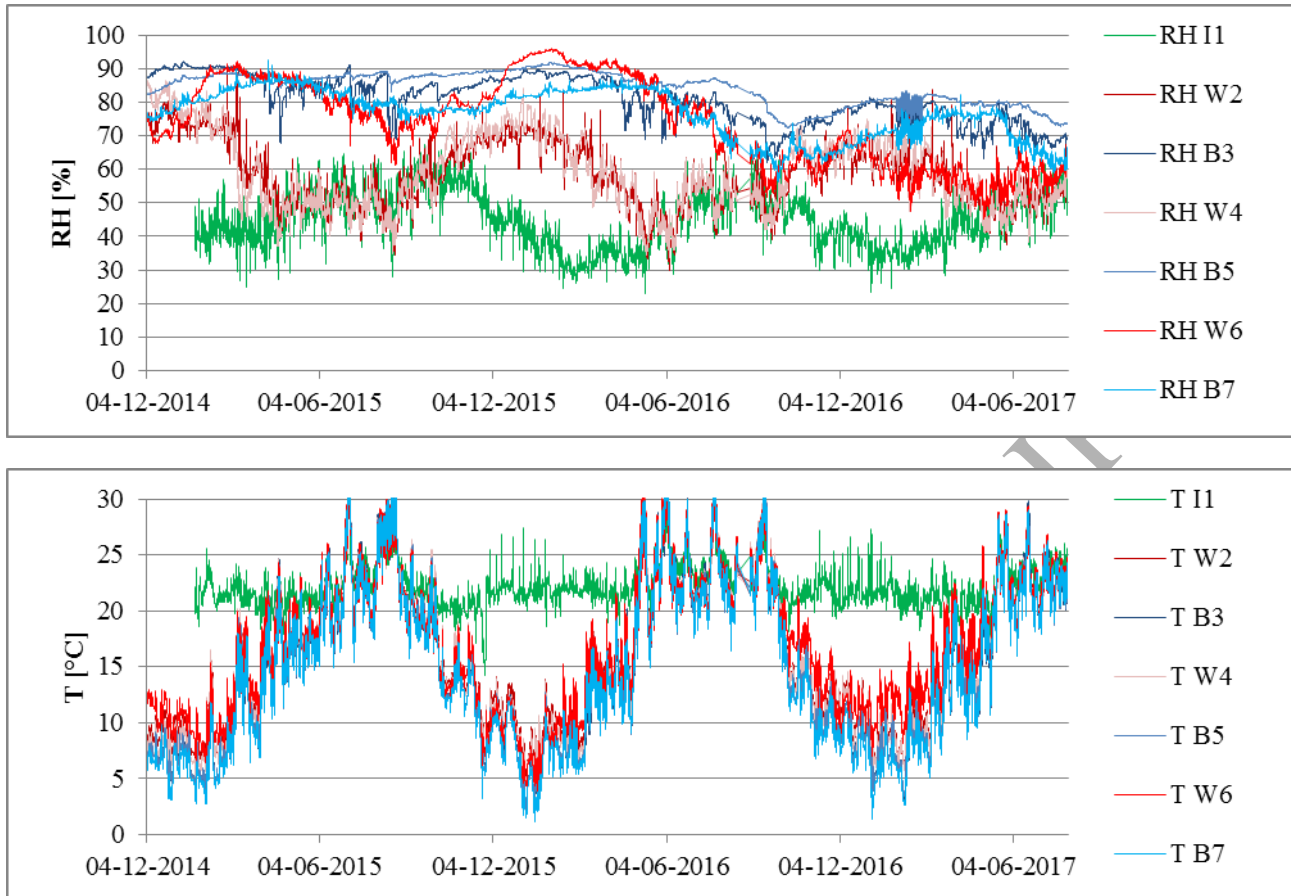
Figure 7: Measured hygrothermal conditions in Meinungsgade (60mm, system 1, southern (B3, W2) and southwestern (B5, B7, W4, W6) façade). The blue nuances represent sensors behind the beam ends, whereas the red colors represent sensors at the wall-insulation interface.

Generated hourly averages from measurements performed in Meinungsgade are represented in **Error! Reference source not found..** For wall interfaces, sensors W2 and W4, it is seen that the relative humidity rarely exceeds 80%. It is seen that for warmer periods, the relative humidity resembles interior conditions, whereas the external moisture influences during winter are apparent, as the relative humidity increases. The integrated vapour barrier inhibits drying inwardly in the colder periods when the masonry becomes moist. The relative humidity at the wall interfaces fluctuates between 40-80% which is considered acceptable. In the first 2 years, sensor W6 generally exhibits higher relative humidity. This sensor is located by an indentation in the wall for the previous installation of a downspout. This indentation makes the wall thinner, thus the penetration of wind driven rain may reach closer to the sensor. The indentation furthermore limits the drying potential in form of both radiation and wind. Additionally, sensor W6 is placed in southwest orientation as opposed to south, as W2 and W4. This again contributes to more wind-driven rain and less sun at W6 compared to W2 and W4. The conditions behind the beam ends are rather high, 70-90%, during the first 2 years of measurements. For the last months of measurements, the relative humidity barely exceeds 80%. Neither weather data from Copenhagen or interior conditions indicate any obvious explanations for the 2-year drying period. The beam ends are embedded in the wall, so the external wall is thinner at the location behind the beam ends, thus leaving this area more exposed to external conditions, such as penetrating wind-driven rain. The intentional thermal bridges do not seem to have the desired effect; the temperature behind the beam ends is the same, or less than, the temperature at the wall interfaces. The temperature conditions show very similar results for all sensors. During summer, the temperatures resemble the interior conditions. This tendency also applies to the relative humidity measurements after the initial drying period.

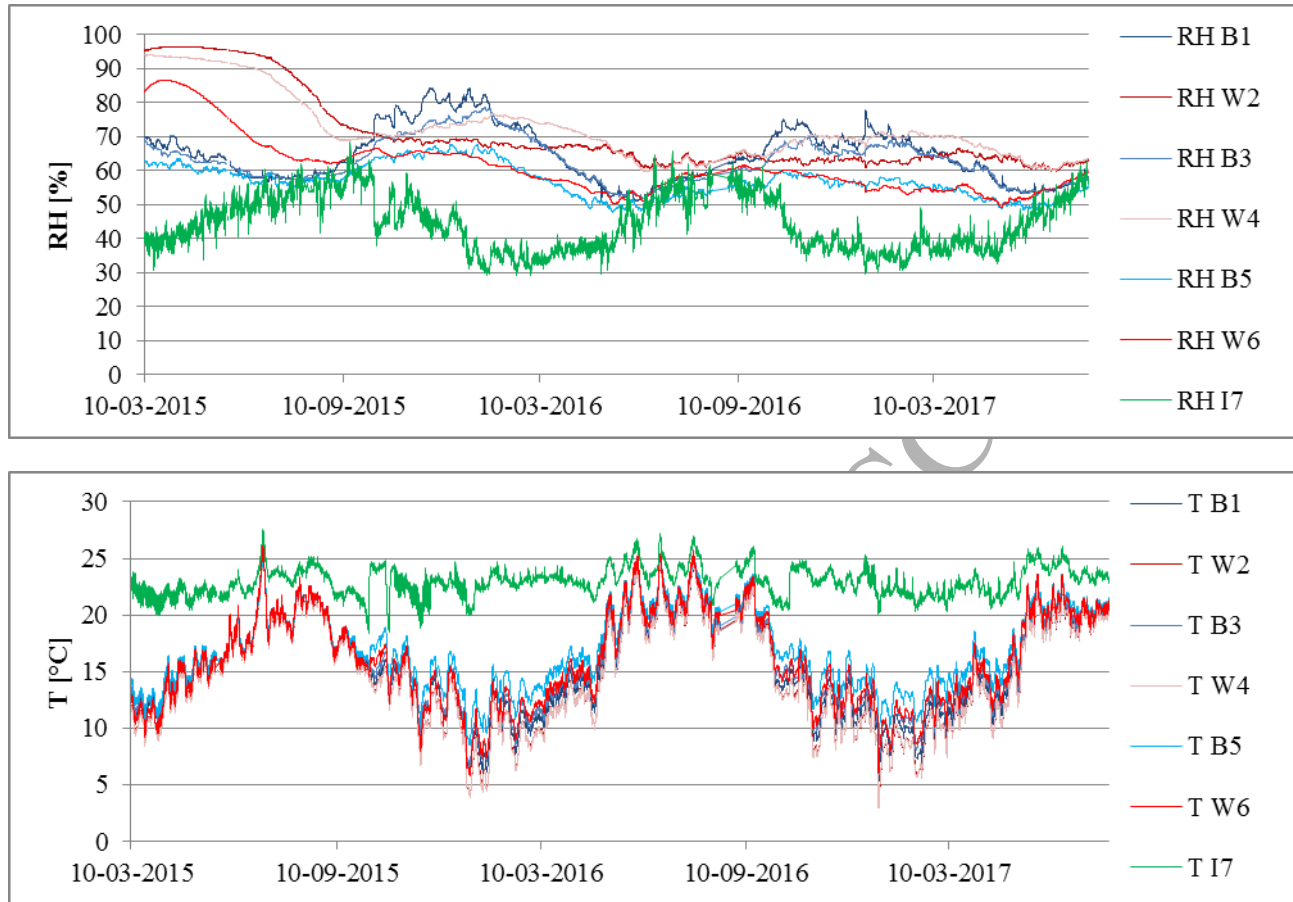
Figure 8: Measured hygrothermal conditions in Kildevældsgade (25mm, system 1, southern (B3, W2) and southwestern (B5, B7, W4, W6) façade). The blue nuances represent sensors behind the beam ends, whereas the red colors represent sensors at the wall-insulation interface.

In the case of internal insulation installed in Kildevældsgade, the initial building moisture and successive drying out period is very apparent; see **Error! Reference source not found..** In the first 6 months, the relative humidity is very high in the wall interface, sensors W2, W4, W6, and hereafter a seasonal dependency is apparent, but the relative humidity does not exceed 80 %. During the course of measurements, sensor W6 exhibits a significantly faster decline and generally lower relative humidity compared to the other wall sensors. There is a slightly higher temperature measured by W6, and by studying pictures from the installment of insulation, it is seen that hot water pipes are installed in the vicinity of sensor W6, increasing the drying potential in this area. The beam end sensors also do not exceed 80% relative humidity, with the exception of sensor B1 that exceeds 80% for shorter periods during the first winter. It is seen that sensor B5 has the lowest relative humidity, and again this can be explained by a slightly higher temperature, or possibly the location of the sensor not drilled all the way into the cavity behind the beam end. The temperature and

relative humidity both behind the beam ends and at the wall-insulation interfaces resemble the interior conditions measured.

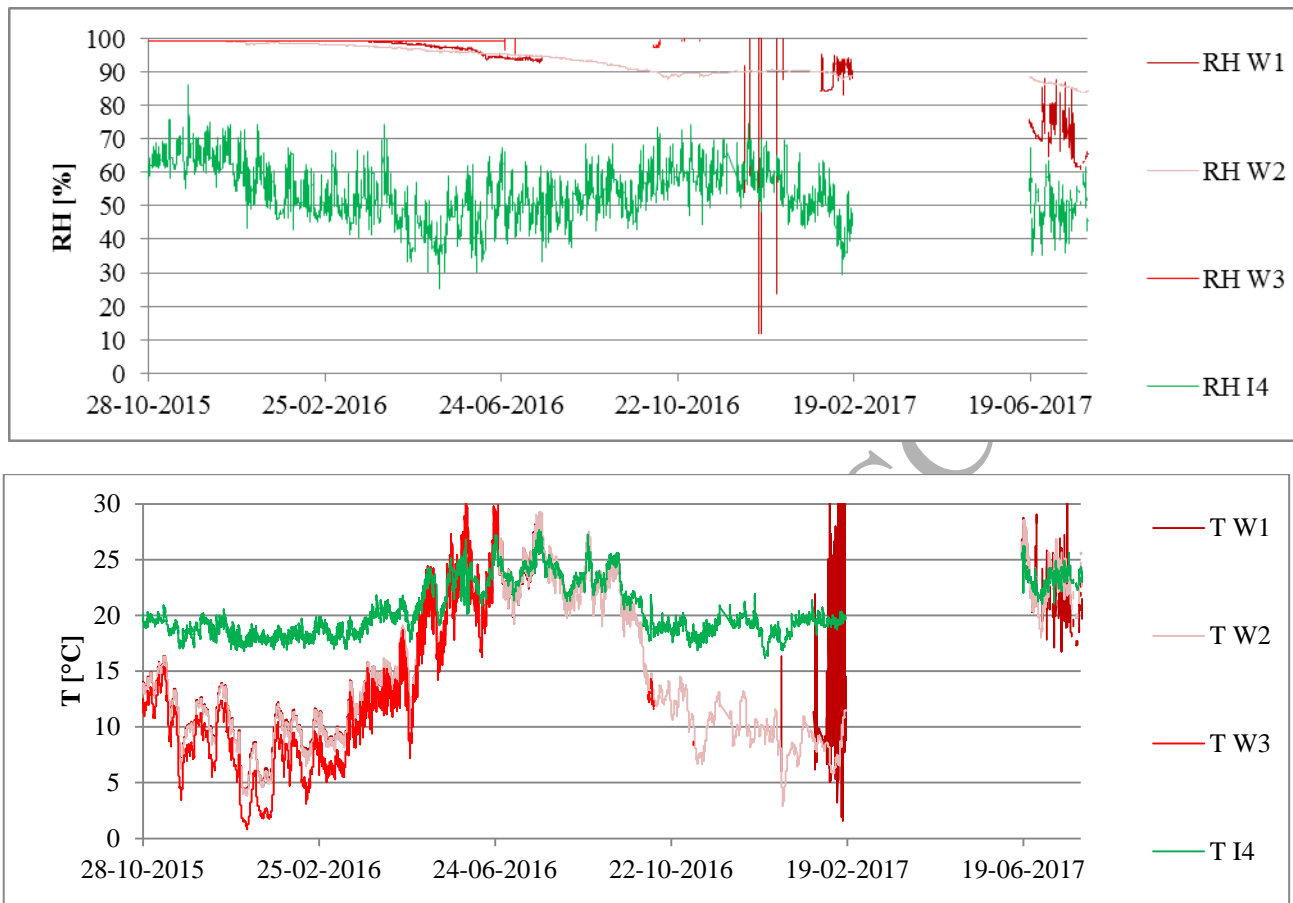
Figure 9: Measured hygrothermal conditions in Thomas Laubs Gade (30mm, system 2, eastern façade). The blue nuances represent sensors behind the beam ends, whereas the red colors represent sensors at the wall-insulation interface.

At Thomas Laubs Gade, the relative humidity is initially very high, due to installing the insulation with a wet glue mortar. Despite unreliable sensors and missing data, a decline of the relative humidity is seen, **Error! Reference source not found.** During the 20 months of measuring however, the relative humidity still exceeds 80 % in sensor W2, whereas sensor W1 seems to decrease to acceptable conditions. For the initial period, sensor W1 exhibits the highest relative humidity, but also the lowest temperature. This is the sensor placed below the window. The spandrels are thinner (one brick thick with render = 240mm) and thus this measuring point is more exposed to exterior conditions. It

is seen that the temperatures measured at the wall-insulation interfaces resemble the interior conditions during summer seasons.

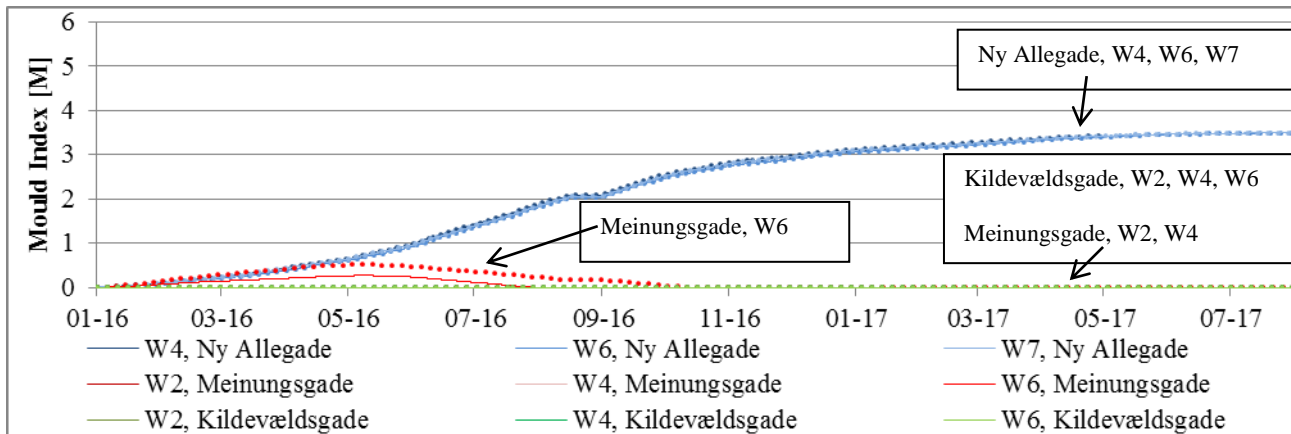
Figure 10: Mould index for wall-insulation interfaces as a function of time. W: interface. Dashed lines represent cases where 5% uncertainty was added to measurements above 90% RH.

The assessment of the hygrothermal performance of the post insulated façades with damage model (Mould Index) is presented graphically in this section. Furthermore, due to the expected increasing uncertainty of the measured relative humidity, the assessment has been performed as well on measured data as + 5 % RH for relative humidity above 90% RH in each case. The results for + 5 % relative humidity are presented with dashed lines. The results for the damage models are presented in Figure 10. The data from Thomas Laubs Gade is unfortunately insufficient for generation of mould model, due of the large data gaps, as seen in **Error! Reference source not found.**

The basic alkaline conditions in the cementitious glue mortar, prevent mould growth for the first year of measurements, why these data have been excluded in the model calculations [29]. The calculated mould indexes are presented in Figure 10. It is seen that at Ny Allegade the measurements from all sensors yield mould indexes above 1, thus the theoretical risk of mould growth exists, and the conditions can be considered unacceptable. There is no sign of decline, as the measured RH is so high. In these cases, the mould index peaks at 3.5 and stays there. At Meinungsgade it is seen that for the measured values, the mould growth is only initiated for measurements of sensor W6, however it never exceeds Mould Index 1, not even with the uncertainty factor included. Furthermore, the mould index in this sensor declines to 0 after a short period. At Kildevældsgade there is no indication of risk of mould growth from any of the measured data.

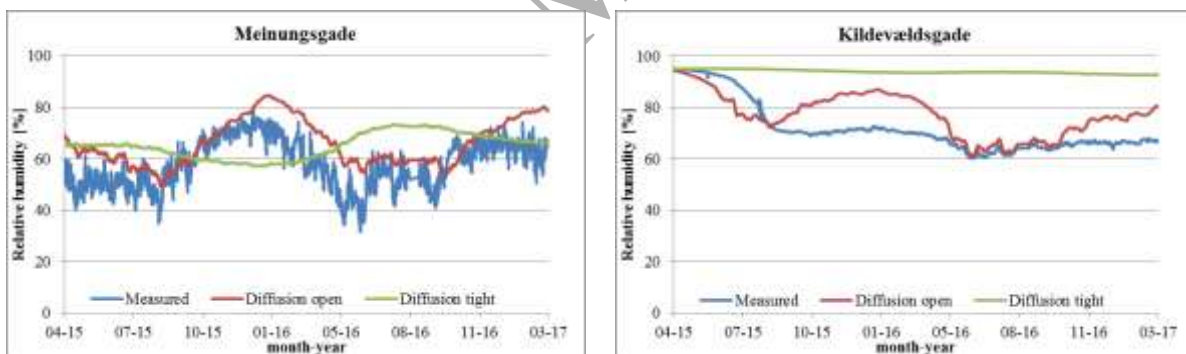
Figure 11: Validation of cases with insulation system 1 were achievable when making the phenolic foam diffusion open and omitting the vapour barrier.

The quality of simulation results depends highly on the input variables, and there are numerous unknown parameters estimated in the performed simulations, they include material parameters of the existing walls as well as climate data being from nearby weather stations, and not necessarily representing e.g. wind patterns at the exact locations. However validated models were made based on measured data, and the following projections were based on the validated models. In general, as also seen in Figure 11, for the two cases of insulation with system 1 (phenolic foam), Kildevældsgade and Meinungsgade, good validation results could not be achieved. Initially insulation system 1 was simulated as diffusion tight, as phenolic foam is diffusion tight, and furthermore the system includes a vapour barrier. These simulations generated very different moisture levels than the measured data in the interface between insulation and the existing wall. By implementation of a model without a vapour barrier and reduced water vapour diffusion resistance factor of the insulation to $\mu=1.0$ better agreements were achieved, as seen in Figure 11. The discrepancies in simulation results are

assumed to be caused by the installation method. In both cases, the insulation systems were installed with a 20cm gap left at the bottom of the wall, for an intentional thermal bridge in order to achieve higher temperatures at the beam ends. The vapour barrier, incorporated in the insulation boards, was discontinued at the bottom gap as well as joints. In addition, a notched trowel was used for the glue mortar, and likely not smoothed out. Thus the plates were not fully bonded and yielded the possibility of convection or vapour diffusion in air pockets at the interface. For the 1D hygrothermal simulations, this air movement was attempted to be incorporated in the models, by alterations of the vapour diffusion resistance of the phenolic foam and removal of the vapour barrier, as stated above. Thus the further simulations include both the diffusion tight (fully bonded plates) and the diffusion open (validated model) version of insulation system 1. Simulations indicate, that despite the vapour barrier, and diffusion tight phenolic foam, the system performs diffusion open in the measured cases presented. In regards to 1D simulation, the application method is critical to avoid air channels behind the plates and hence allowing convection and vapour diffusion. This was taken into account by alteration of material parameters, and the achieved validations are illustrated in Figure 11. As it can also be seen in Figure 11, the simulation results resemble measured data mostly for summer and fall periods, whereas the relative humidity seems to lie a bit higher in the simulations for the winter periods. This means, that at least the models present results that are on the safe side according to moisture risks. The same tendency was found by Hamid et. al. [23].

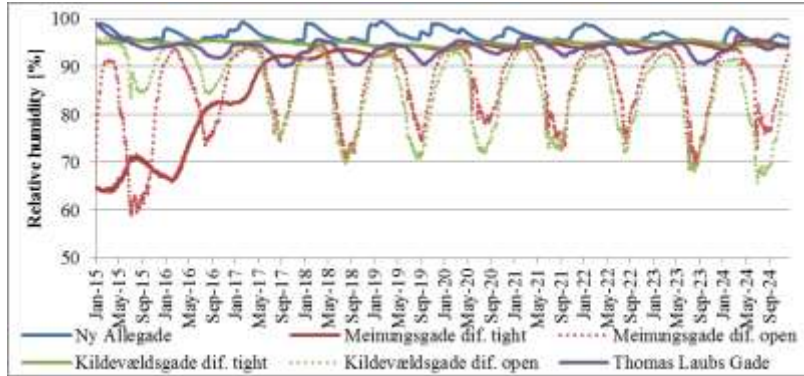
Figure 12: 1-dimensional simulations for 10 years of each presented case at the wall-insulation interfaces. The dotted lines represent the diffusion open version of insulation system 1.

10 year predictions for each case are represented in Figure 12. All cases show unacceptable hygrothermal conditions ($RH > 80\%$) during the 10 years of simulations - with the exception of the diffusion open version of insulation system 1. The worst moisture conditions appear to be in winter periods for the cases of insulation system 2 and diffusion open system 1. The case with 80mm of insulation system 2 (Ny Allegade) appears to show the worst performance, whereas the case with only 30mm of system 2 insulation (Thomas Laubs Gade) appears to perform better during the 10 year

period. Unacceptable conditions still apply however. The diffusion tight versions of Meinungsgade and Kildevældsgade, both insulated with system 1, show significantly less seasonal variation. The diffusion open version of system 1 exhibits significantly more seasonal variations and only unacceptable conditions during winter periods.

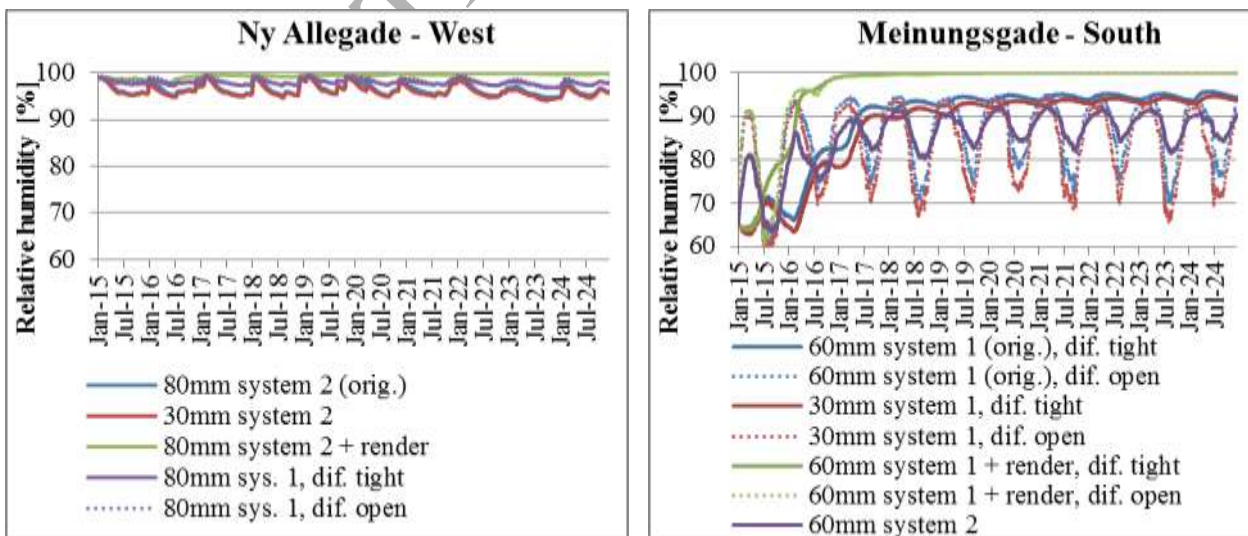
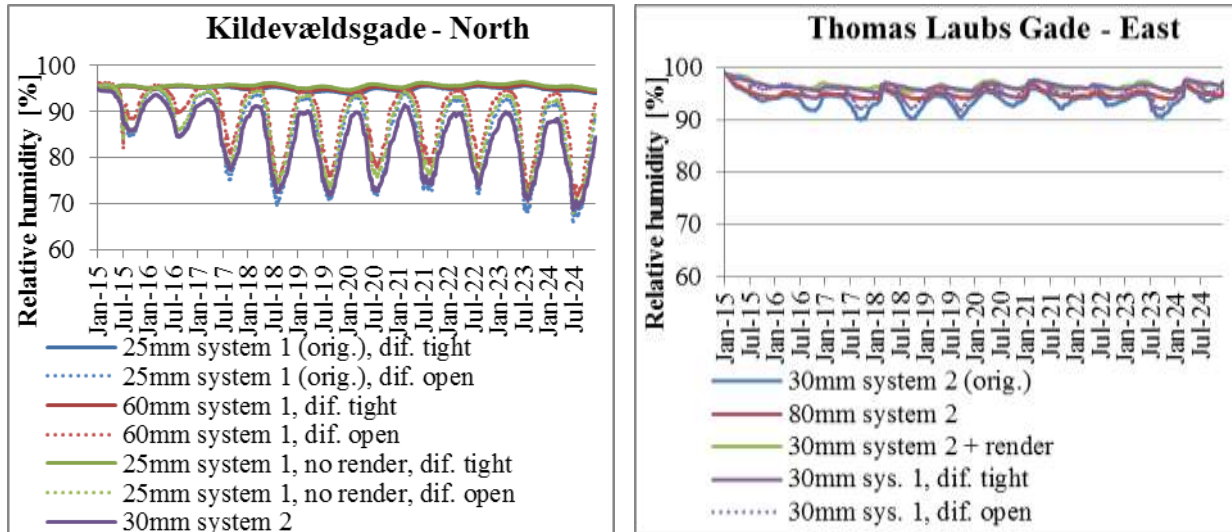
Figure 13: 10 year simulation variations of insulation thickness, external surface (with/without render) and insulation system.

In Figure 13 the results from the parameter variations are presented for each case. In each case, the original model is presented in blue, the thickness variation in red, the external surface with/without render in green, and finally the variation between the insulation systems is depicted in purple. Kildevældsgade with system 2 insulation rather than system 1, is the only case that exhibits a tendency of reduced relative humidity during the 10 year period. For the cases of insulation system 1 (Meinungsgade and Kildevældsgade), it is apparent, that the diffusion open version yields better hygrothermal conditions at the interface.

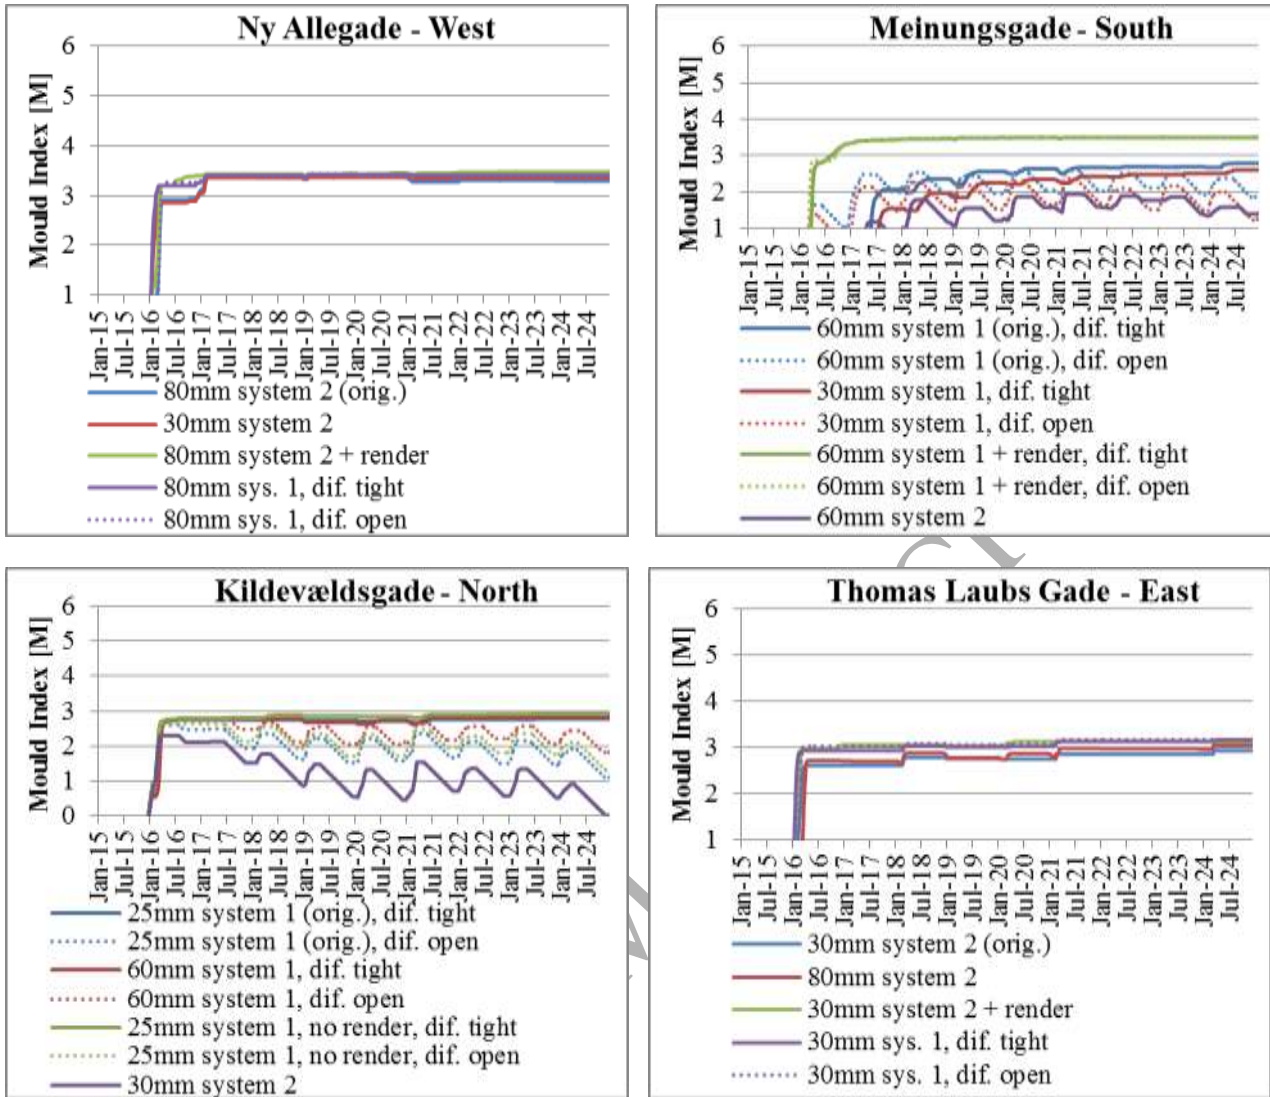
Figure 14: Generated Mould Indexes for simulated variations of insulation thickness, external surface and insulation system for the four cases.

The mould indexes for the four 10-year simulations are illustrated in Figure 14. For both cases with insulation system 2 (Ny Allegade and Thomas Laubs Gade), the mould index quickly reaches a steady maximum value of 3.3 and 3 respectively, for all the variations implemented, and thereby presenting a high risk of visual findings of mould growth. As seen in the relative humidities displayed in Figure 13, these two cases have continuously high relative humidities and minimal the seasonal variation thus leading to optimal mould growth criteria. The risk of mould growth is also apparent in both cases of insulation system 1. The risk of mould growth is significantly less, when insulation system 2 is applied to these cases. In the case of Meinungsgade, the largest display of the effects of the variations is seen. The addition of external render to the surface yields a higher mould index. This could be attributed to the reduction in drying potential from the sun and increased diffusion resistance on the southern façade, which is the most exposed to wind driven rain. The reduction of insulation thickness yields a slightly reduced mould index, which can be expected. It is also seen that the diffusion open version of system 1 yields more seasonal variation, and in general a lower risk of mould growth in the long run.
