Danish EPA-NR pilot studies

Overall report on the pilot projects

**Energy Performance Assessment
of Existing Non-Residential Buildings**

Overall report on pilot projects

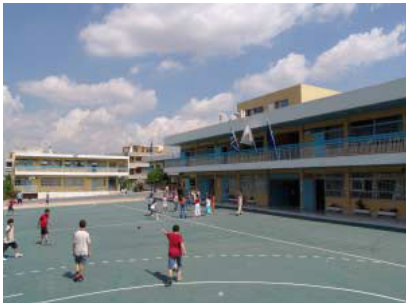
<p>Athens/Greece</p> <p>Primary school and Kindergarten Gross area: 2709 m² Year of construction: 5 buildings, built in different stages 1970, 1976 and 1989</p>

<p>Building envelope: Among the five buildings only one is thermally insulated, the other four have only roof insulation. Brick walls with concrete rendering. Single glazed windows with aluminium frames and internal curtains.</p> <p>Heating/cooling: Two central oil fired boilers for space heating/ electric heaters for DHW/ceiling fans in offices.</p> <p>Ventilation: Natural ventilation.</p> <p>Lighting: Fluorescent tubes.</p>

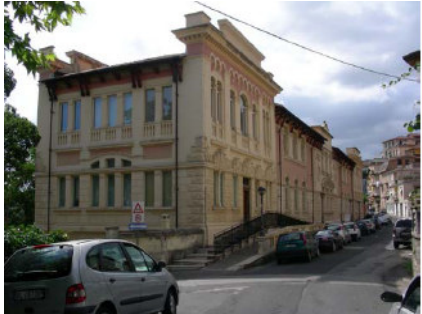
<p>Fiuggi/Italy</p> <p>Gross area: 2380 m² Year of construction: 1932</p>

<p>Building envelope: No insulation / double glazed windows with no thermal break aluminium frame.</p> <p>Heating/cooling: One standard boiler and radiators without any control/ Distribution systems runs inside the walls.</p> <p>Ventilation: Mechanical ventilation.</p> <p>Lighting: New fluorescent lamps manually controlled.</p> <p>Specific aspect: The walls are very thick and heavy, this gives the building a high thermal capacity, the high between floors and ceilings is important (4.20m).</p>

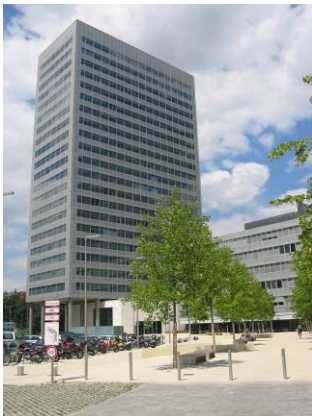
<p>Munich/Germany</p> <p>Gross area: 27172 m² Year of construction: 2003</p>

<p>Building envelope: Double skin facades with the inner layer as the main thermal insulation, the outer layer is framed glazing, the inner layer has about 70% transparency and 30% opaque areas/ internal solar shadings.</p> <p>Heating/cooling: The building is connected to the district heating system. Heating emission with convectors and ceilings (water pipes in building mass). Meeting rooms are cooled. The cooling generation is realised by a compression refrigeration machine.</p> <p>Ventilation: Hybrid ventilation composed by a central ventilation system with preconditioned air via an earth channel used for winter preheating and summer pre cooling and a big fan in the cellar.</p> <p>Lighting: Lighting is realised by compact discharge lamps with direct mode. The meeting rooms have direct/indirect mode. The ballasts are of the type 'electronic' in the offices and 'low losses' in the other rooms. The lighting control of the office lights is done via the BEMS with an automatic dimming that can be overruled by the user.</p> <p>Specific aspect: The EPBD required certificate was made on the basis of DIN V 18599</p>

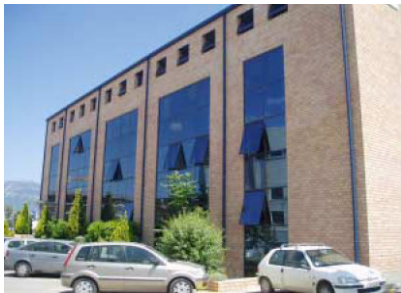
<p>Athens/Greece</p> <p>Gross area: 1910 m² Year of construction: 2000</p>

<p>Building envelope: Thermally insulated building. Brick walls with decorative bricks. Reinforced concrete sloped roof, covered with iron sheet. High efficiency double glazed windows with aluminium frames and internal blinds.</p> <p>Heating/cooling: Nine VRV heat pumps for heating and local air handling units for space heating and cooling/ electric tankless heaters for DHW.</p> <p>Ventilation: Mechanical ventilation by air handling units.</p> <p>Lighting: Fluorescent tubes and spots</p>

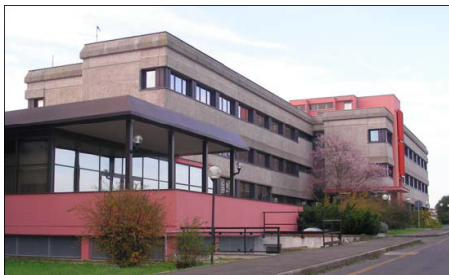
<p>Rome/Italy</p> <p>Gross area: 3200 m² Year of construction: 1990</p>

<p>Building envelope: External insulation/reflective double glazing windows with aluminium frame without thermal break/ no insulation in concrete ground floor.</p> <p>Heating/cooling: Gas boiler for heating and chillers with cooling tower for cooling/ fan coil units are used as emission system/ electric boilers for DHW.</p> <p>Ventilation: Two air handling units are installed for offices, these AHU are also used for heating and cooling and ventilation for conference room.</p> <p>Lighting: Fluorescent lamps.</p> <p>Specific aspect: The stairs volume should be in principle separated by the heated volume by double glazed doors but in practice these doors are always open.</p>

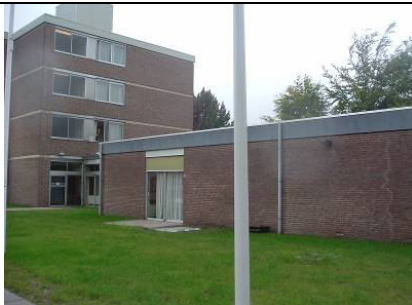
<p>Apeldoorn/The Netherlands</p> <p>Gross area: 3108 m² Year of construction: 1974</p>

<p>Building envelope: Opaque walls are not insulated/ windows consist of double layered glass in second and third floor and single glazed in the two first floors.</p> <p>Heating/cooling: Gas fired high efficiency (condensing) heating system with radiators/ part of building is provided with air conditioning units.</p> <p>Ventilation: Natural ventilation except for toilet and kitchen where exhaust ventilation is installed.</p> <p>Lighting: Conventional fluorescent tube lighting.</p> <p>Specific aspect: Poor indoor air quality due to the low ventilation rates, natural ventilation by opening the windows in winter is not adequate/ the single pane glazing in the two first floors have large dimensions, it's not comfortable in winter.</p>

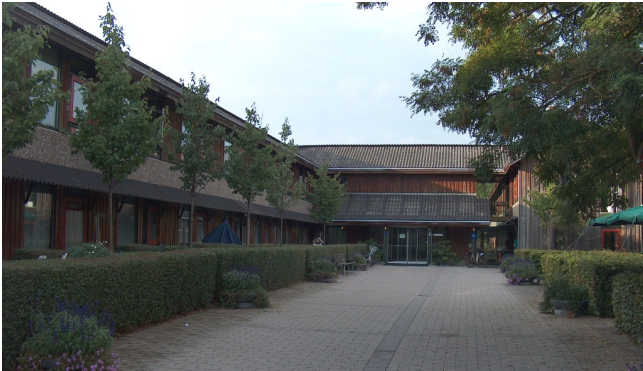
Location And general information	Photo
  <p>Denmark</p> <p>Gross area: 9,562 m² Year of construction: 1977</p>

<p>Building envelope: Pre fabricated concrete elements with wooden covering and minimum insulation (10 cm). Windows are double-glazed. The thermal properties of the claddings are in accordance with building standards of the 70ies. The cladding needs replacement and the rooms upgrade to meet today's standard.</p> <p>Heating/cooling/DHW: Two natural gas boilers operating in cascade supplying a heating system with radiators and DHW; no cooling system. Floor heating system in the bathrooms of the residential sectors.</p> <p>Ventilation: Mechanical ventilation with heat recovery in the service and common sections, natural ventilation in the residential sections.</p>

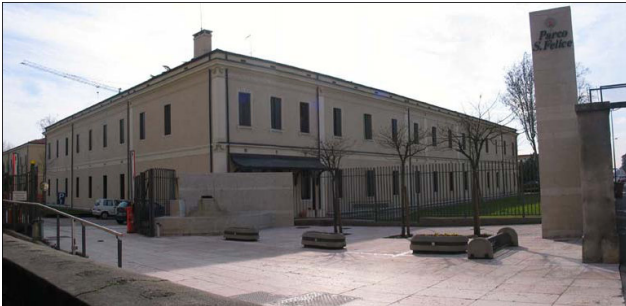
<p>Vicenza/Italy</p> <p>Gross area: 1320 m² Year of construction: early 20th century</p>

<p>Building envelope: Very poor insulation/simple double glazing windows with wooden frame.</p> <p>Heating/cooling: Single group of conventional boilers serving a group of 10 buildings for heating, air handling units and DHW/ radiators without local control/ Single chillier serving the group of buildings, it produces cold water for batteries of AHU/ the chillier is not designed to satisfy the whole cooling demand but to cool down the air entering into the building through the mechanical ventilation system.</p> <p>Ventilation: Mechanical ventilation system feeds all the rooms with heat/cool recovery.</p> <p>Lighting: Fluorescent lamps manually operated.</p> <p>Specific aspect: The walls are very thick and heavy, this give the building a high thermal capacity.</p>

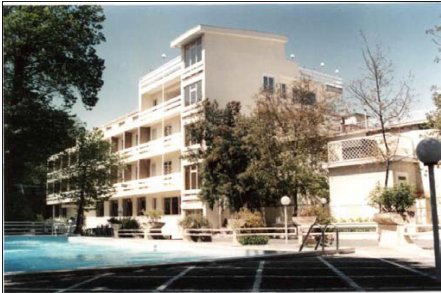
<p>Fiuggi/Italy</p> <p>Gross area: 3200m² Year of construction: late 70' + a new part in 2000</p>

<p>Building envelop: Old part has a double layer of hollow bricks with air gap , single glazed windows with aluminium frames/ new part has thick alveolar brick with reinforced plastering, double glazing windows with aluminium frames.</p> <p>Heating/cooling: Two gas boilers feed the heating and DHW systems/ A chiller feeds the fan coil units in the hall and in new rooms and the Air handling units of the restaurant/ radiators in old rooms.</p> <p>Ventilation: Mechanical ventilation system feeds all the rooms with heat/cool recovery.</p> <p>Lighting: From obsolete incandescence lamps to compact fluorescent lamps fluorescent lamps manually operated.</p>

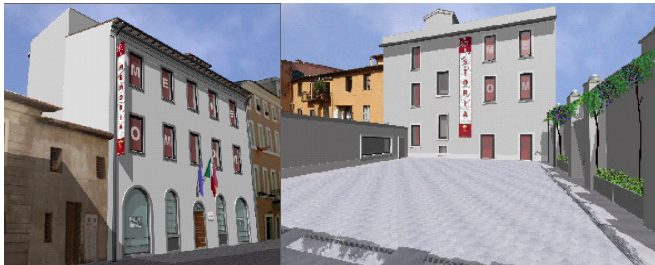
</div> <p data-bbox="308 786 438 815">Rome/Italy</p> <p data-bbox="220 835 533 954">Mixed library and offices Gross area: 810 m² Year of construction: early 1900, refurbished in 2005.</p> <p data-bbox="193 987 560 1167">A 3 floors block with the two main façade south and north oriented host the offices. The library is hosted in the block at the ground and consists of one level only</p>	<div data-bbox="647 560 1305 824" data-label="Image">

</div> <p data-bbox="587 846 1370 965">Building envelope: The envelope of the building consists of plastered massive stone walls. Non insulation was added during the refurbishment. Double glazing units with aluminium frame with thermal break were installed.</p> <p data-bbox="587 987 1370 1167">Heating/cooling: Condensing boilers are installed to feed the heating and DHW systems, and the air handling units. The chiller feeds the fan coils units and the air handling units. These units have energy recovery installed. Different artificial light sources (from obsolete incandescence lamps to compact fluorescent lamps) are installed in the building.</p> <p data-bbox="587 1189 1370 1245">Ventilation: Mechanical ventilation system feeds all the rooms with heat/cool recovery.</p> <p data-bbox="587 1267 1370 1323">Lighting: From obsolete incandescence lamps to compact fluorescent lamps.</p>
