## **10 years After The Largest River Restoration Project In Northern Europe**

### *Hydromorphological changes on multiple scales in River Skjern*

## 10 years after the largest river restoration project in Northern Europe: Hydromorphological changes on multiple scales in River Skjern

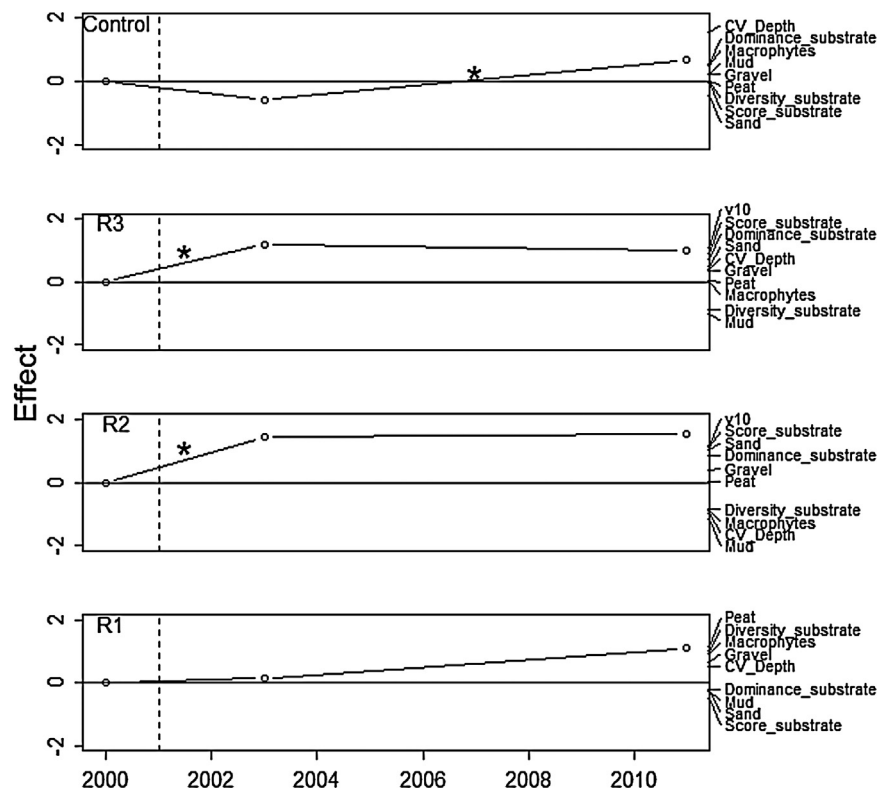
**Fig. 2.** Principal response curve analyses of the development of in-stream habitat parameters in four different sites of the vegetated zone (depths 0–130 cm) of River Skjern: control upstream the restored reaches (R1, R2, R3).

When comparing RDA scores, we found no significant overall change to in-stream habitats in the vegetated zone of the control reach from 2000 to 2003 ( $P=0.493$ ; Fig. 2) however, from 2003 to 2011 there was a significant change ( $P=0.0008$ ; Fig. 2). This change was primarily caused by an increase in CV Depth, indicating more heterogeneous stream profiles with larger variation in depth in

2011 compared to 2003. In the vegetated zone of R3 and R2 the restoration resulted in a significant change to in-stream habitats ( $P=0.022$  and  $P=0.026$ , respectively). In this zone of R3, the restoration resulted in higher current velocities (v10), a coarser substrate (Score\_substrate) although still dominated by sand, a higher coverage of gravel, a reduction in coverage by mud and consequently a lower substrate diversity (Fig. 2). In the vegetated zone of R2, the restoration also resulted in increased current velocities (v10), a coarser substrate (Score\_substrate) although still dominated by sand, a relatively higher coverage of gravel, lower coverage of mud and a lower substrate diversity (Fig. 2). In addition, the analysis showed that the overall significant changes to in-stream habitats of the vegetated zone of R3 were also related to a reduction in macrophyte coverage (Fig. 2).

The observed changes to in-stream habitats in the vegetated zone of R3 and R2 were stable over time showing no change from 2003 to 2011 ( $P=0.906$  and  $P=0.722$ ; Fig. 2). The in-stream habitats of the vegetated zone in the most downstream reach (R1) was not significantly affected by the restoration as only very small changes occurred from 2000 to 2003 (Fig. 2). From 2003 to 2011 there was some development in in-stream habitats but these changes were not significant ( $P=0.897$ ; Fig. 2).

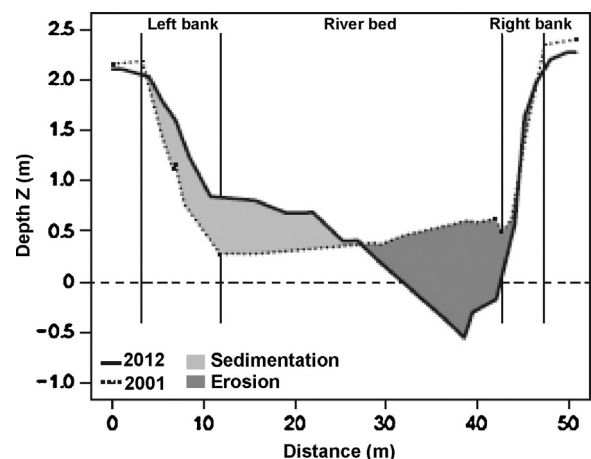
**Fig. 4.** Example of cross-sectional adjustments of the River Skjern between 2001 and 2012.

The survey of 65 cross-sectional transects along the lower 10 km of River Skjern in 2001 and again in 2011 revealed marked morphological adjustments through erosion and sedimentation in the newly restored stream channel (Fig. 4). There was large variations in the morphological adjustments among transects during the 10 year period (Fig. 5). Average sedimentation and erosion volume ( $\pm$ SD) measured at the left bank amounted to  $231 \pm 360 \text{ m}^3$  and  $274 \pm 325 \text{ m}^3$ , respectively, resulting in a net erosion of  $43 \text{ m}^3$  sediment. For the right bank, average sedimentation and erosion volume ( $\pm$ SD) was  $192 \pm 340 \text{ m}^3$  and  $536 \pm 740 \text{ m}^3$ , respectively, yielding a net erosion of  $344 \text{ m}^3$  sediment. However, the most pronounced morphological changes were observed at the river bed. Average sedimentation ( $\pm$ SD) for this part of the cross-sectional transects was  $2259 \pm 2333 \text{ m}^3$  sediment and average erosion ( $\pm$ SD) was  $707 \pm 996 \text{ m}^3$  resulting in a net sedimentation of  $1552 \text{ m}^3$  sediment. Combined, the net balance resulted in a gain of  $1166 \text{ m}^3$
