2-D Model Test Study of the Suape Breakwater, Brazil

Report No. 70

October 2009

This report deals with a two-dimensional model test study of the extension of the breakwater in Suape, Brazil. One cross-section was tested for stability and overtopping in various sea conditions. The length scale used for the model tests was 1:35. Unless otherwise specified all values given in this report are prototype values by assuming Froude scaling.

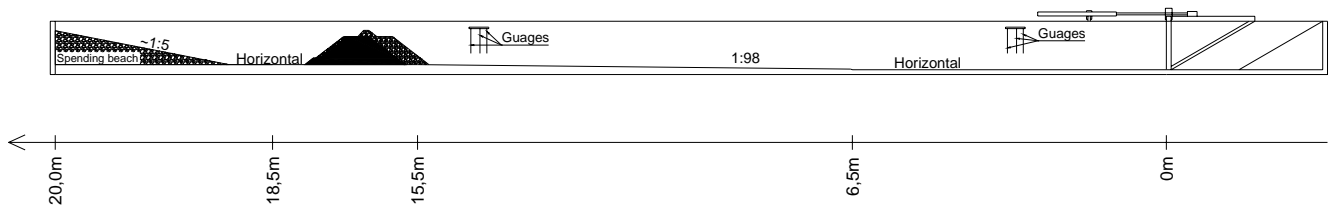
A two-dimensional model was constructed in scale 1:35 in a 1.5 m wide and 25 m long wave flume. Fig. 1 shows the test setup in the flume. The bottom in the flume was horizontal in the first 6.5 m (model scale), then a small step followed by an approximately 1:100 slope that continues till just before the model. In order to separate into incident and reflected waves three resistance type wave gauges were installed both at the deeper part near the paddle where the bottom is horizontal and at the toe of the breakwater.

Figure 1: Layout in flume.

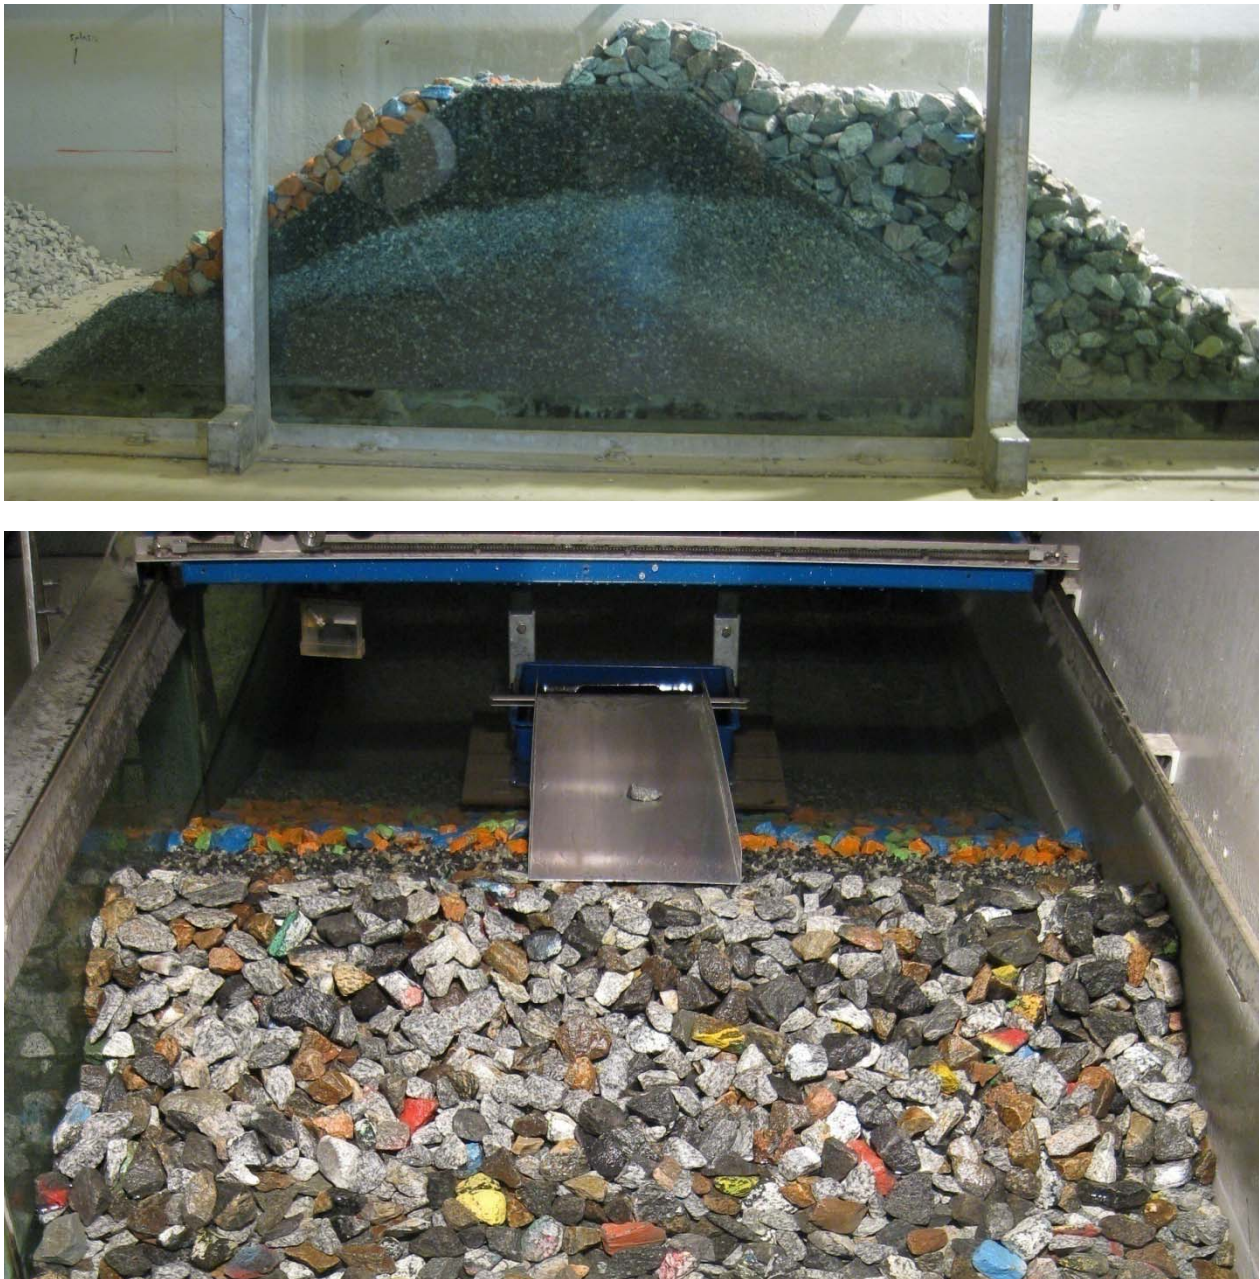
Pictures of examples of the cross-section tested are shown in Fig. 2. As seen from these pictures the overtopping water is led to an overtopping tank by a 0.3 m wide ramp extending from the rear corner of the crest. The overtopping volume was registered by weighting the tank after each test.

Figure 2: Pictures of the cross section and the overtopping ramp and tank.

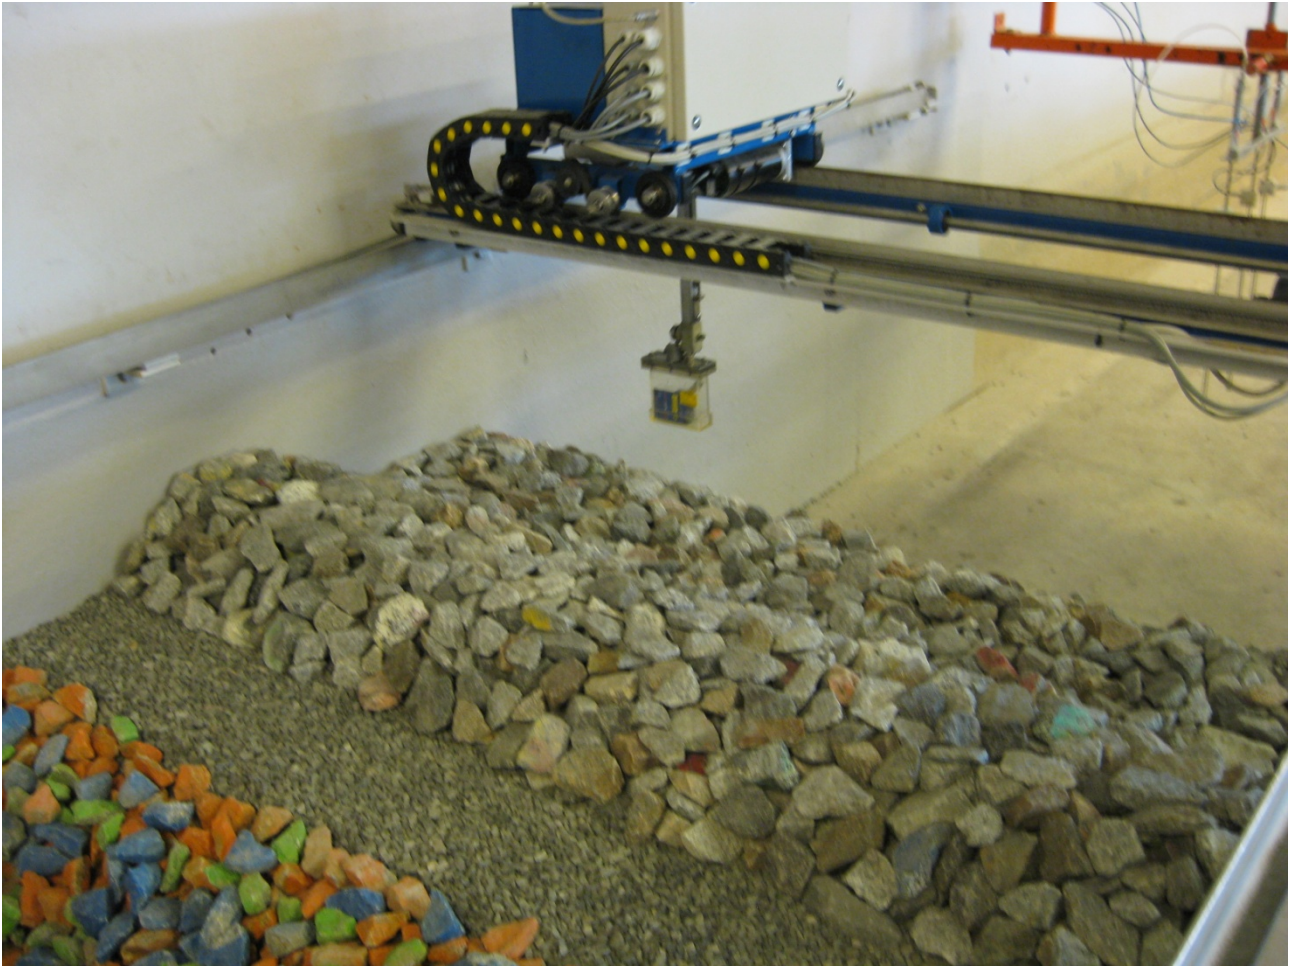
Damage/deformation of the breakwater was registered by photo-technique in all tests and supplemented by some profiling by an in-house developed PC-controlled laser profiler with step motors to move the profiler in all three directions, cf. Fig. 3. The profiler is controlled from the

computer program EPro also developed in-house [Aalborg University 2008b]. In the present case the profiler was setup to measure the profile in a grid with 1 cm spacing across the flume and 2 cm along the flume.

Figure 3: Pictures of laser profiler and the initial cross section viewed from the harbour side.

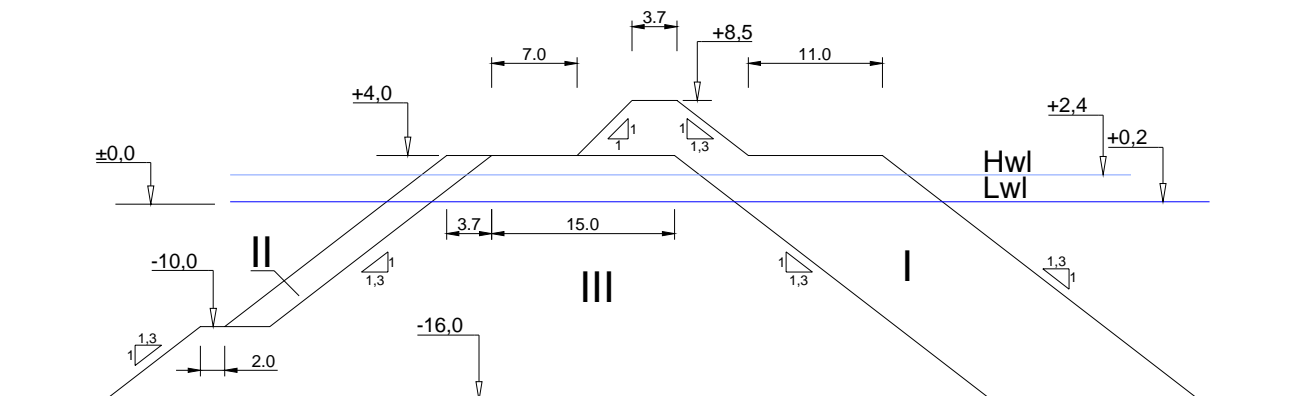
The cross-section proposed by the client for the Suape breakwater is shown in Fig. 4. The client has proposed three stone classes for the different layers of the breakwater. In the figures is also given the range of design water level variations (LWL to HWL).

Figure 4: Cross section.

- I: Primary Armour layer
- II: Secondary Armour Layer
- III: Core

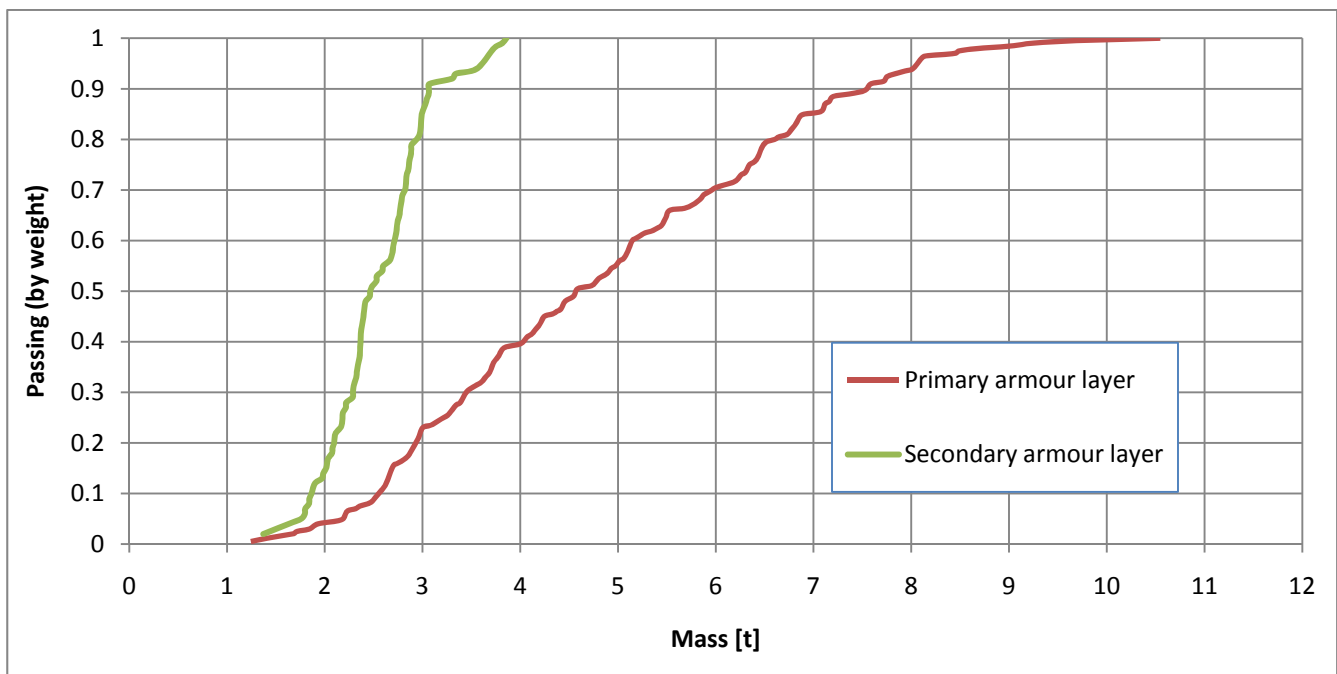
Figure 5: Gradation curve of secondary armour and primary armour material.

Weight measurements of individual stones were performed for 100 randomly selected units of each layer. Table 4 shows the main material parameters and Fig. 6 show the distribution curves.

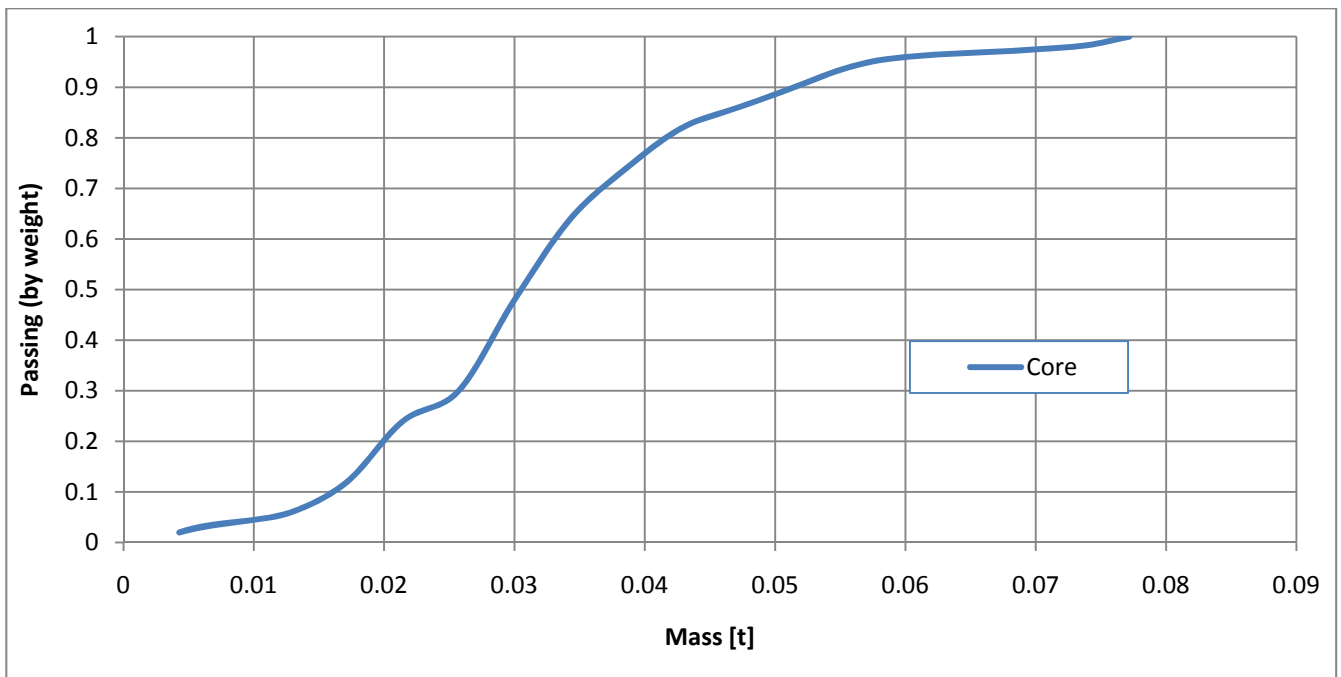
Figure 6: Gradation curve of core material.

Table 3 shows materials property as defined by the client for each layers in the prototype. The stones of the primary and secondary armour have been hand sorted. This has made it possible to quite accurately match the prescribed armour grading. For the core material a very wide gradation is used in prototype, cf. Table 3. In the model a narrow gradation with sizes close to the lower limit is conservatively used.

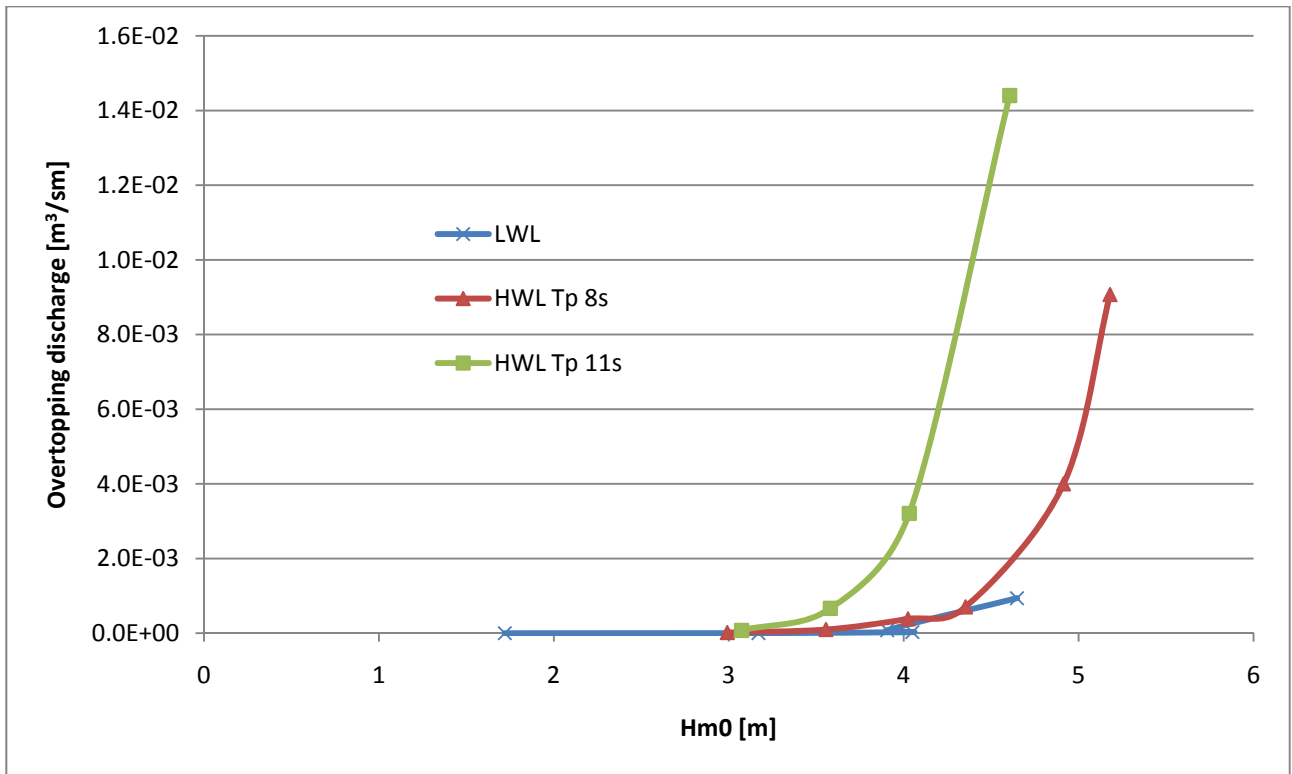
It can be concluded that at the low water level (+0.2 m), average overtopping discharge is below 1 l/sm for a wave height of 4.7 m. For high water level (+2.4) overtopping discharges are significantly larger due to the smaller freeboard, cf. Fig. 7. It should be mentioned that overtopping discharges are subjected to scale effects and especially the lower discharges will be significantly higher in prototype, cf. De Rouck et al. (2005) and Lykke Andersen (2006).

Figure 7: Overview of overtopping results.

At high water level overtopping discharges were so large that significant damages to the crest took place for significant wave heights above 4.0 m. However, erosion of the core material on the roadway started already around $H_{m0} = 3$ m.

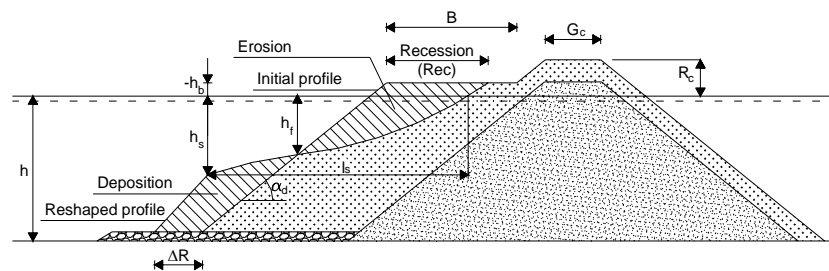
The measured profiles presented in the report are the average profile over the width of the model but discarding approximately 20 cm at each side of the flume due to wall effects. The damage is observed not to be uniformly distributed over the width. This is mainly due to the wide gradation used for the armour stones which leads to some parts of the armour layer are stronger than other parts. Especially for smaller damages large variations occur, but when the berm recession (Rec) is close to the initial berm width (B) the damage is close to uniformly distributed, both parameters defined in Fig. 8.

Figure 8: Definition of initial and reshaped profile parameters.

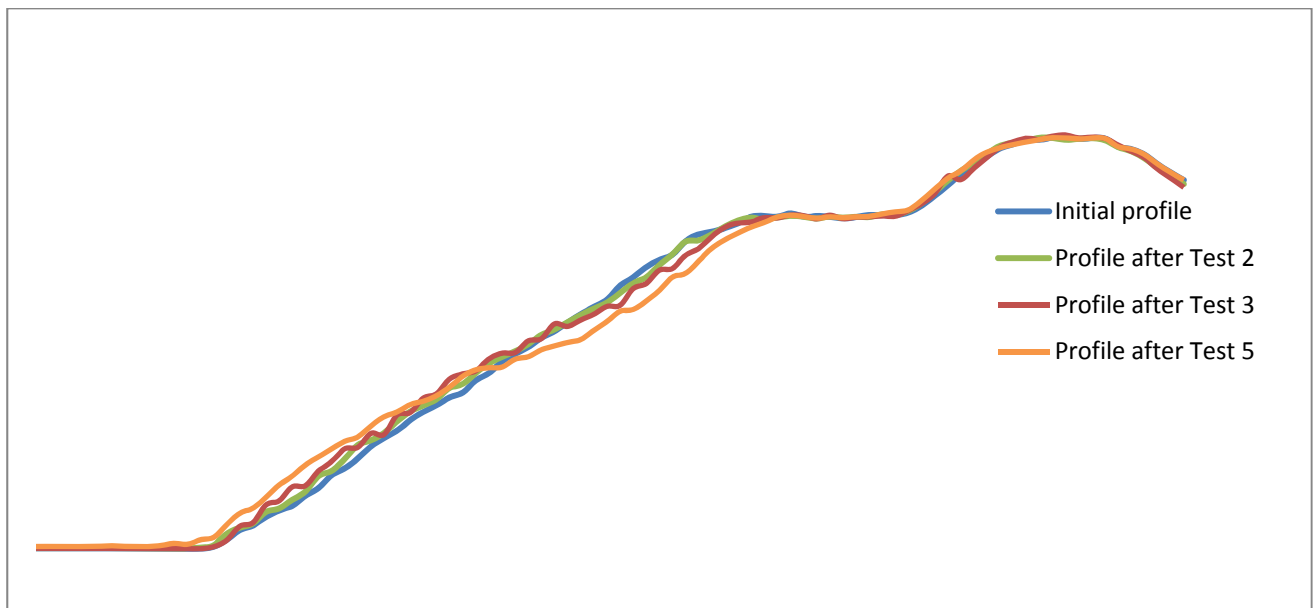
Figs. 9 and 10 shows comparison between the initial profile and the reshaped profile after each test as measured by the laser profiler. It can be seen that the recession is acceptable in all cases as $Rec < B$. However, for high water level conditions and $H_{m0} = 4.61$ m and $T_p = 11$ s (Test 015), some significant erosion of the crest took place. Fig. 11 shows a picture of the crest after test 15 and it can be seen damages to the crest and a significant part of the core material behind the crest is extracted and deposited on the rear armour. The damage to the unprotected core material in the roadway started approximately at $H_{m0} = 3$ m.

Figure 9: Measured profiles for LWL conditions.

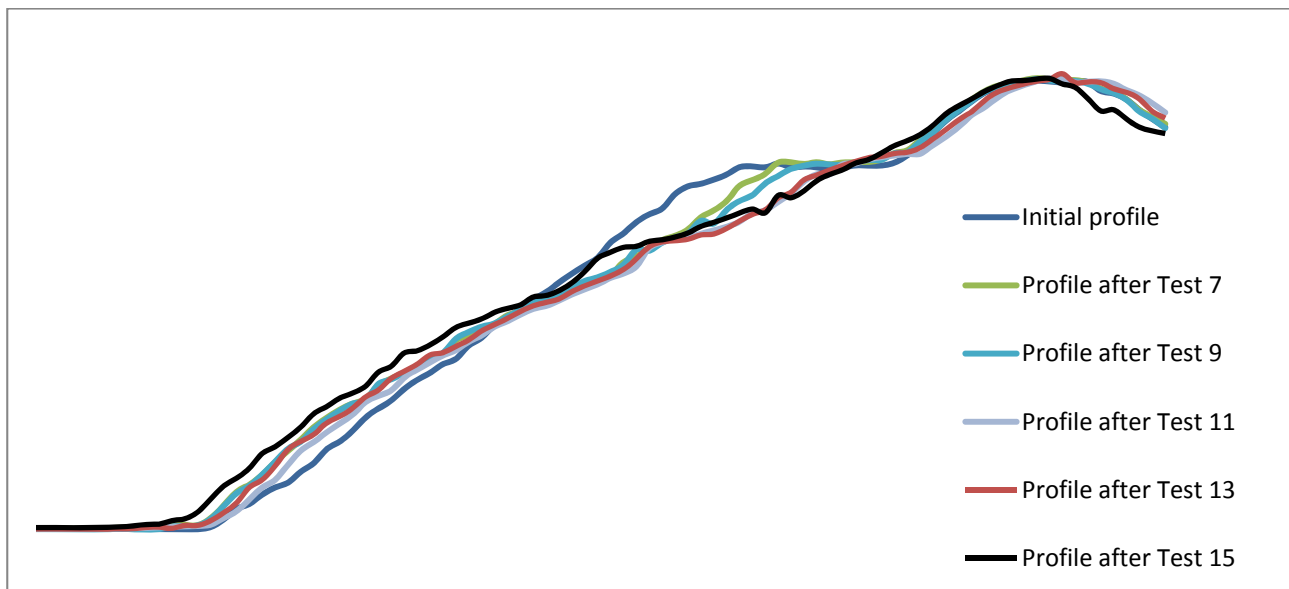
Figure 10: Measured profiles for HWL conditions.

A model test study for the new breakwater in Suape, Brazil has been carried out. Different design wave conditions were tested. For the low water level acceptable damages of the structure were measured and overtopping was below 1 l/sm even for extreme sea states. At high water level the recession is larger probably partly due to the cumulative effect. At high water level overtopping discharges are very high for the extreme sea states and significant damages to the crest occurred for significant wave heights above 4.0 m. Erosion of the unprotected core material in the roadway started for significant wave heights larger than app. 3.0 m for both wave periods tested. The eroded core material was deposited on the rear slope armour layer. This erosion could probably be prevented by covering the area with secondary armour stones (2t to 3t).

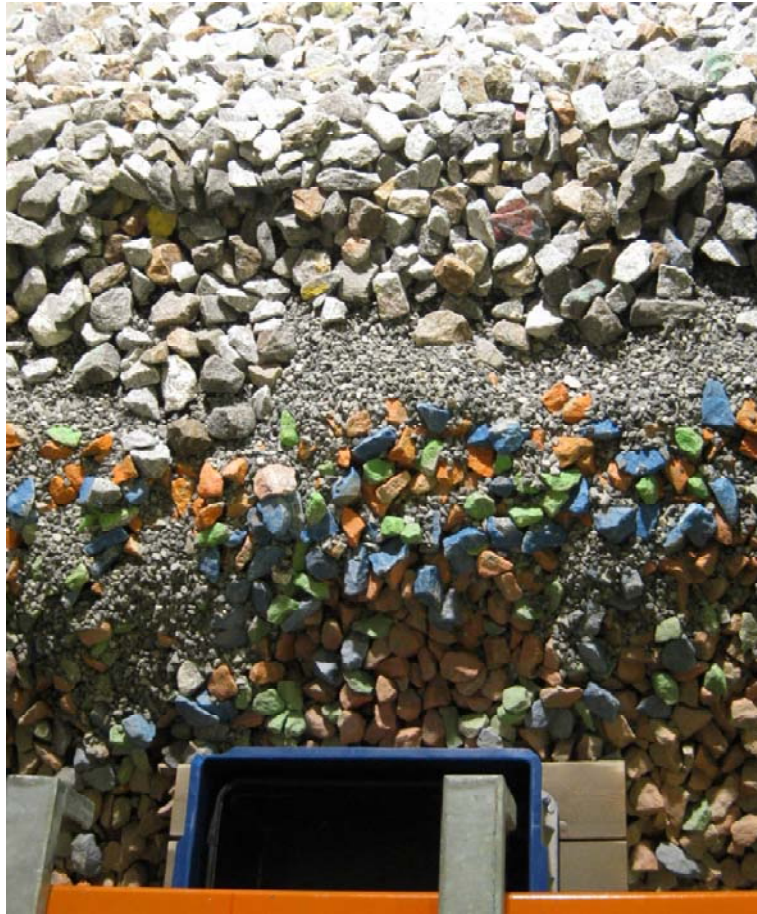
Figure 11: Damages to crest of structure after test 15.

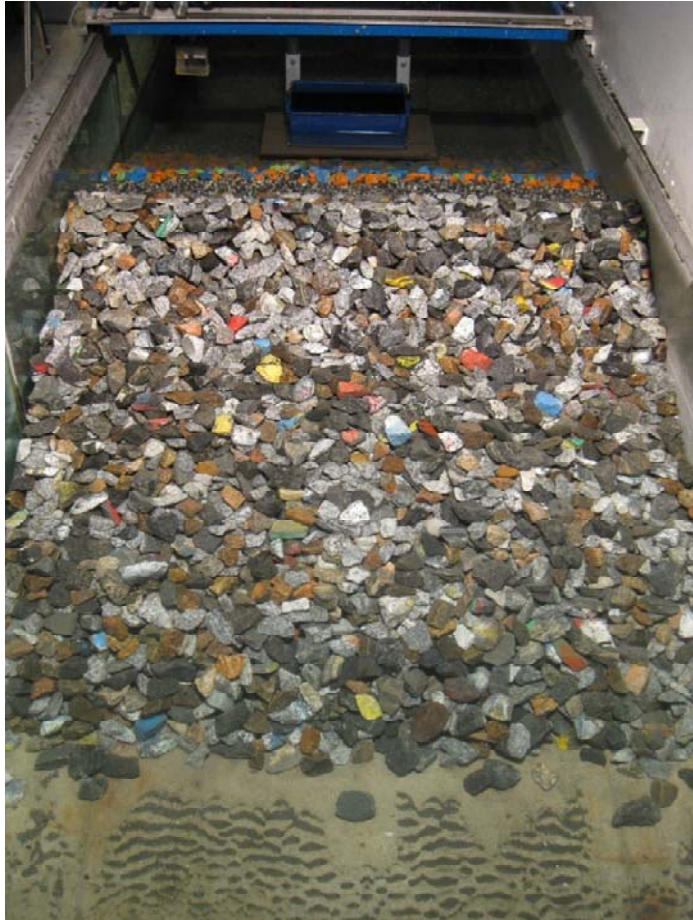
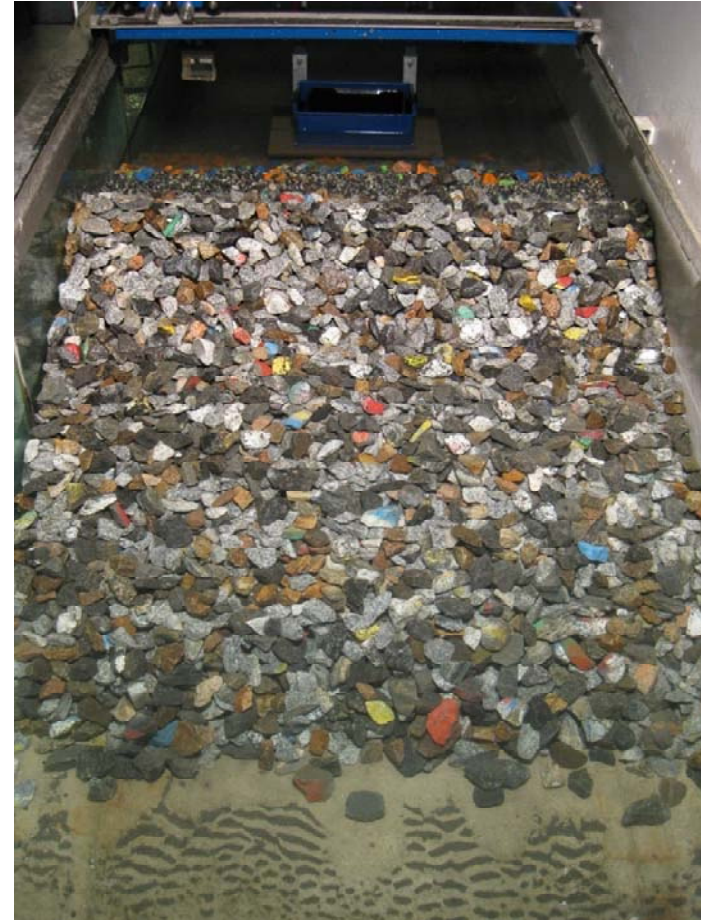
Test 15: $WL = +2.4 \text{ m}$, $H_{m0} = 4.6 \text{ m}$, $T_p = 11.0 \text{ s}$, $N = 3000$

Figure 41: After picture.

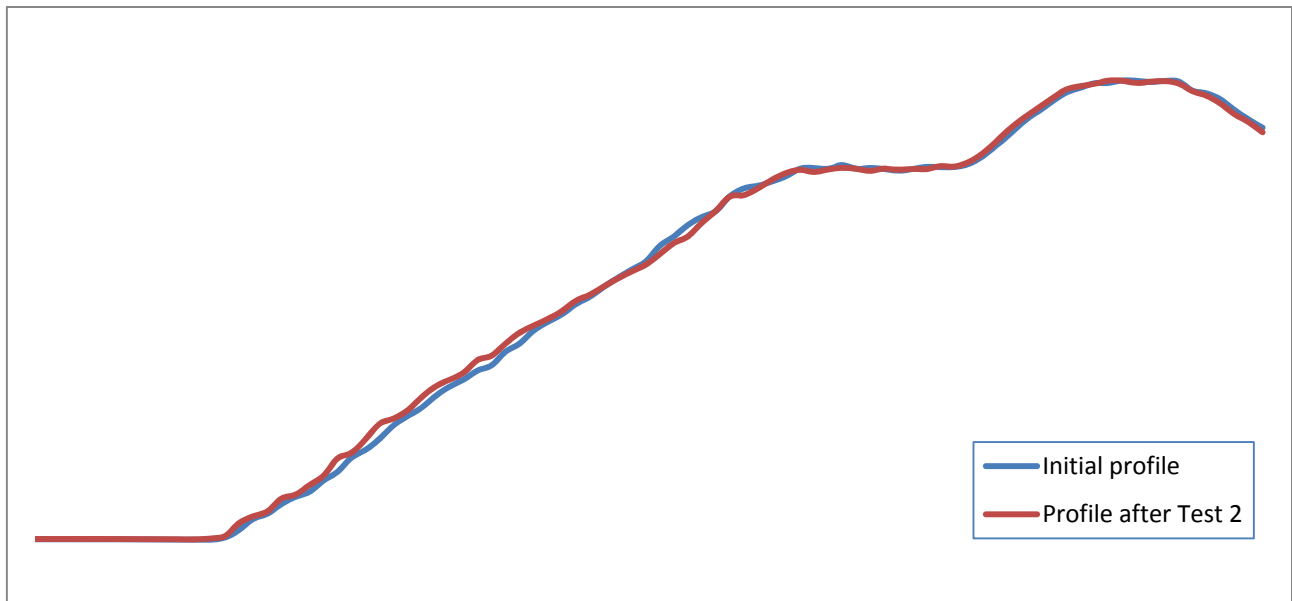
Figure 42: Profile after test 2 ($H_{m0} = 3.17$ m, $T_p = 8$ s and WL = +0.2 m).

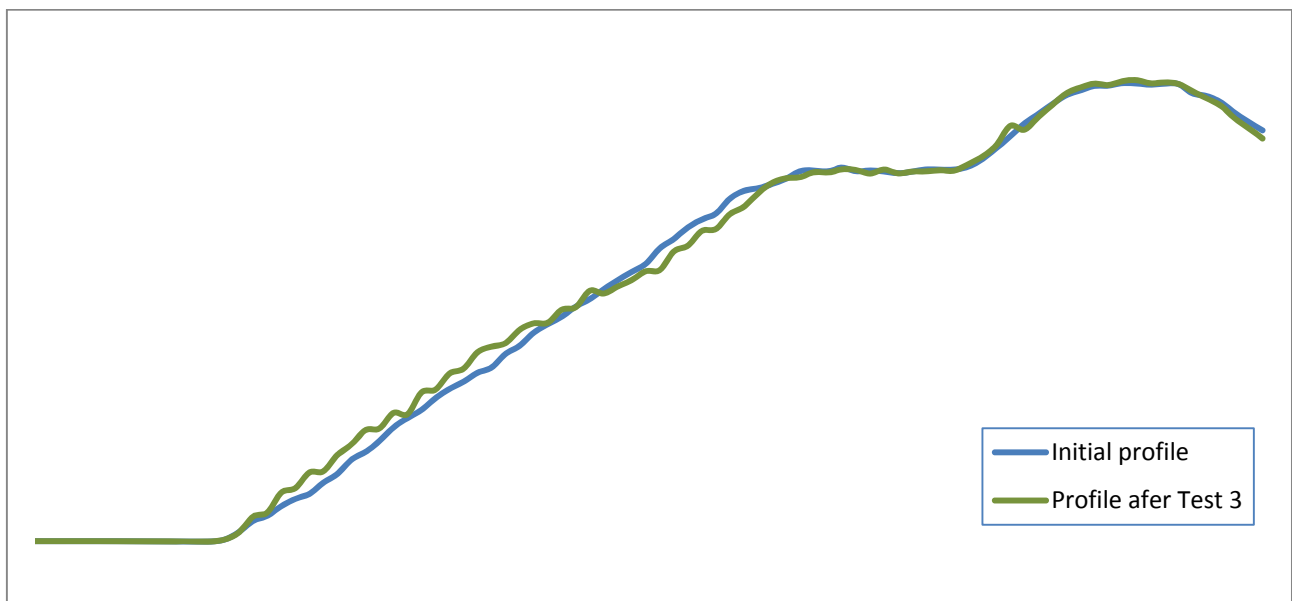
Figure 43: Profile after test 3 ($H_{m0} = 4.05$ m, $T_p = 8$ s and WL = +0.2 m).

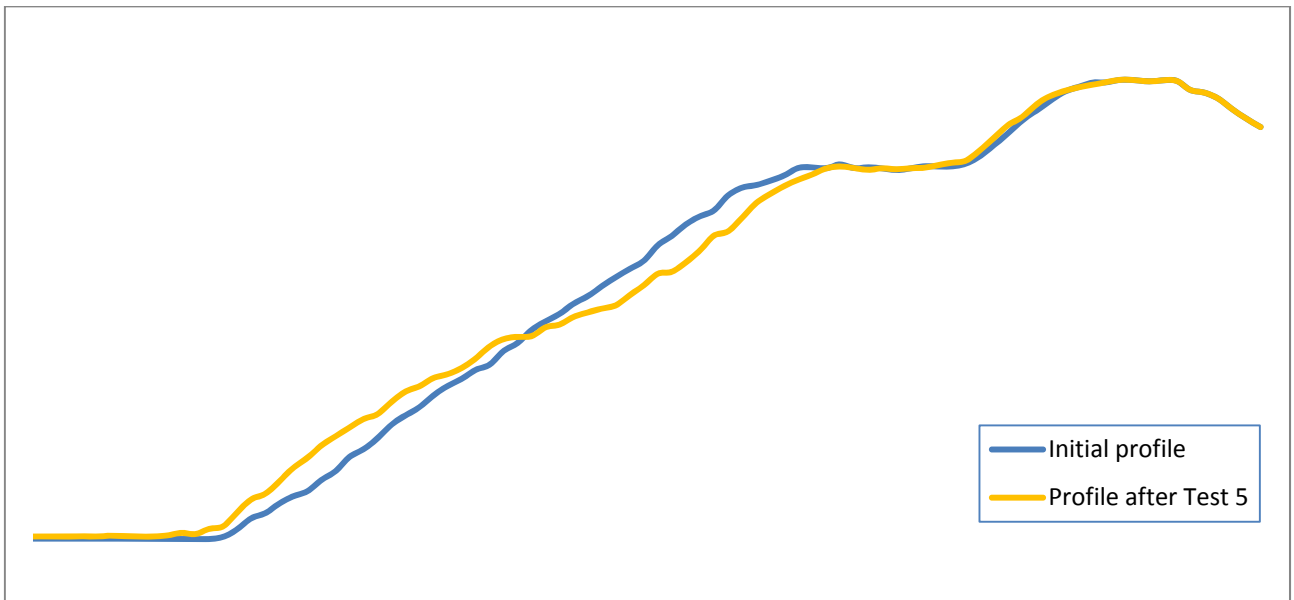
Figure 44: Profile after test 5 ($H_{m0} = 4.65$ m, $T_p = 11$ s and WL = +0.2).

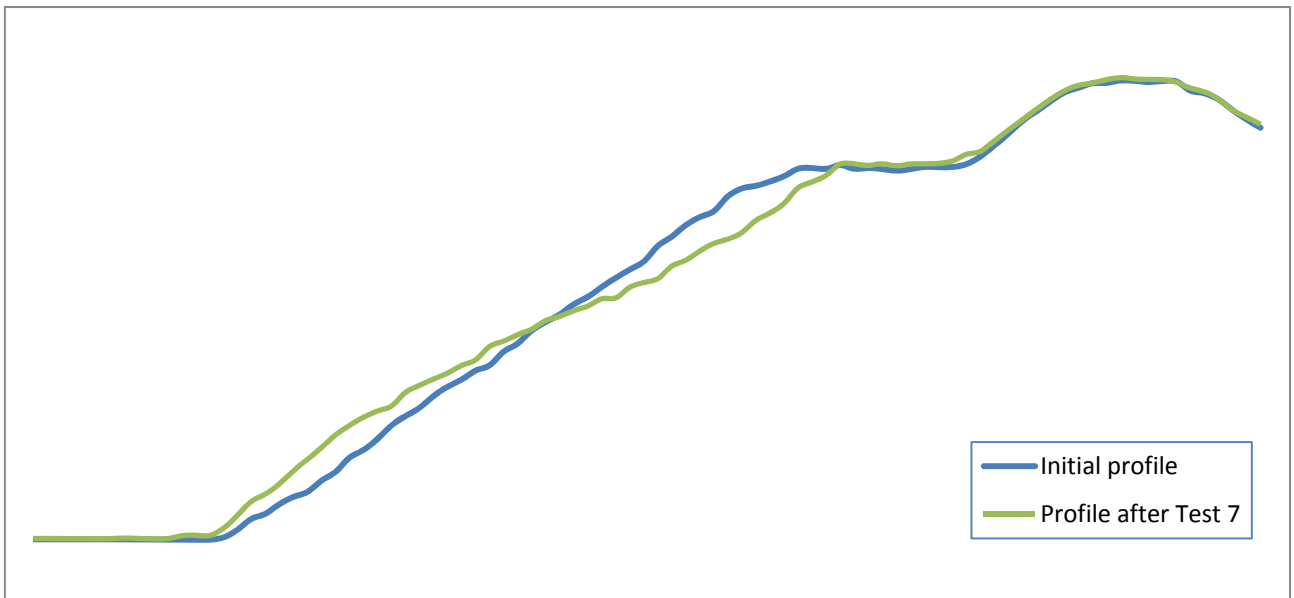
Figure 45: Profile after test 7 ($H_{m0} = 3.56$ m, $T_p = 8$ s and WL = +2.4).

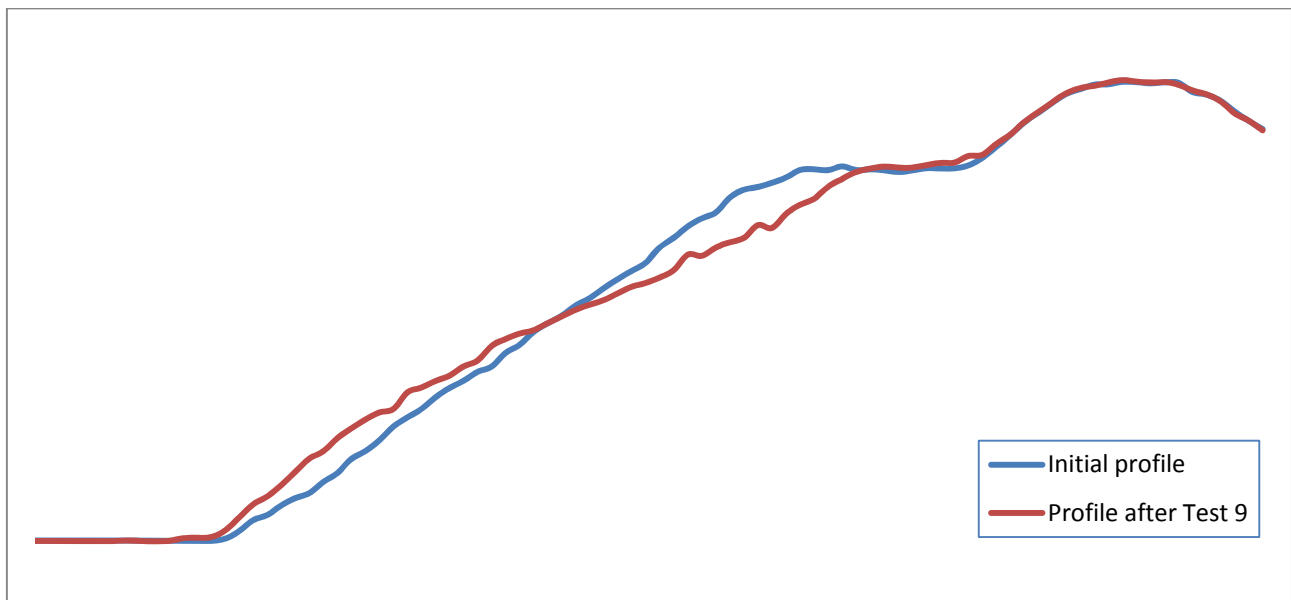
Figure 46: Profile after test 9 ($H_{m0} = 4.35$ m $T_P = 8$ s, WL = +2.4).

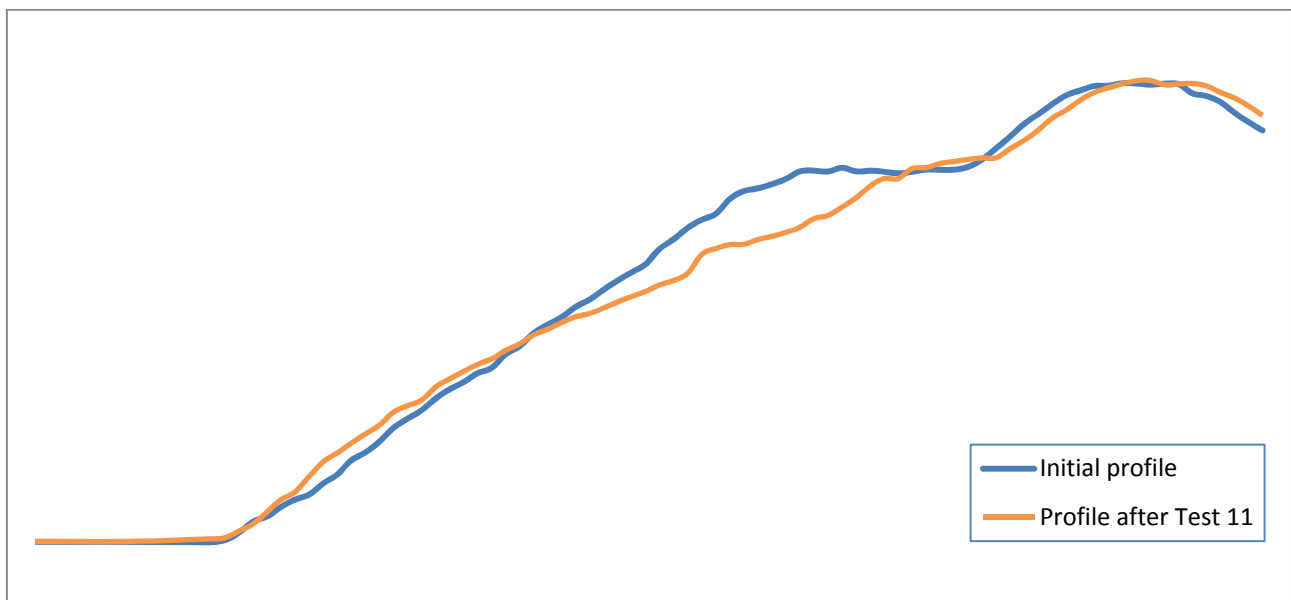
Figure 47: Profile after test 11 ($H_{m0} = 5.18$ m, $T_P = 8$ s and WL = +2.4).

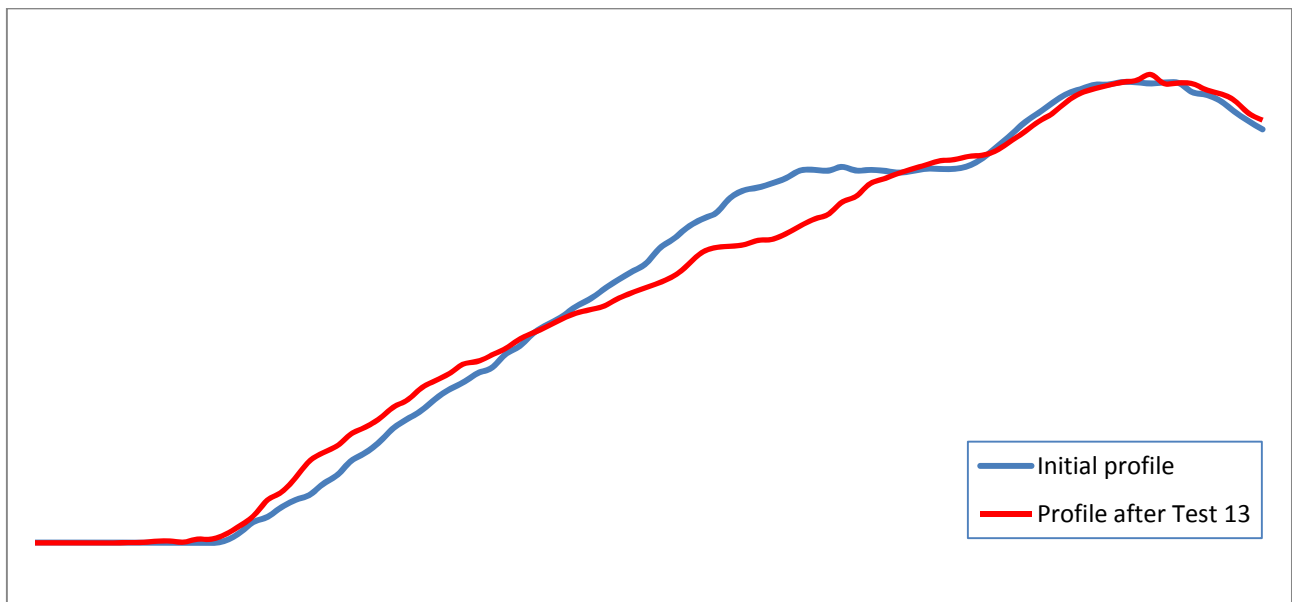
Figure 48: Profile after test 13 ($H_{m0} = 3.58$ m, $T_P = 11$ s and WL = +2.4).

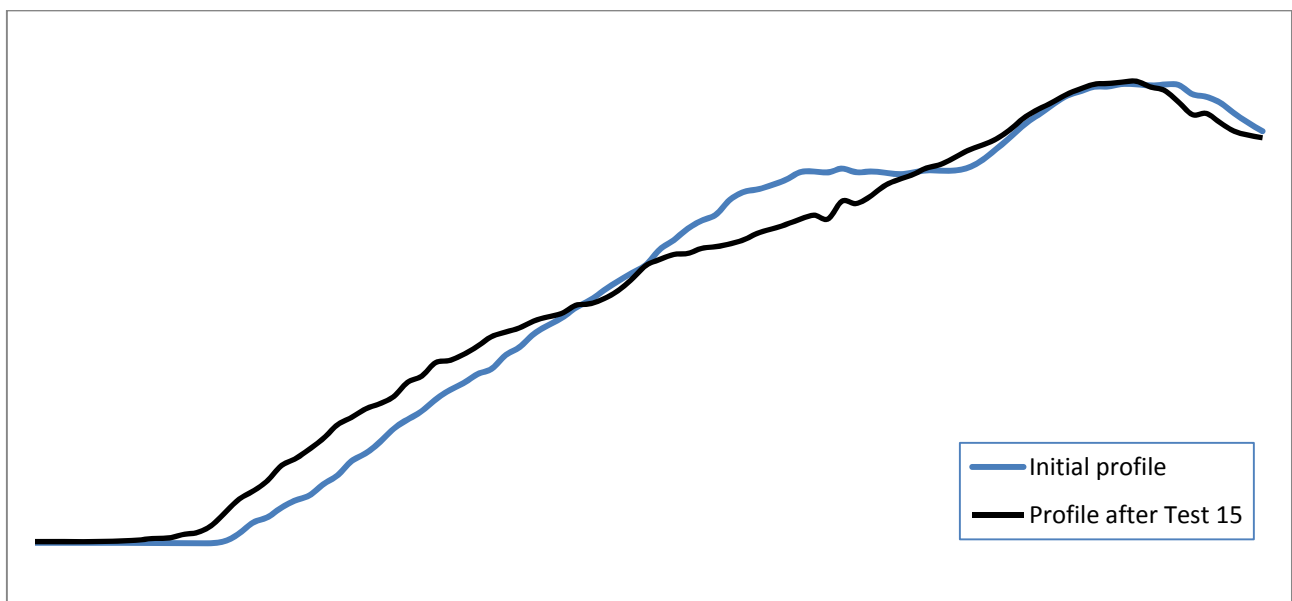
Figure 49: Profile after test 15 ($H_{m0} = 4.61$, $T_P = 11$ s and WL = +2.4).
