*Published in:*  
Journal of Civil Engineering and Architecture

# Refurbishing Fæstningens Materialgård: A Heritage Complex

Torben Valdbjørn Rasmussen

**Abstract:** Fæstningens Materialgård is a listed complex located in downtown Copenhagen. The refurbishment of the listed complex was studied to provide knowledge on how a process for refurbishing heritage buildings can be carried out successfully, as refurbishment of heritage buildings is often a complicated process. The process shows how to choose, evaluate and implement measures creating synergy between the interests of preserving heritage values and to develop affordable refurbishment that meets the requirements for the future use of the building. The refurbishment followed included restoration, energy upgrading and refurbishment of the individual buildings that make up the listed complex. The process focuses on the cooperation and dialogue between the parties involved. Fæstningens Materialgård is a case study where the Heritage Agency, the Danish Working Environment Authority and the owner as a team cooperated in identifying feasible refurbishment measures. Through the process the owner was supported by architects and engine

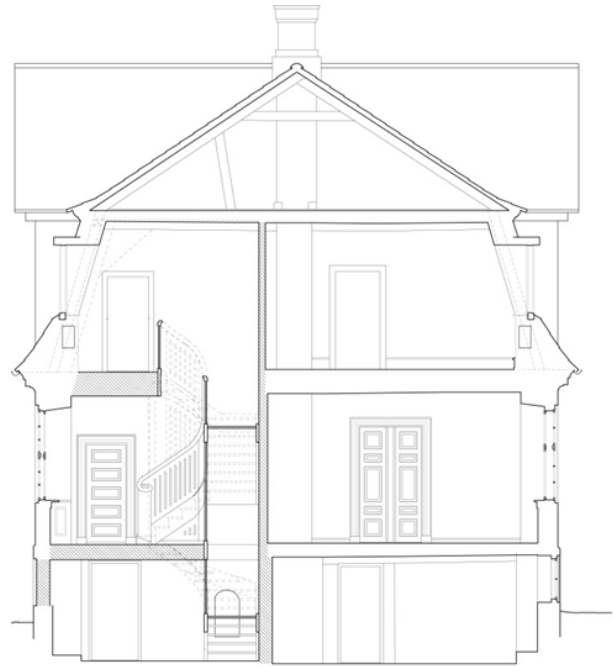
**Fig. 2** Structural section of the building which contains the supervisor's residence.

Each of the buildings in the complex has fundamental heritage values. The supervisor's residence, as shown in Fig. 2, is recognized by its representative character and position in the hierarchy of the complex, the hierarchy between the storeys, the rooms and interiors with a mix of historic styles and the joinery detailing. The supervisor's residence is characterized as the "grandest" building in the complex, and there is a desire to expose and enhance the fine, richly furnished interiors. The still-preserved half-timbered building, as shown in Fig. 3, shows the warehouse character of the building, which clearly shows the longitudinal beam construction and rough, simple detailing. The character of the half-timbered warehouse with clear constructions and rough, simple detailing, as well as its close relationship with the courtyard, is to be emphasized and strengthened through the restoration. The office building is recognized for its longitudinal partition walls, distinction between the northern and southern parts of the building, its room structure unity and joinery details (Fig. 4). The conservation of the office building was undertaken to re-establish valuable elements from different periods of alteration and to restore the old room structures. The monopitch roof building, shown in Fig. 5, includes a still-preserved building which shows the original timber construction with very large dimensions. Restoration of the monopitch roof building was undertaken to re-establish the characteristics of the buildings as more or less open "sheds" with clear constructions,

For the building with the supervisor's residence, the process resulted in the agreement of 11 feasible measures for energy upgrading including low-energy glazing—3 mm glass set into the existing secondary frames, building envelope air permeability ( $0.5 \text{ h}^{-1}$  in the basement,  $0.2 \text{ h}^{-1}$  on the ground floor and  $0.2 \text{ h}^{-1}$  at the first floor), ventilation via opening of windows, combined heating/cooling unit designed so that it looked

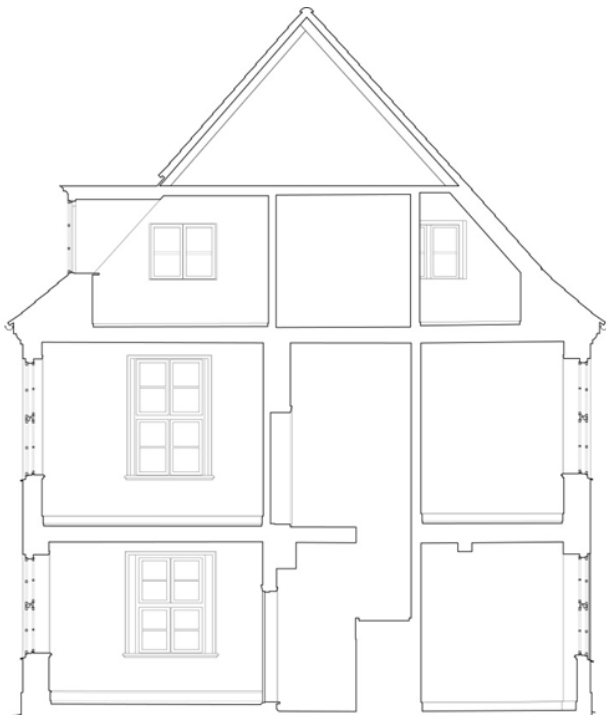
**Fig. 4** Structural section of the office building.

For the office building, the process resulted in agreement on eleven feasible measures for energy upgrading including low-energy glazing—3 mm glass set into the existing secondary frames, building envelope air permeability ( $0.29 \text{ h}^{-1}$  on the ground floor,  $0.2 \text{ h}^{-1}$  at the first floor and  $0.2 \text{ h}^{-1}$  on the second floor), ventilation by opening windows, combined heating/cooling unit designed so that it looked like a flat panel radiator, cooling via a centrally placed unit where excess heat is transferred to the outside air, decentralized domestic hot water production, energy-saving light sources, daylight-controlled lighting, centralized control of electrical components, shared canteen, shared meeting and conference facilities.

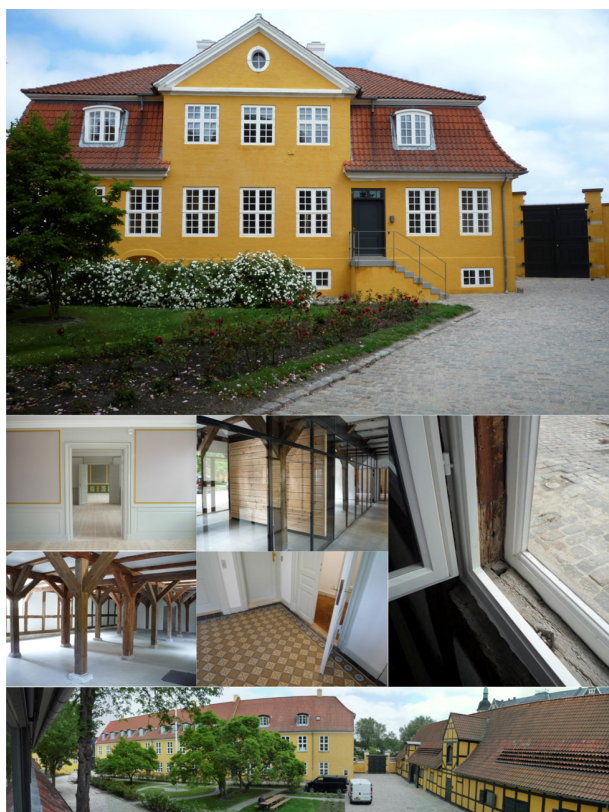
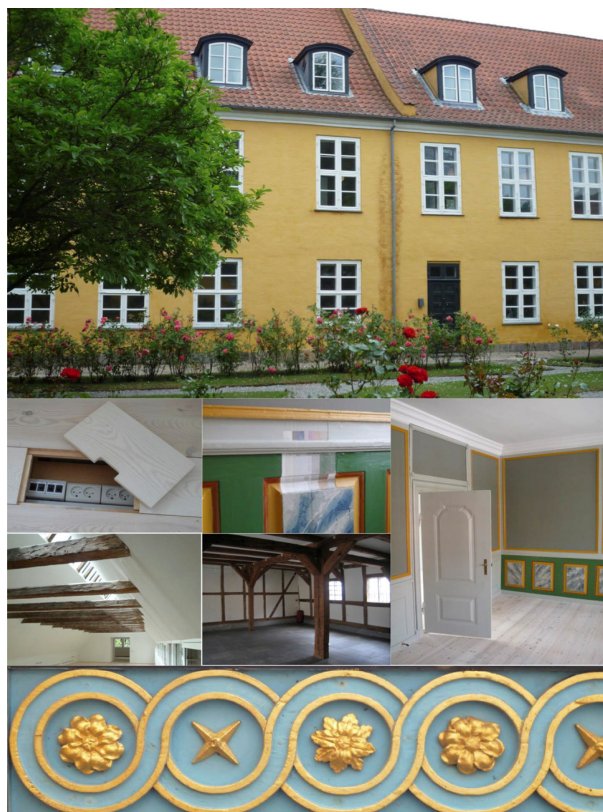
Fig. 7 Photos of the refurbished listed complex, Fæstningens Materialgård.

Fig. 8 Photos of the refurbished listed complex, Fæstningens Materialgård.

Individual feasible refurbishment measures were found for the restoration and energy upgrading of each of the individual buildings in the listed complex. Photos of the refurbished Fæstningens Materialgård are shown in Figs. 7 and 8.

The process of refurbishing Fæstningens Materialgård consisted of a series of meetings, between the authorities and the owner of the listed complex, with the aim of identifying feasible, refurbishment measures to be implemented. The authorities were represented both by the Heritage Agency and the Danish Working Environment Authority. In general, each specific case might need expertise from a different set of experts and authorities. Fig. 6 shows a sketch of the process used to identify feasible refurbishment measures. Figs. 7 and 8 show photos of the refurbished Fæstningens Materialgård [4].
