CLIMA 2016 - proceedings of the 12th REHVA World Congress

BKCity Stay. Renovation of lecture Room A of the Faculty of Architecture of the Delft University of Technology

Regina Bokel¹, Stanley Kurvers²

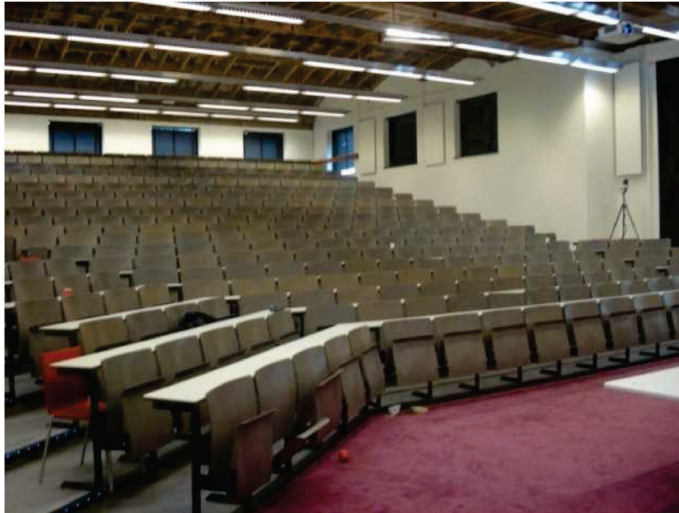
Figure 2: Room A before renovation (February 2009), visible are 6 of the smaller windows [3].

Room A, the largest lecture room in the Faculty of Architecture, has a capacity of 350-400 persons. It is a lecture room with a volume of 3657 m³. The room has four large windows where the lower chairs are and 9 smaller windows where the higher chairs are, see figures 2 and 4. The height of the room is 11.5 meters. The existing ceiling was taken out as an architectural statement. There are 11 radiators in the room

and a ventilation system. The ventilation is mechanical ventilation from outside ventilation which can be heated in the air handling system. The air enters the room through 6 large inlets under the ceiling and 2 exhaust grills in the front of the room near the speaker [6]

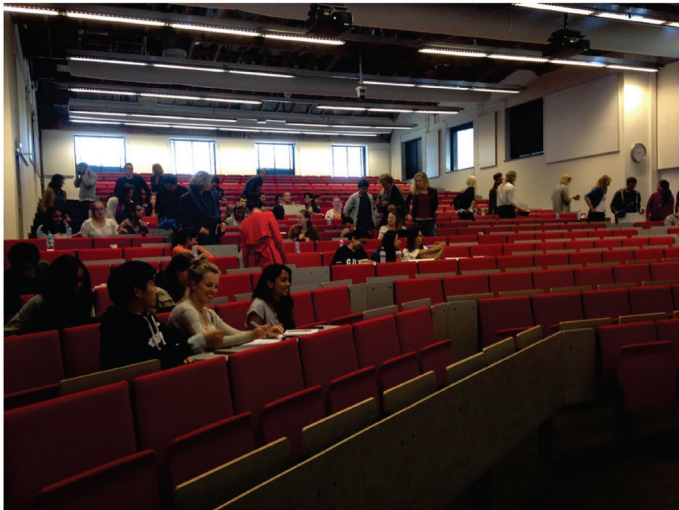
Figure 3: Room A after the renovation, September 2015 [4]. The chairs are new, the ventilation system now consists of airsocks on the ceiling and underfloor supply under the chairs.

The new installation scheme for lecture room A is given in figure 5. The inlet air is heated first with the heat recovery wheel and, if necessary, with extra heating. The air inlet in the room now consists of not one but two systems: 50 % of the fresh air is supplied through air socks in the room, the other 50 % is supplied under the podium and supplies the air through grills in the vertical partitions of the stairs. Floor heating is applied at the location of the speaker. The new outside windows have insulated glazing, with a low g-value. Room A received new chairs to improve the acoustics. The new

chairs have recycled polystyrene fabric on the backs and the seats of the chairs [5], see figure 3.

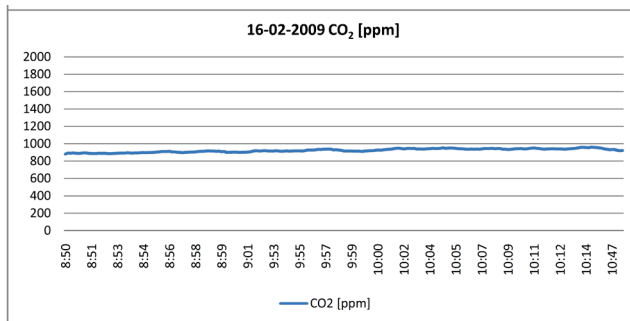
Figure 7: CO₂ concentration in room A on 16-2-2009, before renovation [3].

that the indoor temperature rises during the morning; this is assumed to be caused by the presence of the ~150 students. The low temperatures are probably caused by a high air change rate with unheated outside air of ~ 7 °C. The indoor air quality is reasonable, with a measured CO₂ concentration of 900 ppm on February 16, 2009, see figure 7.

The measurements show that there is room for improvement in room A. After the renovation, the minimum indoor temperature should be 21 °C in winter where 19 °C is measured on February 13, 2009 and an even lower 16 °C is measured on the morning of February 16, 2009. As far as the indoor air quality is concerned: the ideal CO₂ concentration after the renovation should be 800 ppm where 900 ppm is measured on 16 February 2009.
