Deep renovation of an old single-family house including application of an water repellent agent - A case story

De Place Hansen, E. J.; Hansen, T. K.; Soulios, V.

Published in:
IOP Conference Series: Earth and Environmental Science

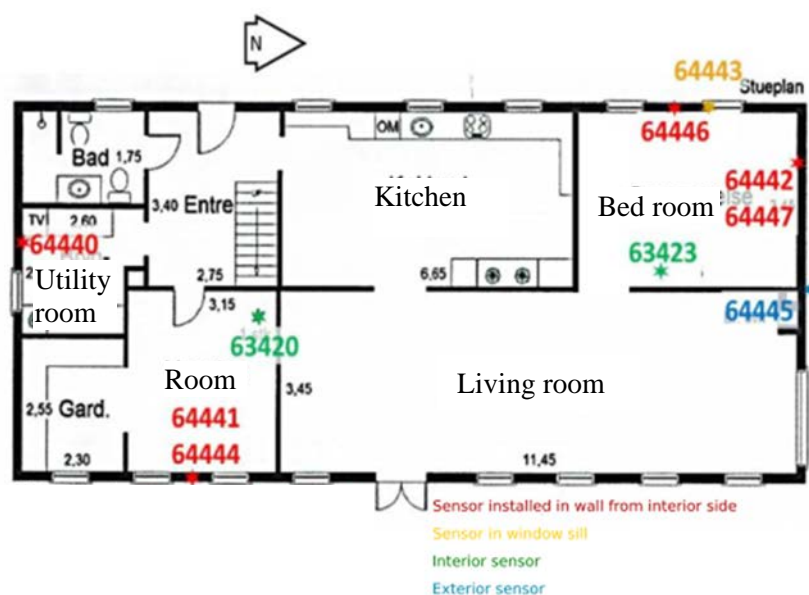
Figure 3. Sensor monitor points at ground floor (original layout, both living room and kitchen later split into two rooms). In the interface between original wall and internal insulation (red, Tramex Hygro-i sensor), in a window sill (yellow, Tramex Hygro-i), indoor climate (green, climaSpot), and outdoor climate (blue, climaSpot). Numbers refer to sensor IDs.

Sensors measuring relative humidity (RH) and temperature (type Tramex Hygro-i) every 30 minutes were installed in all exterior walls at the ground floor, in the interface between masonry and insulation, except for one sensor placed in the window sill, about 1,65 m above floor (Figure 3). In addition to the build-in sensors, reference sensors measuring RH and temperature were placed inside and outside the house (type climaSpot). At those locations where two sensors are shown in Figure 3, one is placed 50 cm above the floor and the other one 180 cm above the floor (50 cm below the ceiling).

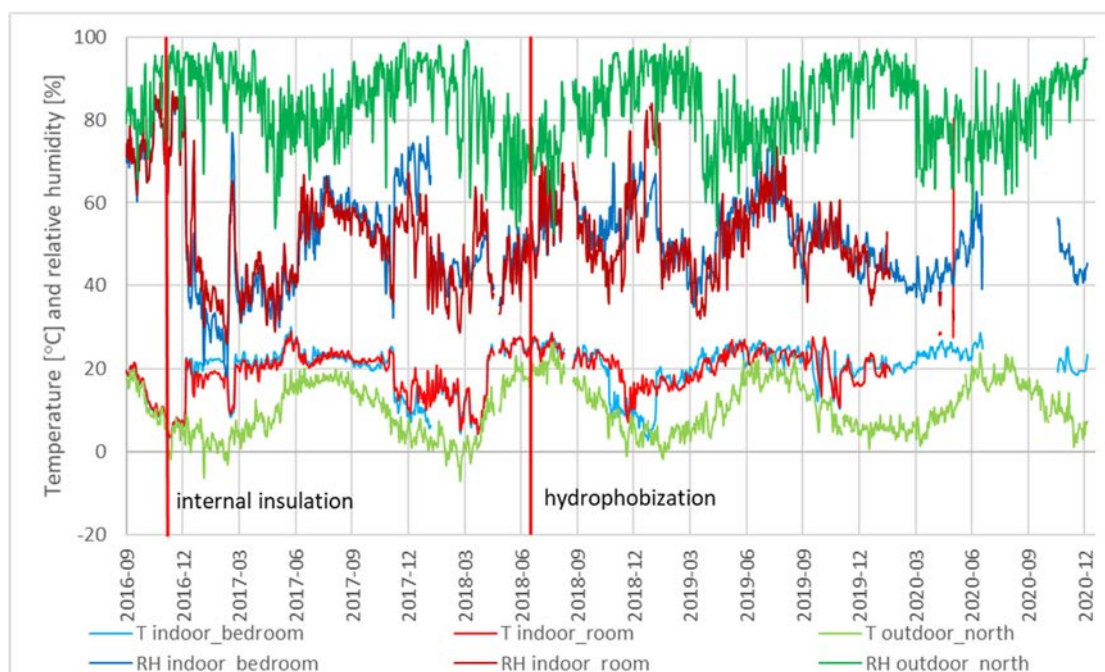
Figure 4. Indoor and outdoor temperature and relative humidity (RH). Daily average values from September 2016 to December 2020. Indoor measurements in the bedroom (blue curves) at northwest corner (Figure 3) and the room at east façade (red curves).

Daily mean values of outdoor and indoor temperature and relative humidity covering July 2016 – December 2020 are presented in Figure 4. For the same period, Figure 5 shows daily mean values of temperature (a) and relative humidity (b) at the different positions in the interface between original wall and internal insulation, and at the window sill, according to Figure 3. Both Figure 4 and Figure 5 include the timing of applying internal insulation and hydrophobization. Notice, that some sensors stopped functioning during the measurement period, not being replaced.

While the outdoor temperature and relative humidity (Figure 4) follow the seasonal changes with some deviations, e.g. a wet, not so sunny summer (2017), a dry sunny summer (2018), or a wet mild winter (2019-2020) [7], the pattern of the indoor relative humidity (and to some extent the indoor temperature) is not quite typical. The measurements started before the renovation was finished in early 2017, explaining why indoor and outdoor measurements for the first 6 months are alike; the heating was not yet turned on. In 2017, the owner had problems with controlling the heating, giving rise to temperatures quite far from the scheduled 21 °C, while later the use of the house mainly heated during weekends may explain extremes. The wet, not so sunny summer 2017 [7] had a lower drying potential than what can be expected. The following winter 2018 had conditions as they can be expected. A moist construction

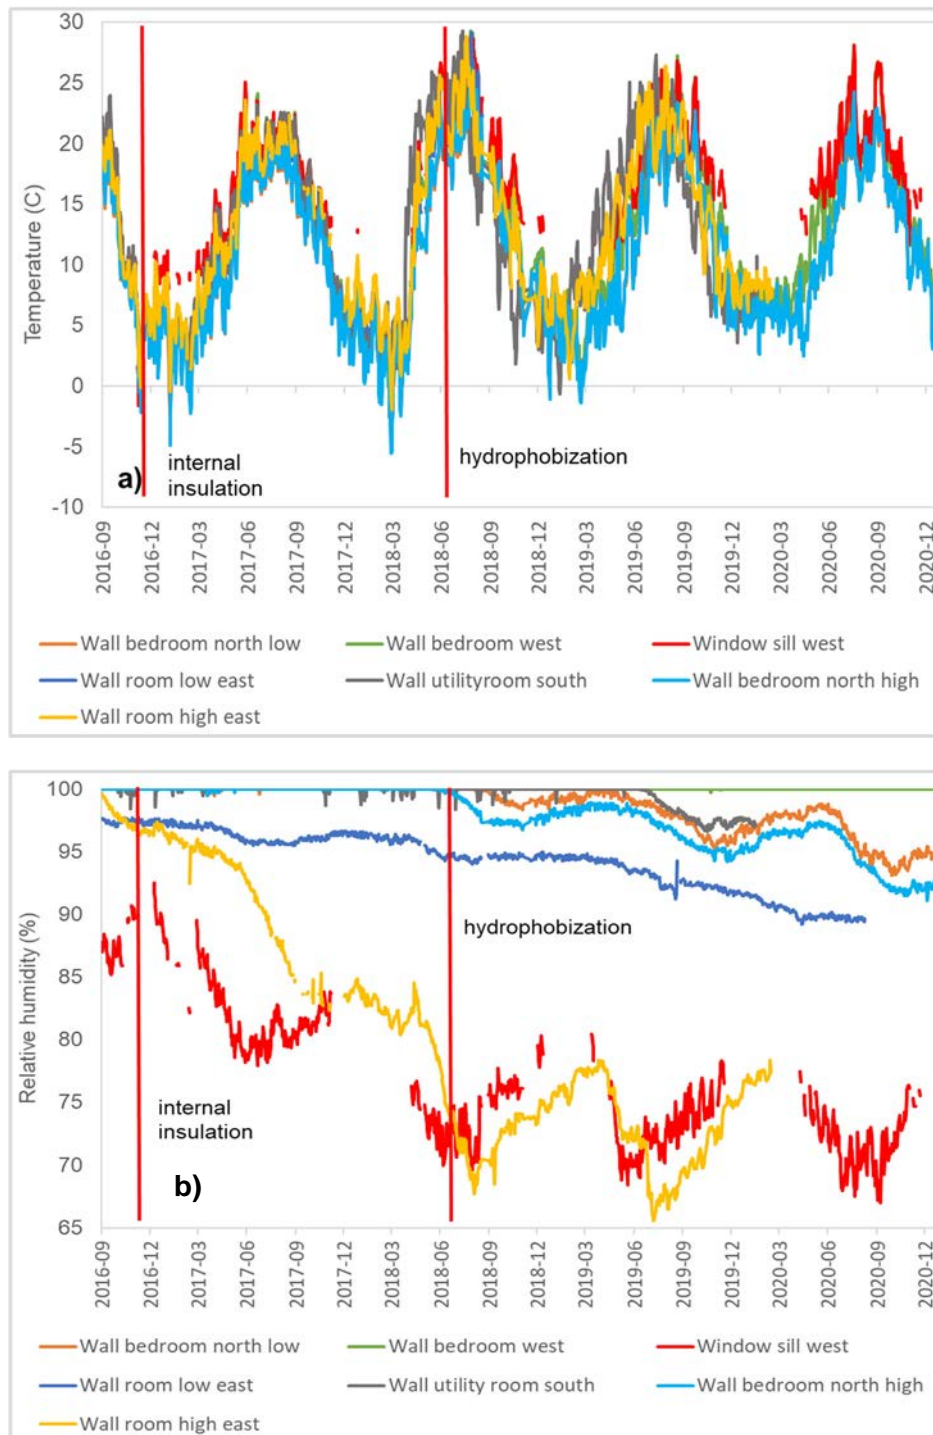
Figure 5. Temperature (a) and relative humidity (b) at the interface between the original wall and the internal insulation and at the window sill (red curve) (daily mean values). Vertical lines: Timing of applying internal insulation and hydrophobization (water repellent agent). For some periods, some sensors contains no data, indicating that they are defect or the signal is unstable.

Measurements from inside the wall of daily mean temperatures (Figure 5a) all show similar trends and show temperatures within 7 °C of each other. The temperature is generally between 0-5 °C (winter) and 20-25 °C (summer). Temperatures tend to be lowest at 'bedroom north', which is to be expected having the north wall oriented towards the nearby coast and with minimum solar radiation. The highest temperature is seen in the utility room at south, however at spring only. In autumn, the highest temperature is seen in the window sill at west, being closer to the interior. In general, orientation of walls is more important than whether measurement takes place at a high or low position on a wall.

The relative humidity at the different positions develop very differently (Figure 5b). While relative humidity high in the east-oriented wall drops below 100 % almost at once, reaches 85 % after a year during a not very "drying" summer (2017) (section 5.1) and reaches 75 % after two years, showing seasonal changes, nothing seems to have happened at the west oriented wall, although it might be a defect sensor, since the sensor in the window sill on the same orientation illustrates a significant reduction in relative humidity. RH in the north oriented wall seems to be independent of the position of the sensor, not being the case in the east oriented; the sensor at low position does not even show any seasonal changes, questioning to some extent the results from this sensor as well. The orientation towards east results in solar radiation (opposed the north oriented bedroom) and less precipitation than towards west. The pattern of the relative humidity in the window sill at west, is comparable with what is seen at the east façade; the even earlier drop in relative humidity is explained by the position close to the interior.

The application of internal insulation alone seems to have no effect on the relative humidity, which starts to decline soon after the walls becoming hydrophobized. However, this effect is not seen at the south oriented wall until a year after the application, i.e. the beneficial drying conditions during summer 2018 and winter 2019 were not enough to dry out the wall. This indicates that the walls still contain built-in moisture 2-3 years after applying the internal insulation and that it takes a couple of years before the level at the east wall and the window sill is reached. Also notice, that even before the walls becoming hydrophobized, the interface in the east oriented wall (high position) becomes dryer than the window sill. The development of the moisture conditions might have looked different, resulting in lower relative humidity in the first two years after applying internal insulation, if a water repellent agent was applied in connection with the internal insulation as suggested by simulation results, seen in Figure 6.

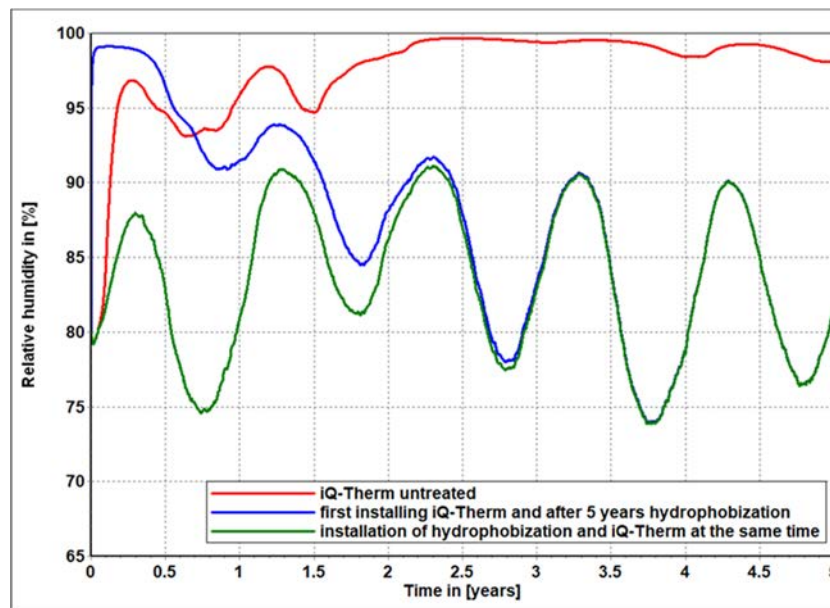
Figure 6. Simulation of relative humidity in the interface between internal insulation (iQ-Therm) and solid masonry in SW-oriented wall configurations for a five year period, when no water repellent agent is applied (red curve), then after five years becoming hydrophobized (blue curve), and if internal insulation and hydrophobization takes place in parallel (green curve). The blue curve should in principle be shown at a 5-10 year scale as it starts where the red curve ends, using the average relative humidity of the internally insulated wall as initial condition for the simulation, but for comparison with the other curves, it is shown on a 0-5 year scale. Simulations were performed with DELPHIN software [3] with climate data for Copenhagen 2020-2024 (www.climateforculture.eu). Characteristics of an untreated and hydrophobized wall were based on [5] for the hygric properties and [4] for the hydrophobic model.

Applying a water repellent agent at the same time (green curve) as applying this type of internal insulation, showing capillary behaviour to some extent – or better, before applying the internal insulation – can accelerate the drying of the wall sufficiently to get rid of the built-in moisture, as it eliminates moisture penetration from wind-driven rain. In the long run, though, hydrophobization will still be beneficial even if done at a later stage (blue curve), as doing nothing (red curve) will keep the relative humidity at a very high level. In accordance to simulations performed in [8] the hydrophobization in Klitgaarden was applied in the optimal season with regard to drying of the wall. While the timing for applying a water repellent agent might not be that important when using PUR-foam with capillary active channels (iQ-Therm), as long as it is done after some time, on the contrary, the timing is very important in the case of applying a vapour tight insulation system (e.g. mineral wool and a vapour barrier). In this case, hydrophobization has to be applied no later than the internal insulation to avoid moisture problems at the early stage (Figure 7), but it is still positive in the long term if done after e.g. five years. This phenomenon has been further studied in [4], showing that in the case of calcium silicate based insulation, being capillary active, hydrophobizing the wall in parallel with the internal insulation or five years later, gives almost the same result. In line with the findings of the current paper, previous studies based on numerical results, reported that the hygrothermal performance of an internally insulated facade can be improved by hydrophobization [8, 9].

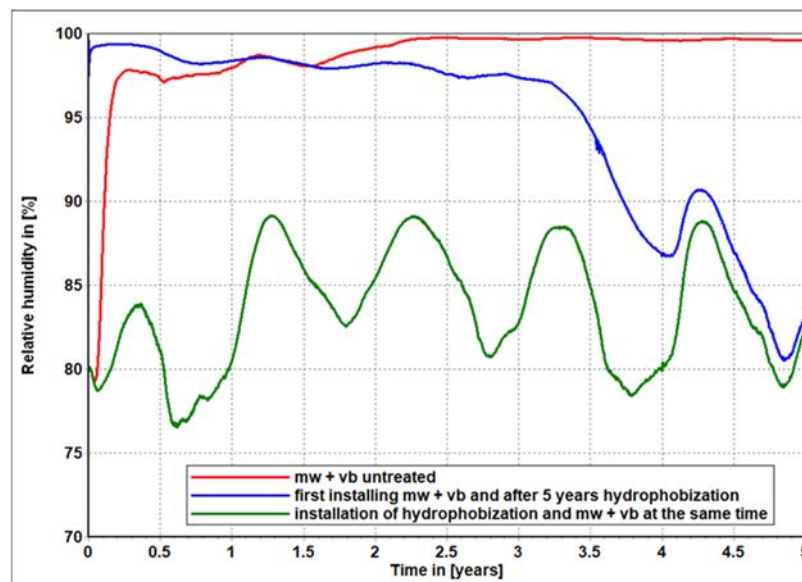
Figure 7. Simulation of relative humidity in the interface between internal insulation (mineral wool with vapour barrier) and masonry, in SW-oriented wall configurations for a five year period, when no water repellent agent is applied (red curve), then after five years being hydrophobized (blue curve), and if internal insulation and hydrophobization takes place in parallel (green curve). Concerning the blue curve, refer also to figure 6. Simulations were performed with DELPHIN software [3] with climate data for Copenhagen 2020-2024 (www.climateforculture.eu). Characteristics of an untreated and hydrophobized wall were based on [5] for the hygric properties and [4] for the hydrophobic model.
