Temperature measurements in the air gap of highly insulated wood-frame walls in a Zero Emission Building

NSB 2023 - Book of Technical Papers: 13th Nordic Symposium on Building Physics

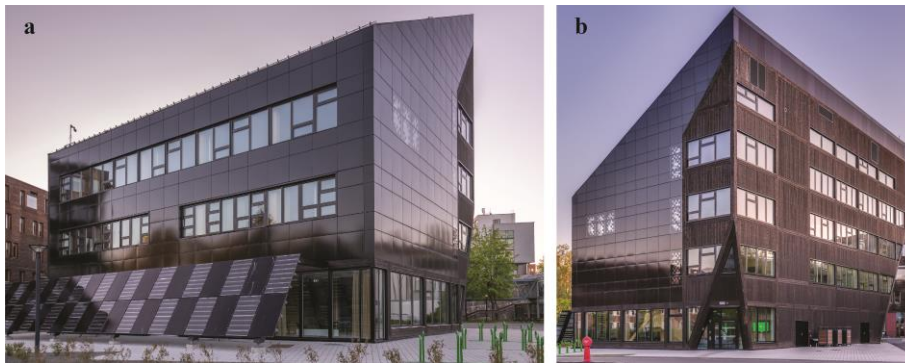
Figure 1. The ZEB Laboratory viewed from the Southeast (a), and Northeast (b). Photos:   Nicola Lolli, 2021.

The building that served as a test facility for the experimental data collected in this study is the Zero Emission Building (ZEB) Laboratory (<https://zeblab.no>). Completed in 2020, the ZEB Laboratory was designed and constructed to provide a research facility allowing for testing new environmentally friendly building components, solutions, strategies, and constructions as well as management processes [6–8]. It is a 4-storey, ca. 2000 m² living office laboratory with glued laminated timber columns, cross-laminated timber floors, stiffening internal walls, and insulated wooden framework in the external walls as load-bearing structure. On the fa ade to the North, charred wood is used as cladding material, BIPV on the roof, and both BIPV and Alu-PE panels on the remaining facades (see figure 1 and figure 2). Unfortunately, no measurements of the optical properties of the cladding materials are available. The determination of which remains subject of further work.
