Investigating the solder mask defects impact on leakage current on PCB under condensing humidity conditions

Published in:
Microelectronics Reliability

Publication date:
2023

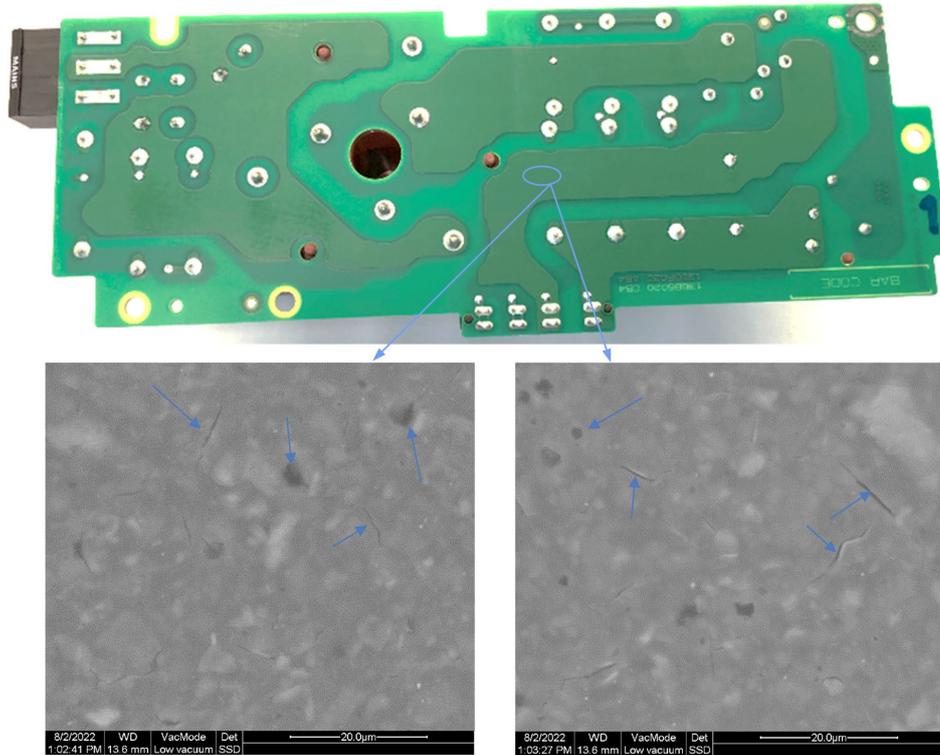
Fig. 1. PCBA under test (backside view) with close-up on solder mask with small cracks and pinholes.

The PCBA under test is as shown in Fig. 1, which is a commercial product designed to operate under $400V_{ac}$, with the potential of the tracks and pads/vias being categorized into three phases and protective earth (PE)/functional earth (FE). The PCBA is a four-layer type with the body of the board made of FR-4 material and four layers (top, two inner, and bottom layer) made of copper. The solder mask layer is liquid film type using green color, the smallest solder mask clearance is 0.10mm, and the via solder mask clearance is 0.00mm. The adopted surface finishing technique is hot air solder leveling (HASL).

The tested board underwent continuous testing until a malfunction occurred, followed by post-failure analysis that focused on examining the solder mask surface. SEM analysis revealed the presence of small cracks and pinholes in μm scale, on the surface and top edge of the solder mask layer of the PCBA, as shown in Fig. 1. The findings using field emission scanning electron microscope (FE-SEM), also

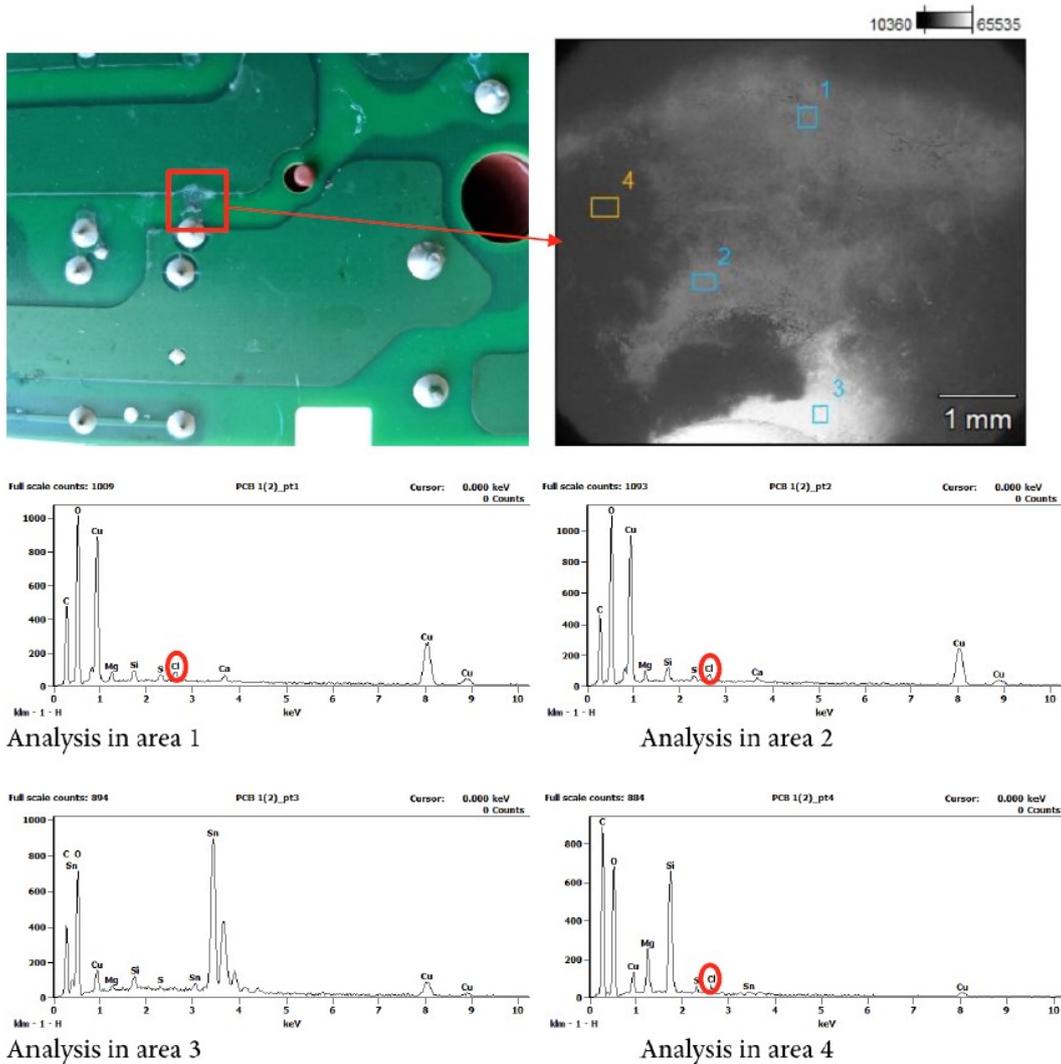
Fig. 2. FE-SEM analysis of the PCBA under test.

confirmed the presence of chlorine on the PCBA surface, which originated from the PCB manufacturing process, is depicted in Fig. 2. To be noted, the presence of chlorine observed could contribute to the occurrence of ECM on the PCBA.

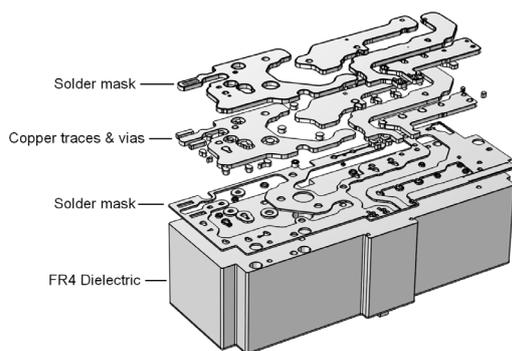
Fig. 4. Exploded view of the numerical model built in COMSOL (50x magnified along the Z-axis).

In the model's geometry aspect, an exploded view showcasing the PCBA's vertical structure is illustrated in Fig. 3. Since the two inner copper layers are embedded within the FR-4 material and are not in direct contact with the condensation, the numerical model only takes into account the top and bottom layers. These two layers were specifically considered as they are more susceptible to corrosion when the board is exposed to moisture and there have high voltage present between the tracks/vias. In order to closely replicate the original design, the solder mask was applied to cover all copper traces and vias, with the exception of certain intentionally exposed vias and copper areas, as presented in Fig. 4.

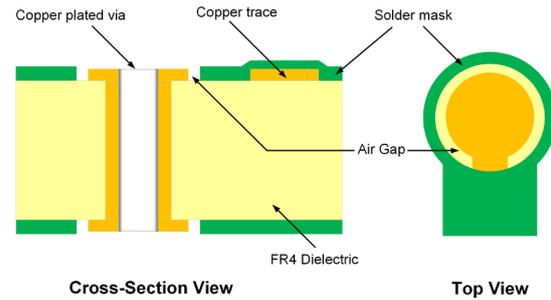
Fig. 3. Cross-section and top view of solder masks represented in the numerical model.

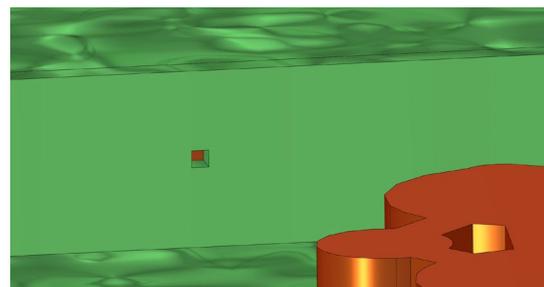
Fig. 5. Pinhole created in the solder mask, exposing the underlying copper (located on the edge of the track).

defect. Small unintended openings were deliberately created as pinholes in the solder mask, to expose the underlying copper traces to the condensation layer. A zoomed-in figure illustrating the pinhole with a width of $5\ \mu\text{m}$ is displayed in Fig. 5.

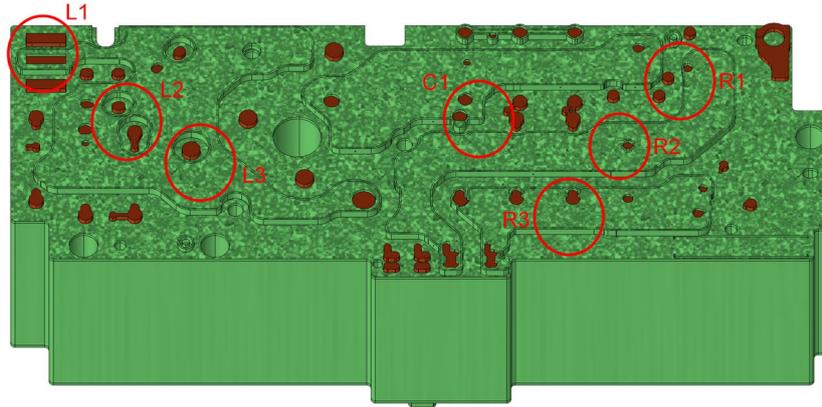
Fig. 6. Numerical model of the PCBA under test with pinholes created on the solder mask (backside view).

In the simulation, both geometries with and without pinholes have been modeled. The geometry with pinholes including ten pinholes strategically placed along the edge of the traces and one pinhole on top of the solder mask is presented in Fig. 6, with tracks and vias being assigned to different potentials. The locations of the pinholes are more clearly visible in Fig. 12, appearing as small openings under the applied high voltage.

To validate the simulation results, a humidity test was conducted by placing the PCBA test samples in a climatic chamber. The chamber maintained a constant relative humidity level of 95% RH and an air temperature of 70°C. The experiments were conducted over a period of 700 hours. Following the completion of the tests, seven regions of interest, as identified in Fig. 6, underwent extractions and conductivity measurements on the PCBA board. The

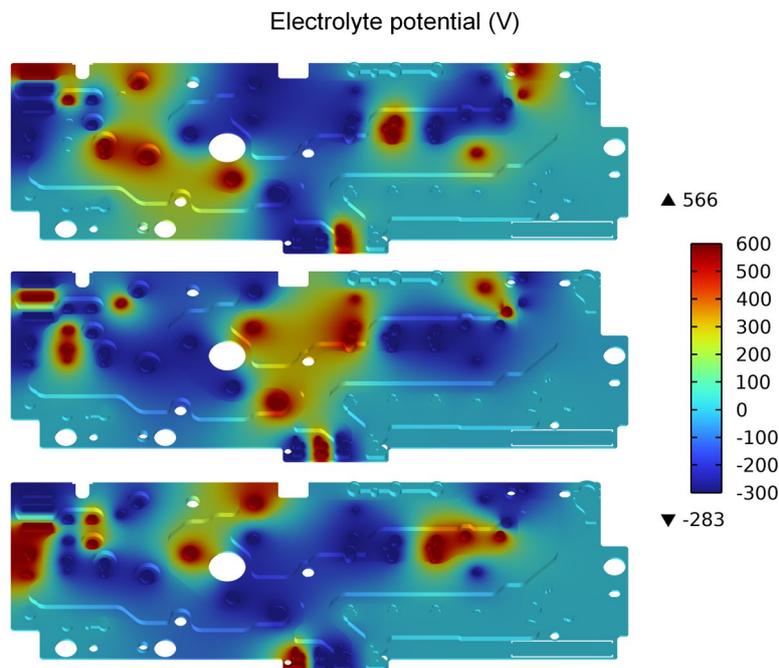
Fig. 7. Electrolyte potential distributions on the PCBA surface (without pinholes).

To evaluate the potential paths of LC and identify the risky regions where the short circuit might mostly occur under real operating conditions, multiple COMSOL simulations were performed. Three different electrical conditions were applied to the tracks and vias as the PCBA under test is designed to operate under three-phase power. Since operational failures under condensation and high electric field are instantaneous, the study only concentrated on the most crucial conditions, specifically those with the highest potential differences among tracks and vias. Fig. 7 illustrates the potential distribution in the condensation/electrolyte layer for three specific

within the condensation/electrolyte layer of the numerical model, considering the presence of pinholes in the solder mask, under one of the three electrical conditions. Compared to the results shown in the first subfigure of Fig. 7 and Fig. 8, the presence of pinholes clearly indicates more biased copper areas exposed to the condensation and leads to the emergence of new LC paths and an elevation in the LC density within the region, which is identified as emerging more brighter areas in the simulation results.

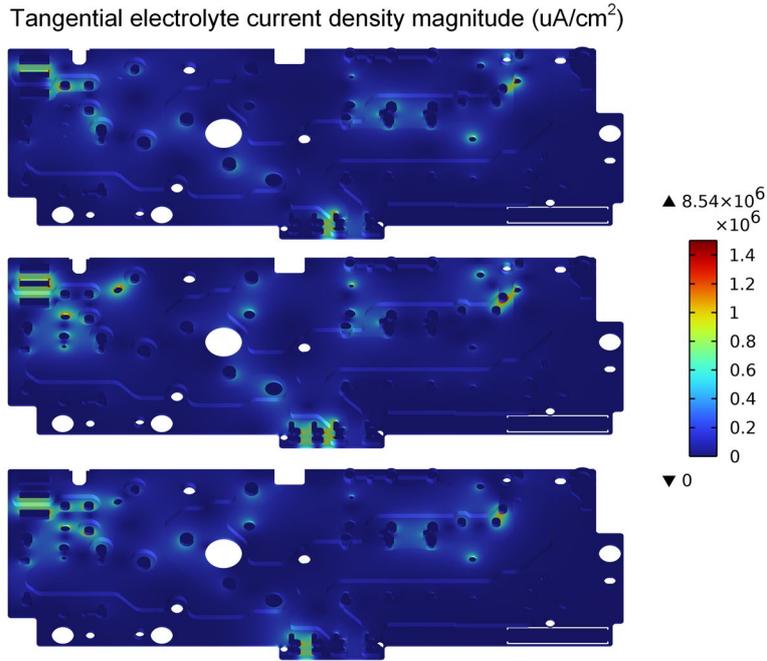
Fig. 8. Electrolyte current density distributions on the PCBA surface (without pinholes).

Correspondingly, under each electrical condition, the LC level and paths under the same humidity level (defined by condensation layer thickness and conductivity) have been identified and presented in Fig. 8.

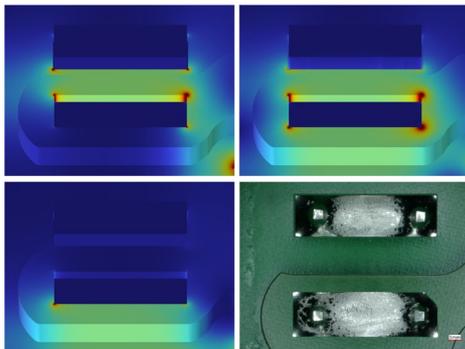
Fig. 9. Simulated current density and optical microscopy picture in region L1.

For comparison, the simulated current density of the condensation under three electrical conditions and the corresponding optical microscopy images of the same regions are presented, respectively in Fig. 9-11. As previously discussed, the simulation results solely indicate the worst-case scenario and can serve as a design reference without giving the real LC value.

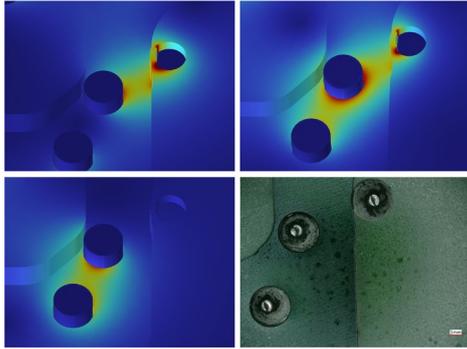
Fig. 10. Simulated current density and optical microscopy picture in region R1.

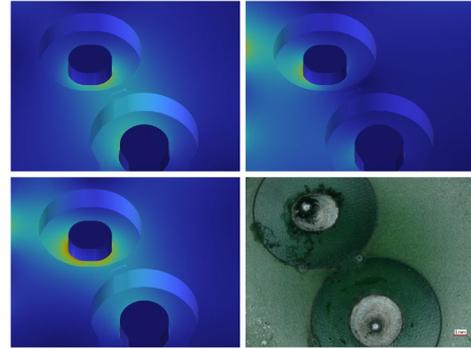
Fig. 11. Simulated current density and optical microscopy picture in region L2.

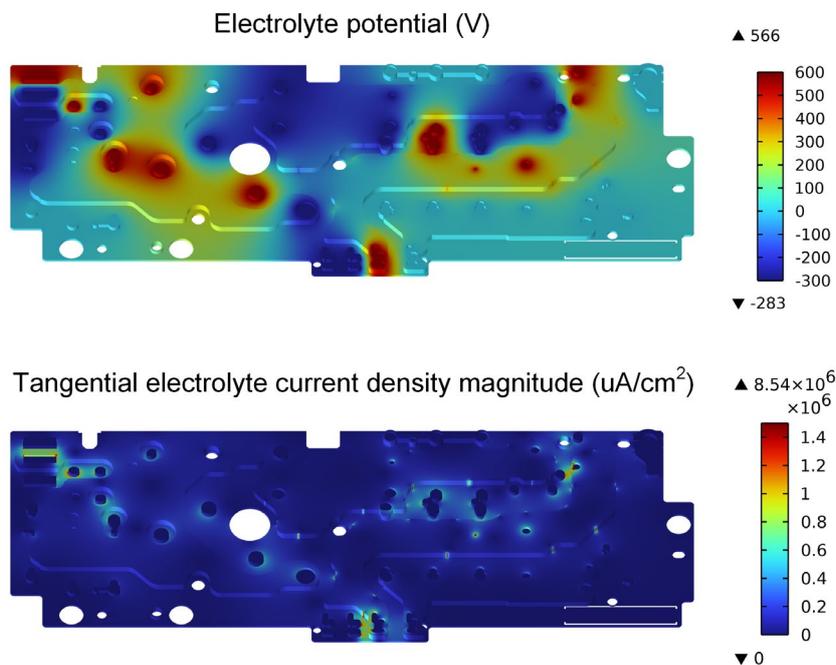
Fig. 12. Electrolyte potential and current density distributions on the PCB surface (with pinholes).

In the simulation results provided above, the solder masks were incorporated into the numerical model without introducing any pinholes. To illustrate the impact of solder mask defects on the LC levels and paths, the simulation outcomes for the model with pinholes will be presented and analyzed. Fig. 12 reveals the potential and current density distribution

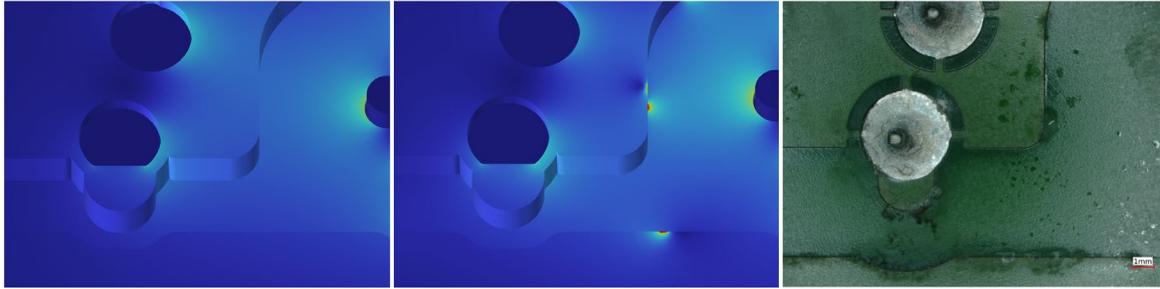
Fig. 13. Simulated current density (without and with pinholes) and optical microscopy picture in region C1.

Based on the findings of the FE-SEM analysis of the PCBA, it was ascertained that the pinholes within the solder mask are predominantly located along the track edges. In region C1, two pinholes were intentionally placed as close to the real case as

possible. The simulated current density results without and with pinholes in Fig. 13 effectively verified the pinhole's impact on the LC level and path, and how it can influence the PCBA's humidity resistance capability.
