Sustainable Refurbishment - Nordic Case Studies

Published in:
CIB Proceedings

Publication date:
2011

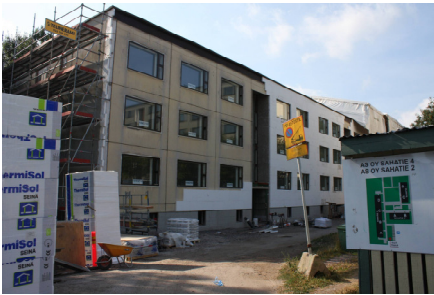
The first Finnish case study deals with 42 rental apartments and living area of 2 586 m² where the owner (VAV Asunnot Oy) wanted first only to renovate the facades (prefabricated sandwich elements), balconies and roof. After discussions with ARA (The Housing Finance and Development Centre of Finland) more ambitious targets were studied for improved energy efficiency (Nordic Passive House level), improved indoor conditions (new ventilation system with heat recovery), accessibility (adding lifts), replacement housing and financing (construction of an additional floor) by industrial, replicable solutions and no major increase in rents.

During the process air permeability measurements, harmful substances mapping, sewer surveys, roof, pipeline facade and balcony inspections were conducted and discussions held on the use of renewable energy. As an end result heating energy consumption was halved (energy class: F → B) and improved indoor conditions achieved [14]. At present the results are monitored and discussion going on with the client how these experiences can be exploited in the coming renovations.

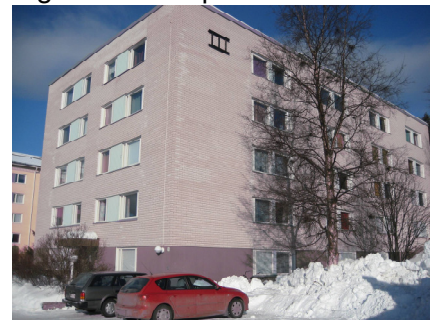
The second Finnish case study is quite similar to the first one. Domus Arctica Foundation (DAS) is an owner and builder organisation who rents student homes in the City of Rovaniemi, at the polar circle. The case study (DAS III) is a five-floor apartment building with 46 apartments for 84 residents and total living area of 1 923 m². The aimed refurbishment included energy-efficiency improvement, new facades, additional spaces for user activities and measures to improve the performance, e.g., new balconies. The average energy consumption for space heating and hot water is 162 kWh/m² gross floor area. The present master plan restricts the possibility for an additional floor. DAS III locates just in front of the railway station and close to the university premises. Improvement of the performance and appearance of the building helps for getting new residents.

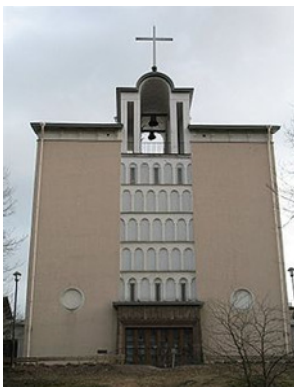
The third case study is a listed Church (1930) which the Parish Union of Helsinki wants to refurbish after some indoor complaints. They also plan to renew their services by constructing two new buildings for office and other services next to the Church and move some of their functions to the same plot because of merging of two congregations. Sustainable procurement was studied in relation with both energy efficient refurbishment and new construction aiming at Nordic Passive House level. The congregation also plans to do carbon footprint calculation for all their activities in the Töölö Parish. Indoor condition inspection and energy simulations resulted in design guidelines and a proposal for carbon footprint monitoring. Design has been started but the required zoning change for additional construction has not been approved.

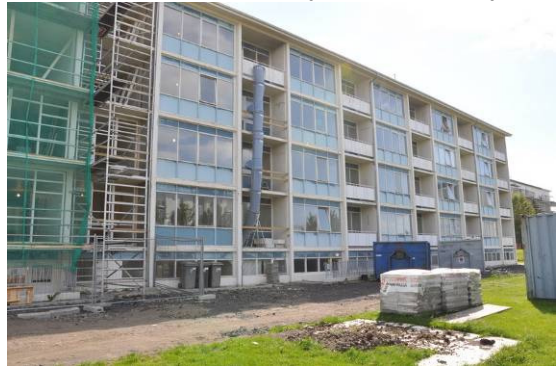
The Icelandic case study is a multi family dwelling at Meistarabellir 19-23 in Reykjavik built in 1964 and is now (2010/2011) being refurbished. The main measures for the refurbishment are insulation of the building envelope, new sewage pipes, partly new windows and installation of an elevator to remodel the building into a “building for life”. The building is owned by Félagsbústaðir hf. (Reykjavík Social Housing), which is a public limited company, owned by the city of Reykjavík, which owns, runs and maintains rented social apartments for individuals and families under a specific income and property maximum. The client

The building has three stairwells and four floors with two apartments on each floor. The apartments are rather small (about 55 m²). The building does not have an elevator, as this was not required at the time of construction. The building is made of in-situ poured concrete (outer walls, floor slabs and inner walls between apartments), the outer walls insulated on the inside with 50mm cork insulation and cement rendering. The roof construction is timber roof on a concrete slab. The use of concrete, insulated on the inside results in a high amount of thermal bridges. The windows are two pane insulation glass with U-value of 2.9 W/m²K and massive wooden frames. The southern wall and a part of the north facing wall have insulated panels to the height of 85 cm, a window band and then 35 cm panel above windows (panels insulated with 50 mm polystyrene). Air tightness of concrete buildings in Reykjavík is usually rather good ($n_{50} < 1$ airchange pr. hour) if tightness of windows is good. The air tightness of the case building has not been measured.
