Robustness of internal insulation systems in practice – Role of installation, physical impact, paint types, and surface covering

*Published in:*  
Journal of Building Engineering

Panagiota Pagoni<sup>a,\*</sup>, Eva Birgit Møller<sup>a</sup>, Ruut Hannele Peuhkuri<sup>b</sup>,  
Nickolaj Feldt Jensen<sup>b</sup>

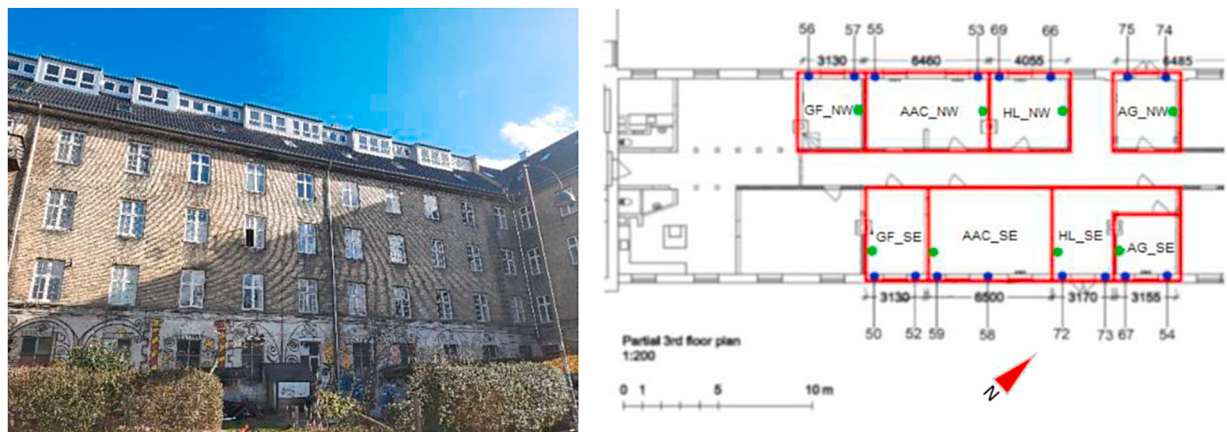
**Fig. 2.** Case building from outside (left) and the floor plan of the section with rooms with internal insulation (right). Each insulation system was installed on both sides of the corridor to test two orientations (SE and NW). The insulated rooms are highlighted in red. The blue dots indicate the interface temperature and relative humidity sensor placement. The green dots are the indoor climate sensors. (For interpretation of the references to colour in this figure legend, the reader is referred to the Web version of this article.)

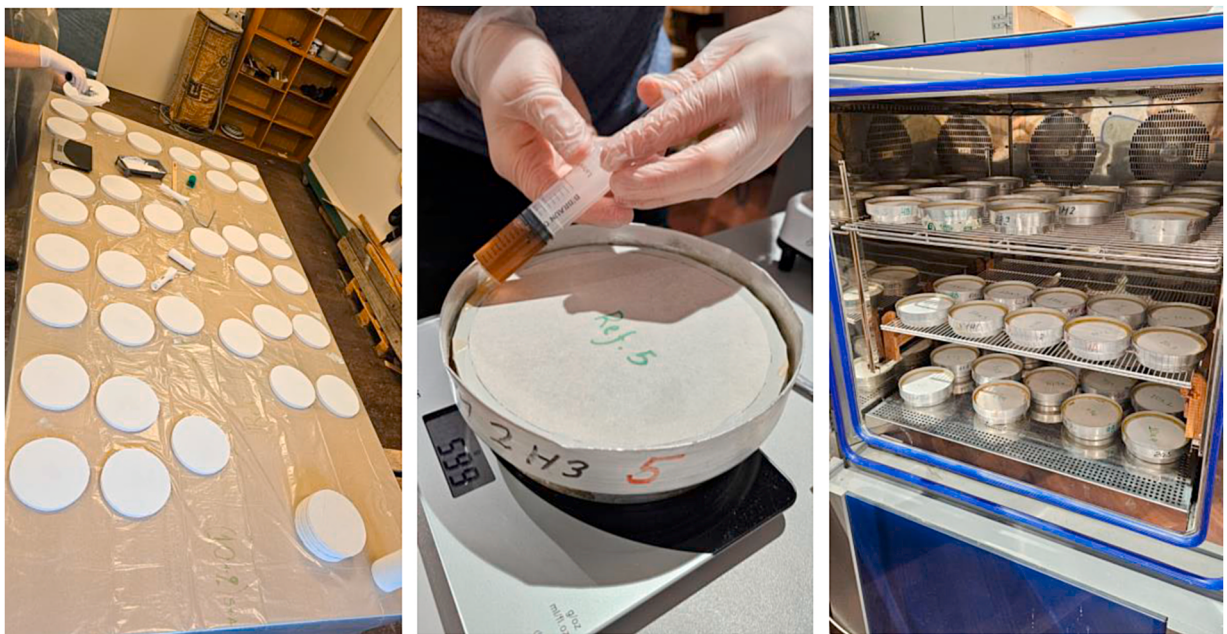
**Fig. 4.** Cup experiment: (a) Paint treatment of gypsum board disks, (b) Sealing test cups with mixture of beeswax and paraffin, (c) Placement of test cups inside climate chamber.

Gypsum disks were sealed inside the test cup using a mixture of 60 % beeswax and 40 % paraffin wax, as recommended in DS/EN ISO 12572. Prior to the paint treatments, the edge and outermost part of specimens were treated with epoxy paint [59]. This was done to prevent unintentional penetration of the wax mixture into the gypsum disks. In Fig. 4, the stages of the preparation of the samples are presented.

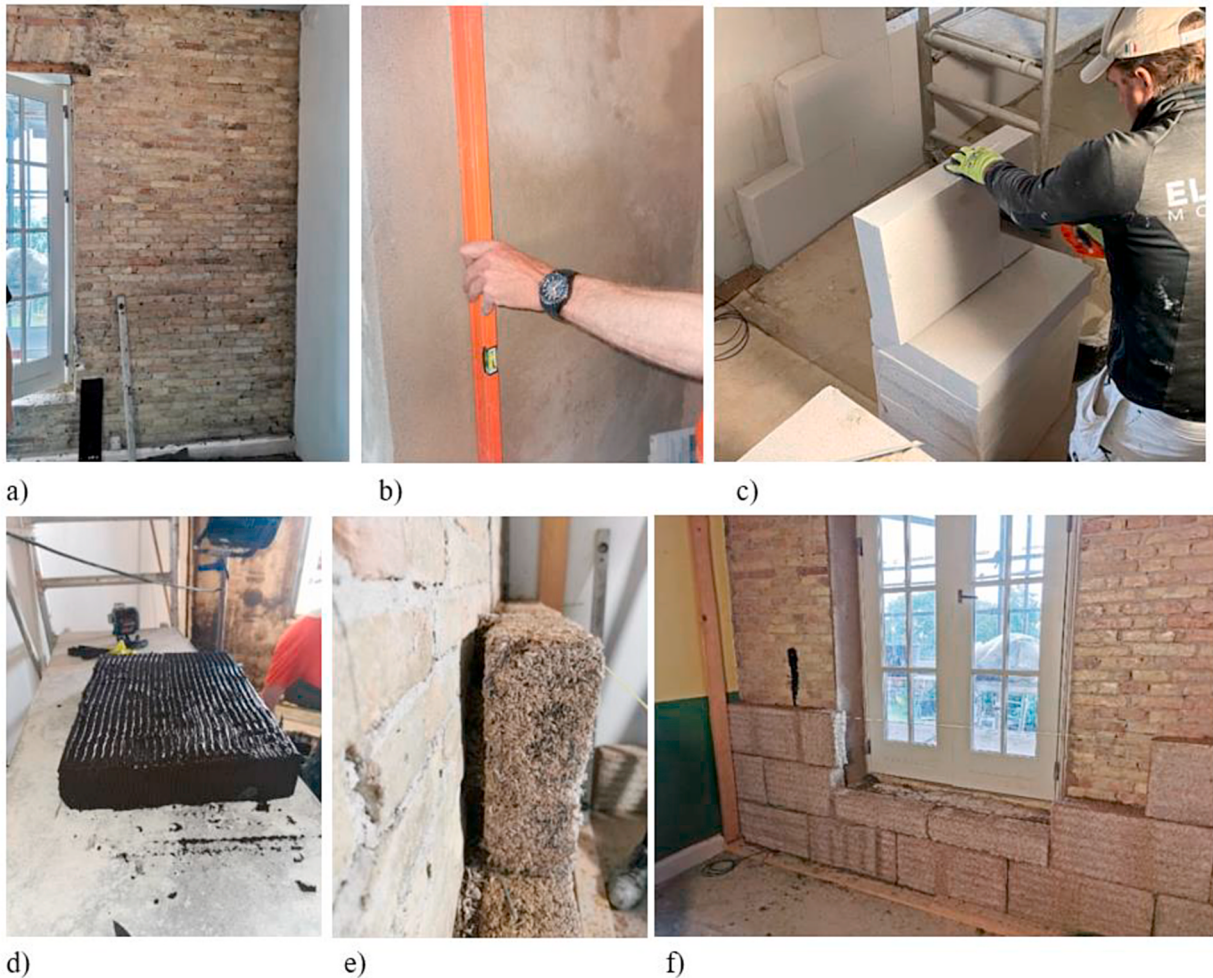
**Fig. 7.** Photos from the installation of the studied insulation systems. a) Existing wall was cleaned for all old plaster, wall paper and dust, b) New mortar plaster was used to make an even underlay for the insulation (except for system HL), c) Cutting and installation of system AAC, d) Bitumen based glue on system GF was difficult to work with, e) System HL was installed without new mortar plaster as the uneven void between boards and the wall was filled in with HL as a wet granulate, f) System HL under construction also showing the partition wall.

In this current case study, all the original masonry surfaces were carefully cleaned (Fig. 7 a), which is expected to contribute positively to the hygrothermal performance of the insulation systems. However, it was also observed in several cases that no attention was paid to cleaning and removing existing plaster or wallpaper from the adjacent walls, ceiling and floor (Fig. 7 f). This lack of focus on these details, even around thermal bridges, may increase the future risk of mold growth in these areas, and in this way the performance of the system is compromised.

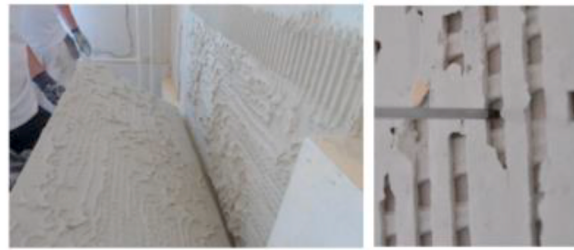
**Fig. 14.** a) Many insulation products are installed with glue mortar on both insulation and the wall as illustrated. b) The resulting contact can be down to 25 % instead of 100 % contact as given by guidelines [50].

Especially for the diffusion-open and capillary-active systems, but also for most other systems with rigid insulation boards, it is essential to create good contact with the wall. A potential failure is created the way glue mortar is - however correctly - applied with a notched trowel on both the insulation board and the wall (see Fig. 14), resulting in a "net" of glue mortar with contact down to 25 % instead of 100 % contact [50]. Also, for all the systems (except GF) primer was not used before applying glue mortar, which may have reduced the ideal contact between plaster and glue mortar. Finally, the post-insulation of older buildings is challenging; it involves cutting and customizing the materials and solving insulation of the uneven surfaces and details on-site, which calls for solutions like digital scanning and cutting.
