Linderum Electricity Quality - Measurements and Analysis

Linderum Electricity Quality

Measurements and Analysis

Filipe Miguel Faria da Silva and Claus Leth Bak

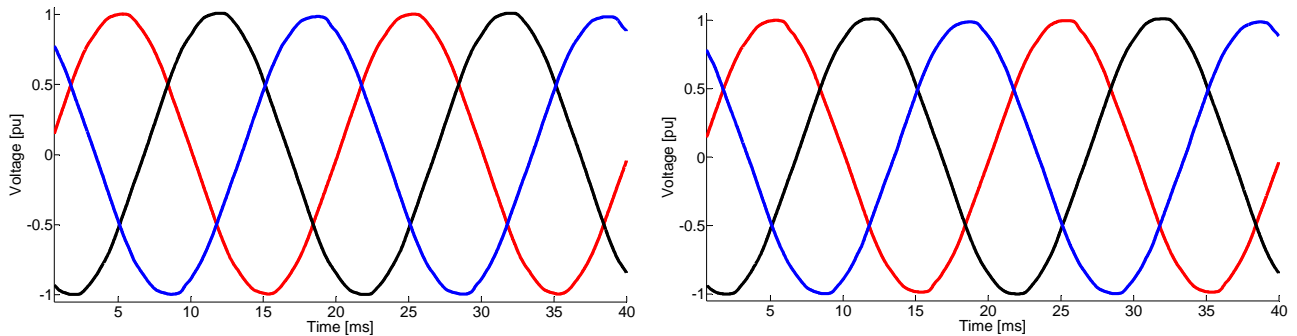
Figure 1 – Voltage waveforms in Linderum (left) and location 2 (right)

The analyse of the results shows that the voltage waveforms are close to perfect in both locations and that there it is a substantial harmonic distortion and unbalance on the current waveforms, being larger in

Conclusion: The voltage at both locations has a high quality and it is well inside of the limits indicated by the standard.

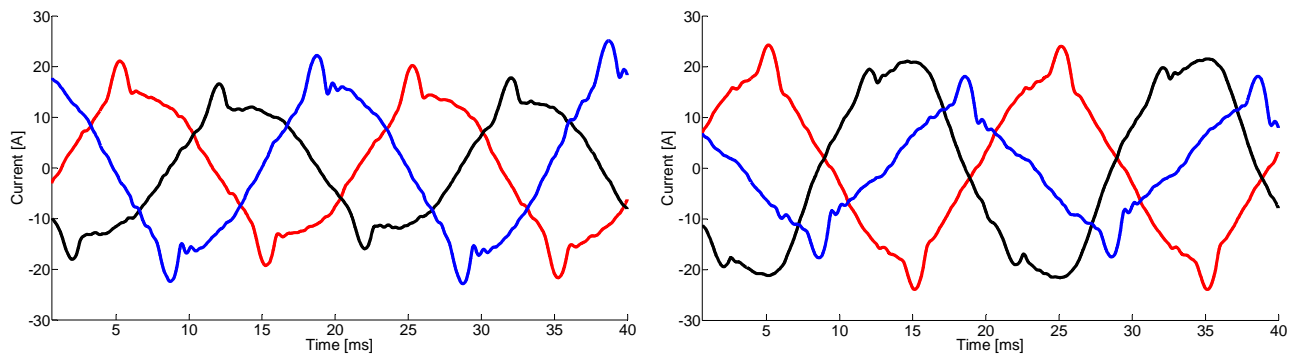
Figure 2 – Current waveforms in Linderum

Figure 1-Figure 3 show the obtained results¹. The current waveforms were acquired twice in Linderum, because of the larger harmonic content.

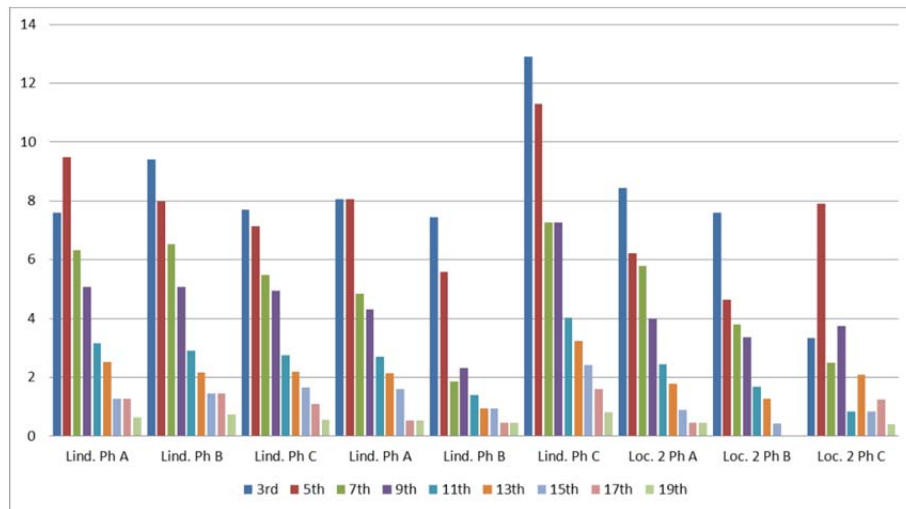
Figure 4 – Harmonic currents in percent of the fundamental

Figure 4 shows the harmonic currents in function of the fundamental for each phase. As expected, only odd harmonics are present and thus, only those are shown. Table 1 shows the current's THD for the different phases.

THD Current: The THD currents are rather high and at some points larger than 50%. The individual harmonic contribution was not measured, but using the results from Figure 4 and Table 1 it can be said with a very high degree of certain that some of the harmonics are rather high.

Example: The short-term measurements show at Linderum an 8-10% harmonic content for the 3rd and 5th harmonics for a THD of 16%. The registered peak values of the THD are the triple of the 16% obtained in the short-term measurements, thus, it is expected that the harmonic content, in percentage, of the harmonics is also approximately the triple⁵.

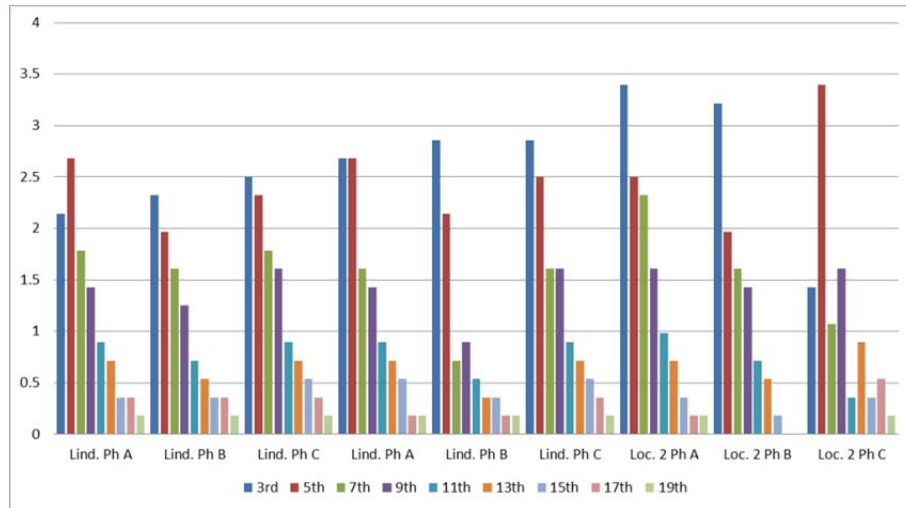
Figure 5 – TDD of the individual harmonics

For the currents more important than the THD is the TDD (Total Demand Distortion), which depends on the maximum load current. Ideally, there would be one year measurements and an average, but due to the existing limitations it is used the measured peak value of one week. In order to have a worst case scenario is also slightly lower the value of the peak current, which is considered as being approximately 40A at both locations. Figure 5 and Table 2 show the total TDD at the Linderum and location 2 for these conditions.

For the short-term measurement the TDD is inside of the limits imposed by both standards and it is not an issue.

Like for the THD there can be used the results from Figure 5 and Table 2 to deduce more about the behaviour of the individual harmonics and then compare it with the standards.

Similar to the THD the maximum TDD is three times larger than the one obtained in the short-time measurements⁶. Thus, an approximation is to say that the TDD of the individual harmonics is also three times larger, using the reasoning also applied to the THD current. In this case the values will still fulfil the demands of the IEEE standard (assuming a strong network), but they would be slightly over the threshold for the IEC standard.

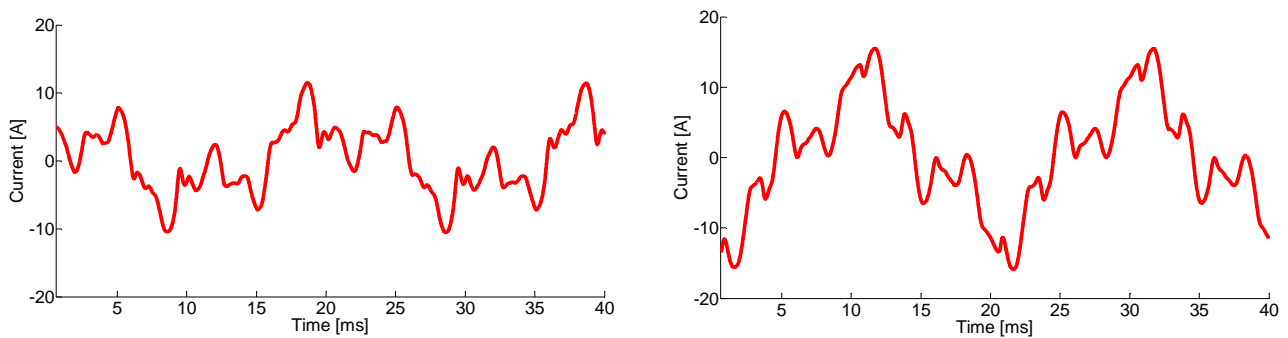
Figure 6 – Return current in Linderum (left) and location 2 (right)

The measurements show also an unbalance on the phases, which can be explained by the reduced number of households connected to the link. Together with the use of single-phase appliances this will naturally result in a current unbalance.

In theory this could be a problem as there is a return current flowing from the houses to the transformer (see Figure 6). However, there is a neutral conductor between the transformer and the houses. As a result, practically all the return current flows in the return current and there is not a risk for humans ⁴.

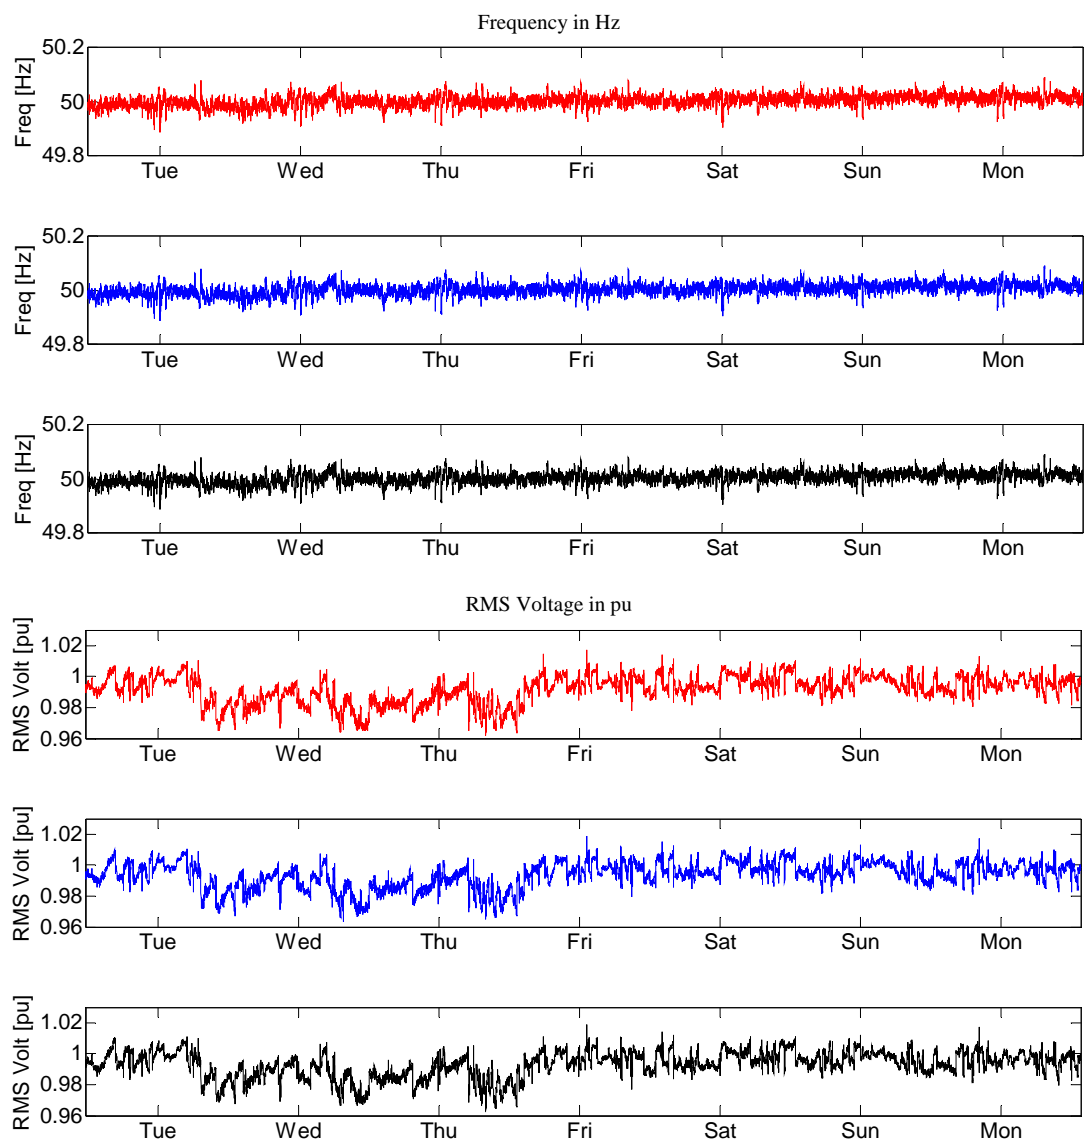
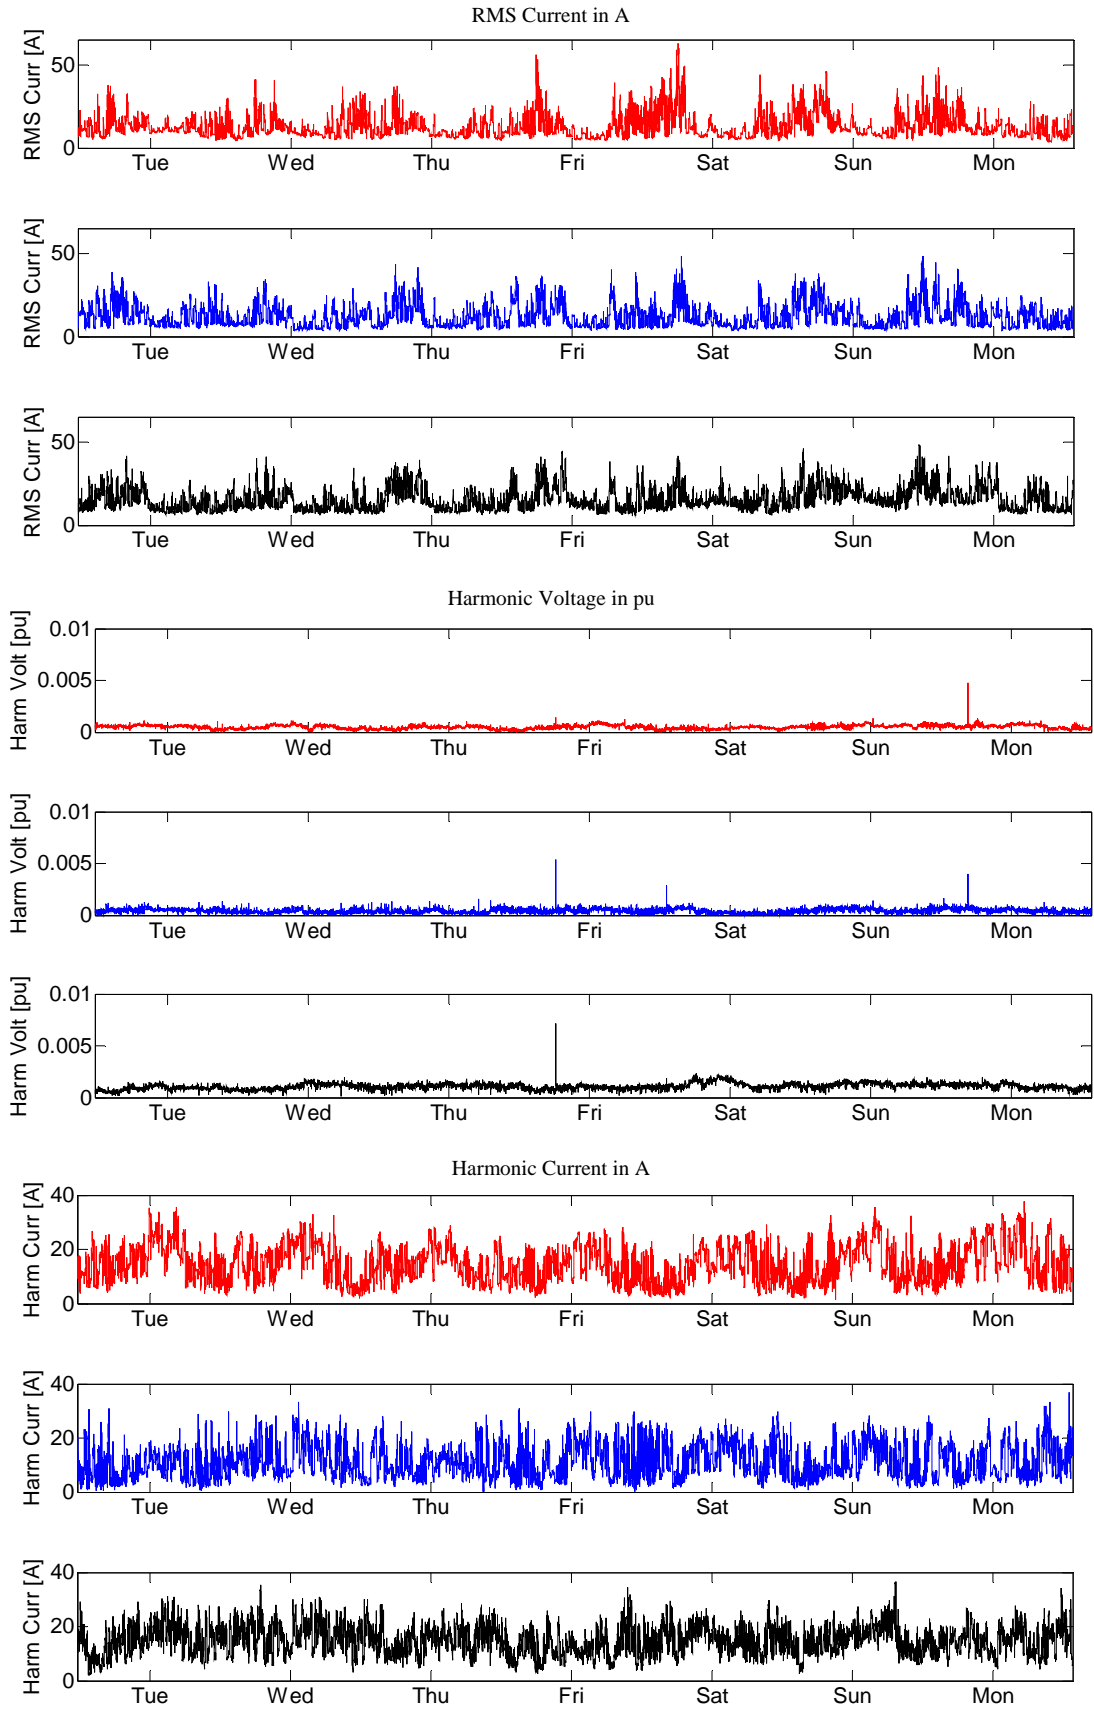
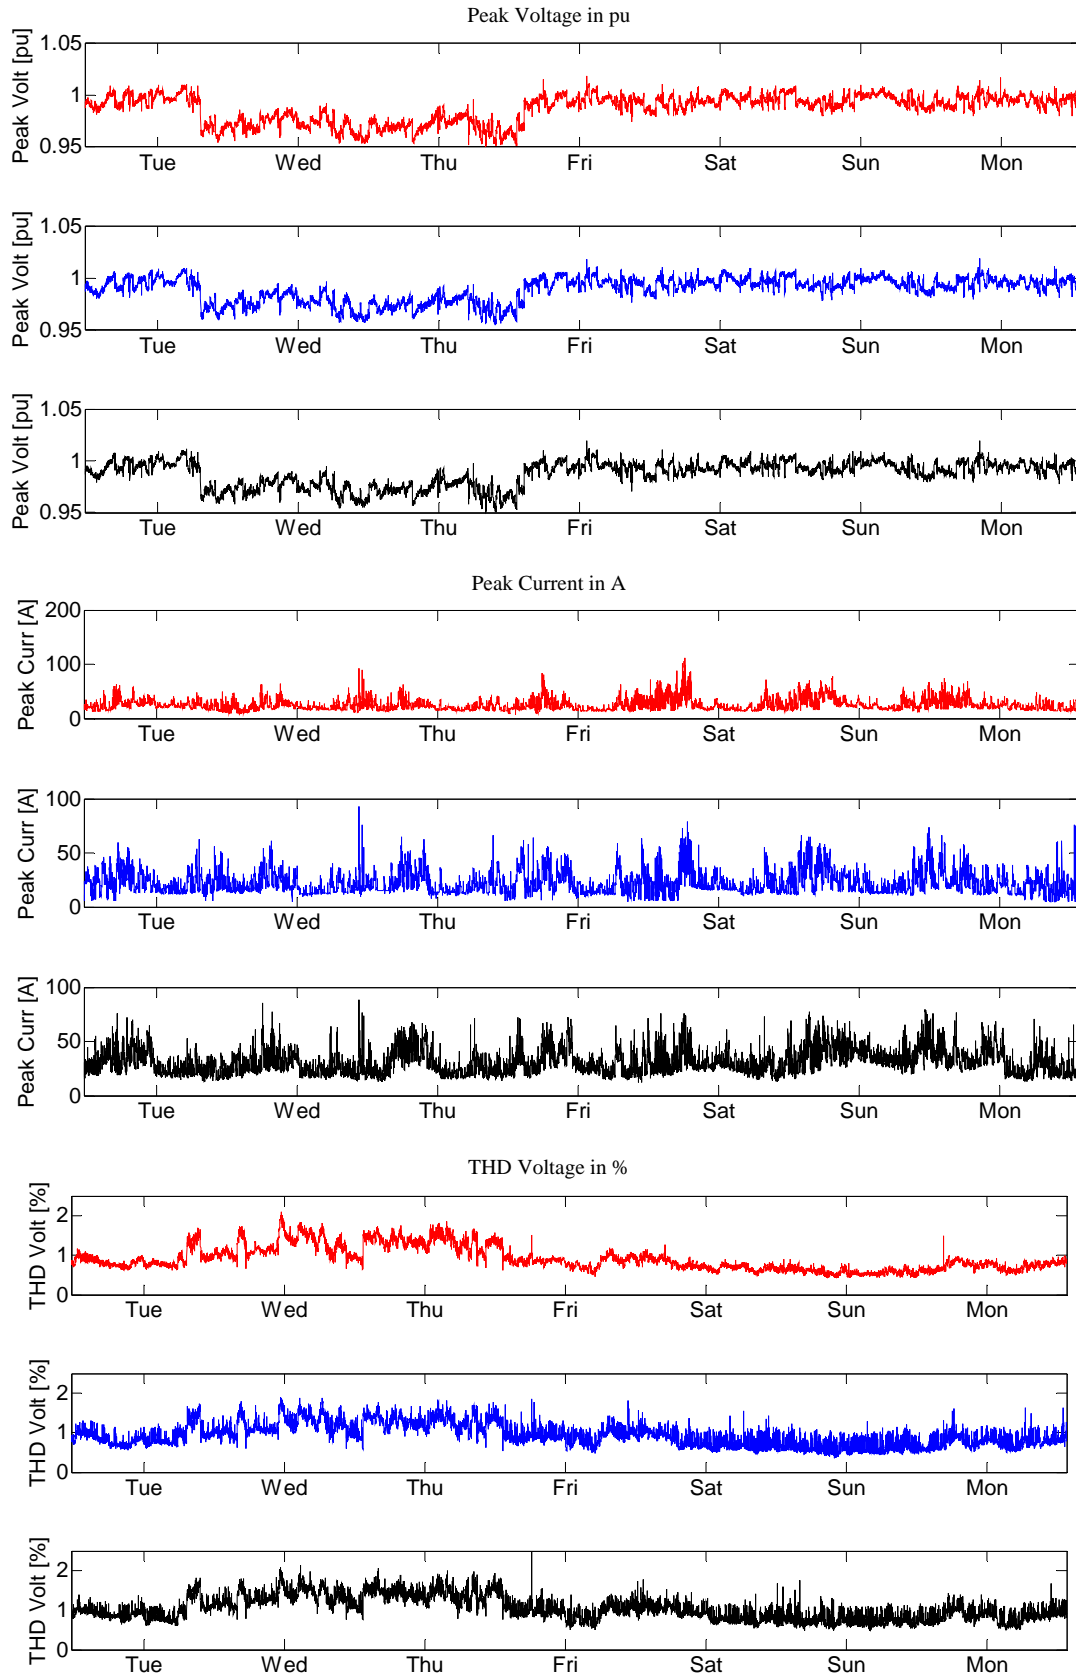
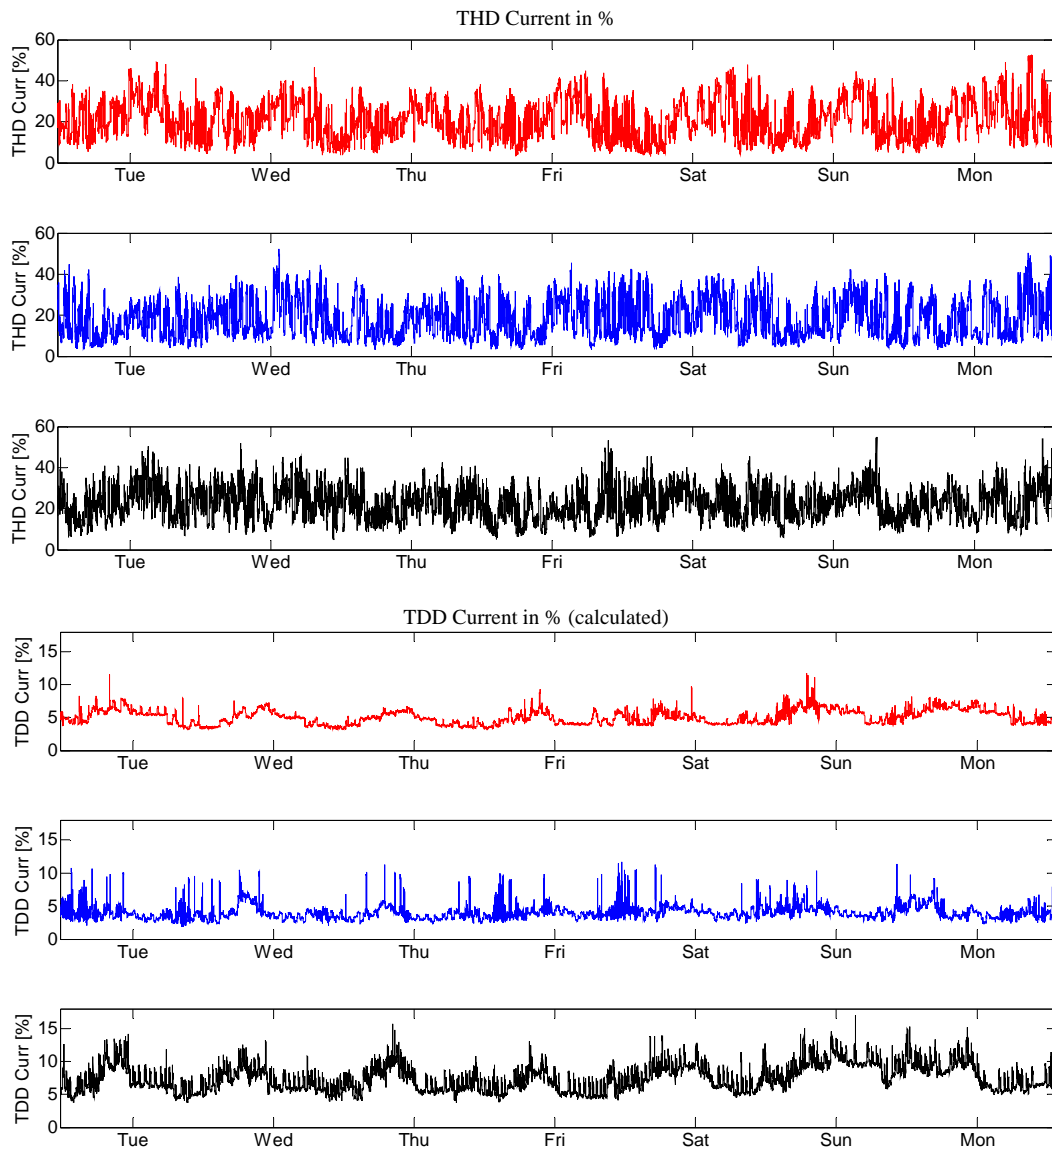
Power Analyzer Results (Linderum)

Frequency: The Danish power system must operate at a frequency between 49.5Hz and 50.5Hz at continuous operation. The measure values are well inside this interval for both locations.

RMS Voltage: The voltage should be between 0.95 and 1.05 pu. The measure values are well inside this interval for both locations.

RMS Current: Depends on the costumers and their use of electricity. The variations of the values are normal, with the peak of consume being those typically associated to residential loads (late afternoon and evening).

Harmonic Voltage: The measured values are very low at both locations and they are not an issue.

Harmonic Current: The harmonic currents seem to be rather large when compared with the RMS currents, which indicated the presence of harmonics that are too high. This topic is developed below in the *THD Current* and *TDD Current* sections.

Peak Voltage: It should correspond to the RMS voltage multiply by square root of two for all the measuring instants. The measured values show a maximum difference inferior to 2% (Linderum) and 0.5% (location 2), reinforcing the conclusion that the voltage is close to ideal.

In Linderum there is a decrease of the peak voltage from middle Tuesday to middle Thursday. At the same time there is an increase of the THD, meaning that the harmonic content was larger during this period. However, the variation is small and both values are still inside of the typical operational range.

Peak Current: It should correspond to the RMS current multiply by square root of two for all the measuring instants. The measured values show that there is often a difference of more than 100% at both locations, reinforcing the conclusion that there is a large current harmonic content.

THD Voltage: The measured values are very low at both locations and well inside of the standards limits.
