Assessment of pre-fabricated bathrooms from the 1990s

Morelli, Martin; Brandt, Erik

Published in:
1st International Symposium on Building Pathology (ISBP 2015)

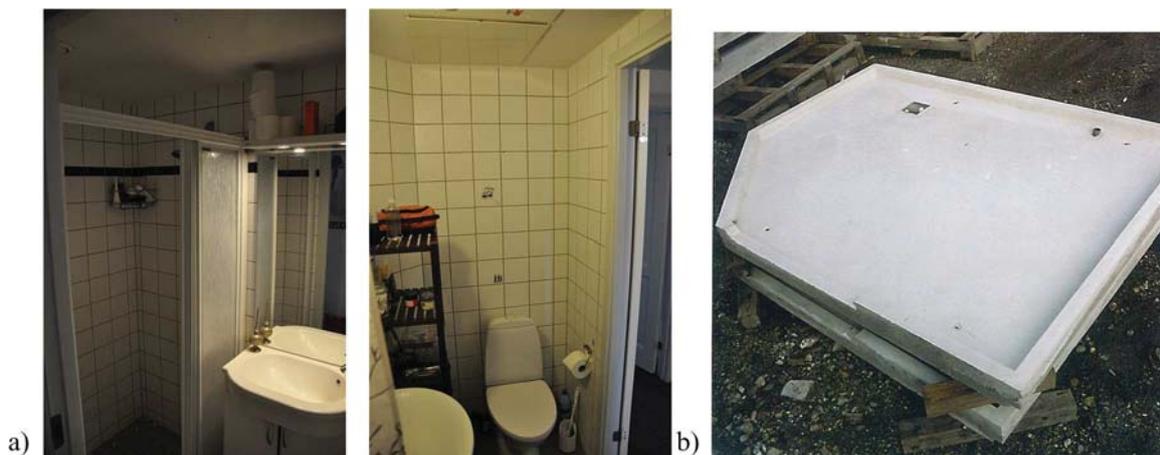
Figure 4. Heavy-weight assembly kit with fibre reinforced concrete bottom with dimension: $2.3 \text{ m} \times 1.2 \text{ m}$, and b) the fibre reinforced concrete bottom [MHUR 1999b].

Perhaps the most critical failure was registered in the heavy-weight assembly kit of fibre reinforced concrete bottom with a plinth. As the crack was observed on different walls but in the same height in

the three inspected bathrooms, the crack might be related to the plinth on the bottom element (Figs. 4b and 6c). However, the cracks could also be related to movement in the building. As no destructive inspections were conducted, the correct reason for the crack cannot be stated.
