## Hydraulic Response of the Wave Energy Converter Wave Dragon in Nissum Bredning

*Determination of Hydraulic Response of the Wave Energy Converter  
Wave Dragon placed in Nissum Bredning*

Jens Peter Kofoed & Peter Frigaard, Aalborg University

December, 2004

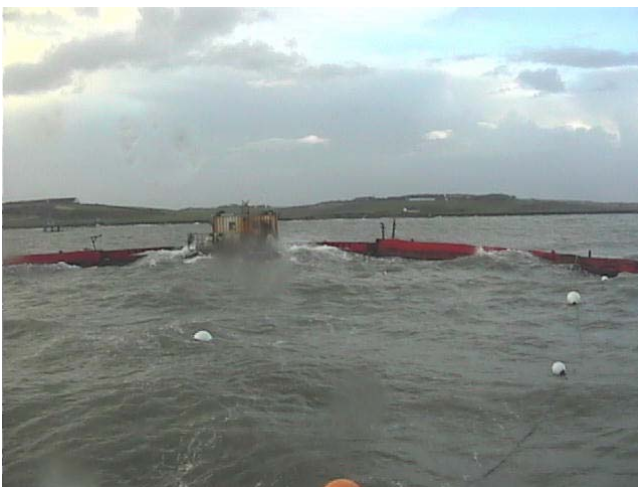
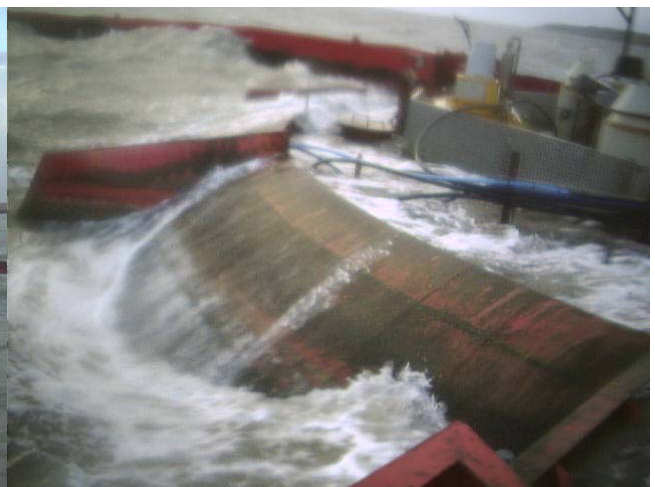
Figure 3.6. Turbines running in good wave and power production conditions.

The change in the turbine speed oscillations are pronounced from figure 3.4 to 3.5 and 3.6. The period of the oscillations are not far from the wave periods, for what reason it seems fair to say that the oscillations are tricked by the changing turbine head due to waves propagating under the platform. West Control was at WD-NB in July 2004 to change some burned IGBT's (transistors) and at this time the EEPROMS containing the West Control programming of the inverters was also replaced. A change in the programming might be responsible for the increased sensitivity to oscillations in the turbine head. This item is currently being investigated.

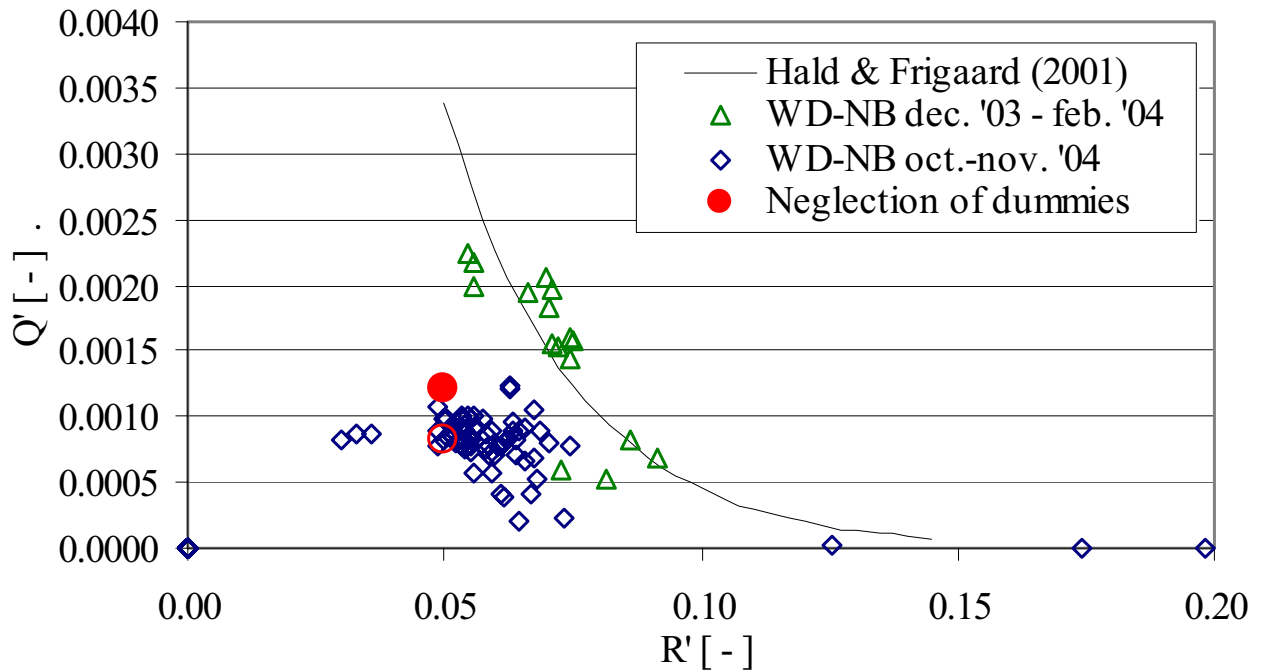
The results are shown in figure 4.1. From this figure it is clearly seen that, in opposition to previous findings, the overtopping rates falls significantly below the lab. results and the previous measurements on WD-NB. There can be a number of reasons for this:

- Dummies are not included in the overtopping rates in the new data. From graphs on the SCADA system (see figure 4.2 for the period corresponding to the power data given in figure 3.1, figure 4.3 the half hour period corresponding to the first data point in figure 3.1 and the red dots in figure 4.1) it can be seen that there are quite frequent dummy turbine activity, and therefore significant amounts of water is 'lost' through these. For a single point, corresponding to the half hour shown in figure 4.3, the flow through the dummies are estimated to be 50 % of what goes through the other turbines (in average during the period).

- Spilling. From figure 4.2 - 4.3 it is also seen that the reservoir level is frequently above 100 %, ie. spilling occurs. Rough quantification of the spilling might be possible by calculation of the water level along the edges of the reservoir, comparing it to the crest height around along the edges, and then using an expression for the flow over an edge.

- Leaks. Earlier a leakage of up to 44 l/s has been seen, but this was primarily due to problems with the closing of the cylinder gates and recent observations shows fall of reservoir level of 6 – 10 cm an hour when no overtopping occurs, which corresponds to a leakage of 2.7 – 4.4 l/s (corresponding to 20 – 30 W at high floating level).

- Turbine calibration. In the calculations the original turbine characteristics have been used, as no other data is currently available. It is expected that TUM will provide updated turbine characteristics for the real turbines as well as the dummies. In the previous data set the characteristics from the first calibration tests of the dummies where used. These calibrations has later been questioned, as a later drain test showed as much as 30 % lower discharge, probably due to marine growth in the draft tubes.

- Bias in estimation of wave conditions. As mentioned in chapter 2 the presence of the mooring caisson and reflections from the WD structure towards the wave measuring point is not taken into account in the wave analyses. This will tend to result in slight overestimation of wave height, i.e. biasing the overtopping data points to fall below the prediction line.

Figure 4.1. Non-dimensional overtopping rate as a function of the non-dimensional crest freeboard compared to lab. results and previous measurements at WD-NB. The effect of neglecting the dummy turbines exemplified in a single point based on observations in the SCADA system (all three dummies open 20 % of the time).

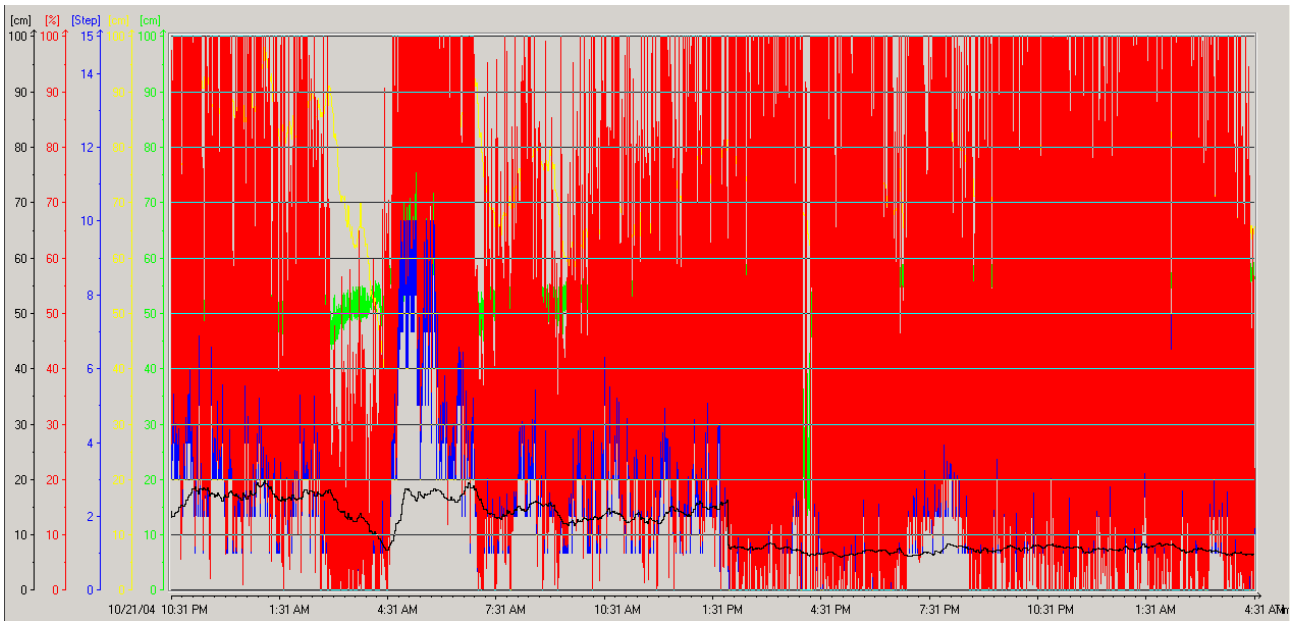
Figure 4.2. Screen dump from SCADA, graph 2, during the 30 hours period shown in figure 4.1.

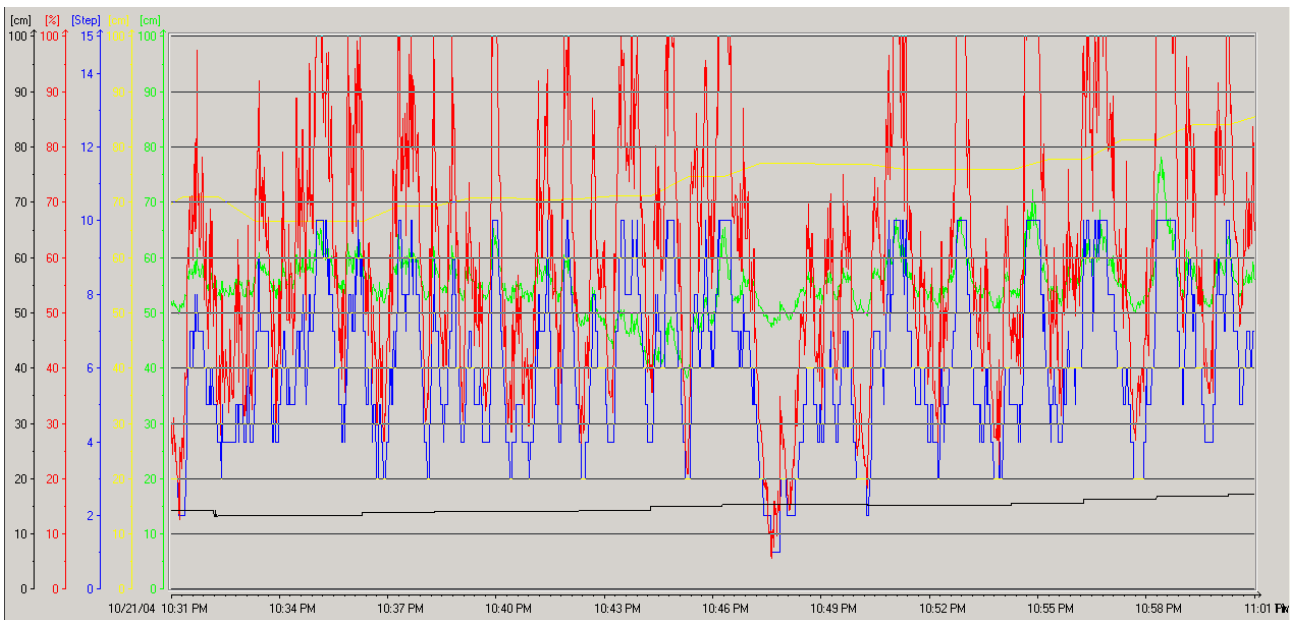
Figure 4.3. Zoom of figure 4.2, the first half hour.

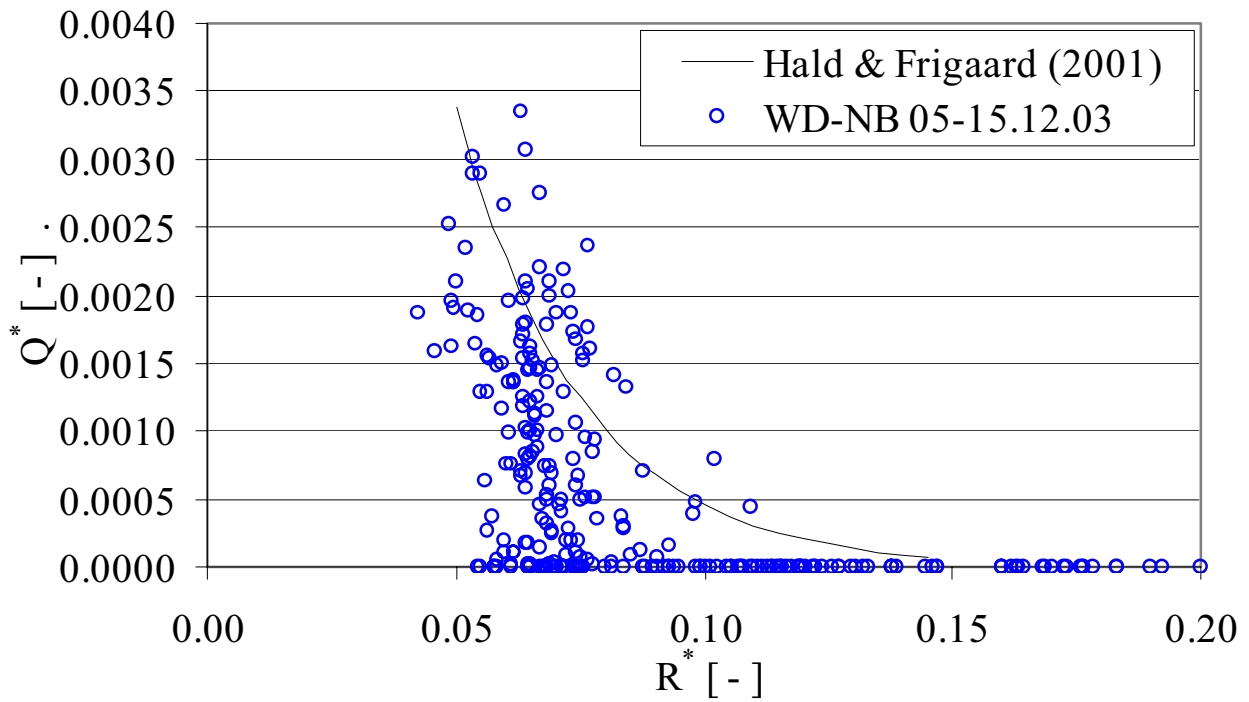
Generally, as in figure 4.1 quite some scatter is seen and a large portion of the data points falls below the prediction line. The possible explanations for this are again the above mentioned points.

Figure 4.4: All the non-dimensional overtopping rates from Appendix B assembled in one graph. The data is also shown in figure 4.5.

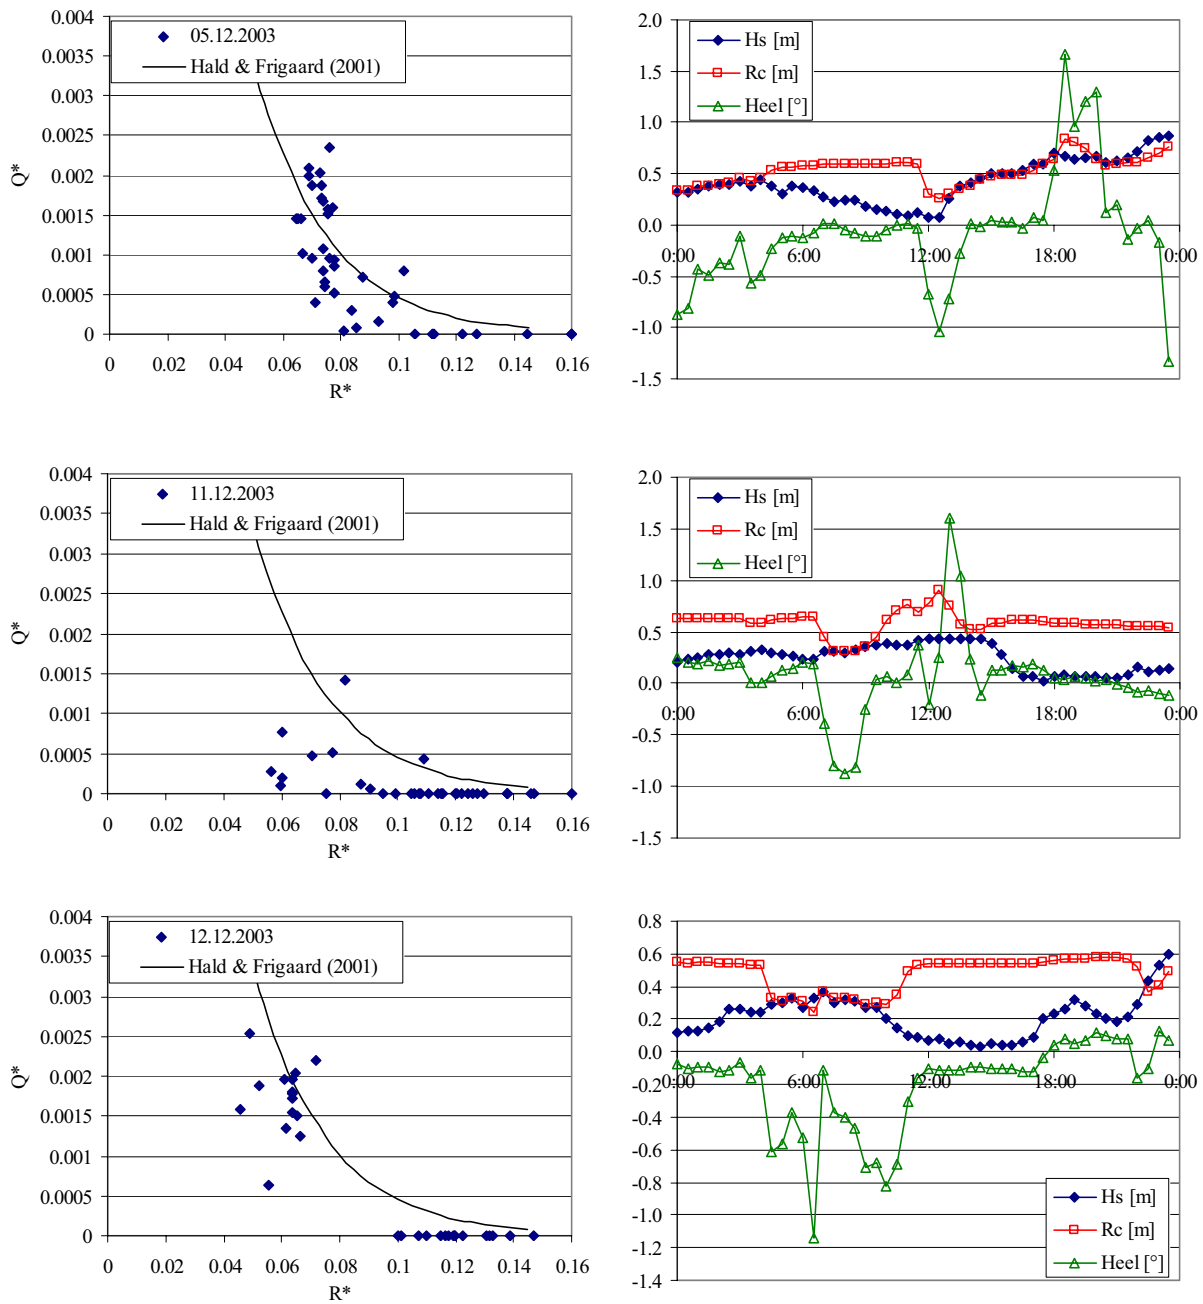
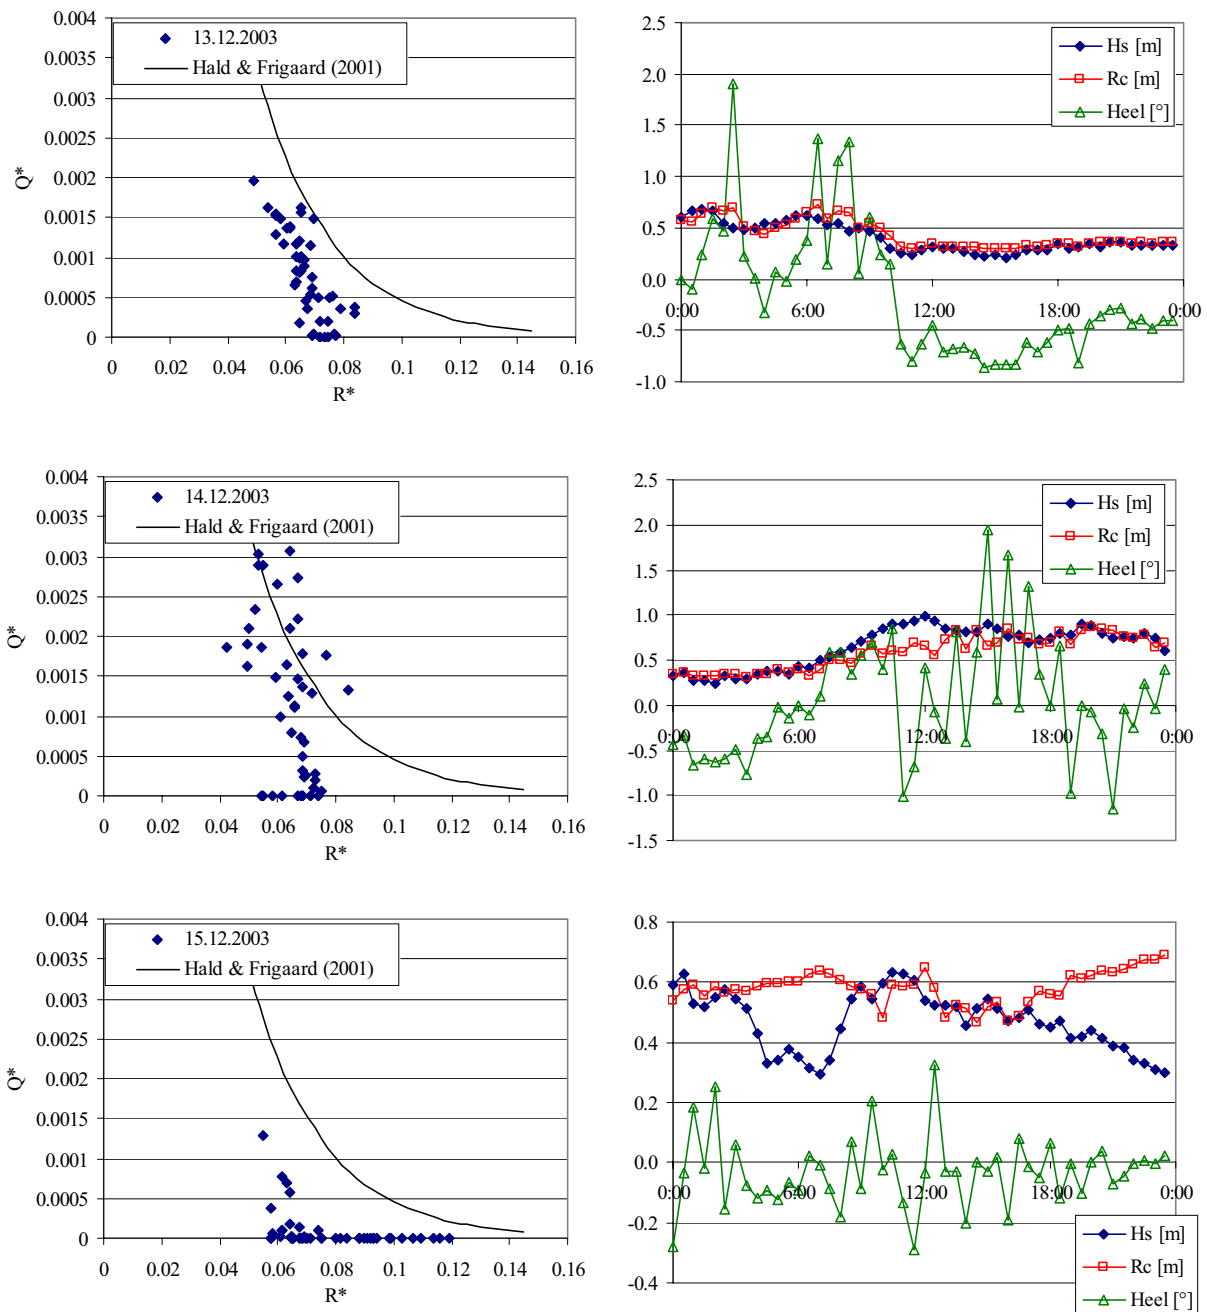
- Periods with heel close to 0 and  $R_c$  close to  $H_s$  seems to result in overtopping rates close to the prediction line.
- Significant oscillations in the heel seem to reduce the overtopping rates badly.

However, it is reassuring that some points are above the prediction line, as this could indicate that the overtopping expression under certain circumstances can be exceeded. Thus, the overall picture is that the overtopping expression is realistic in normal operation, i.e. the reservoir is level and not overflowed and WD is fairly aligned towards the waves.

Figure 4.5a: Non-dimensional overtopping rates plotted for one day at a time (left) along with half hour averages of the heel, crest freeboard (compensated using heel) and significant wave height (right).

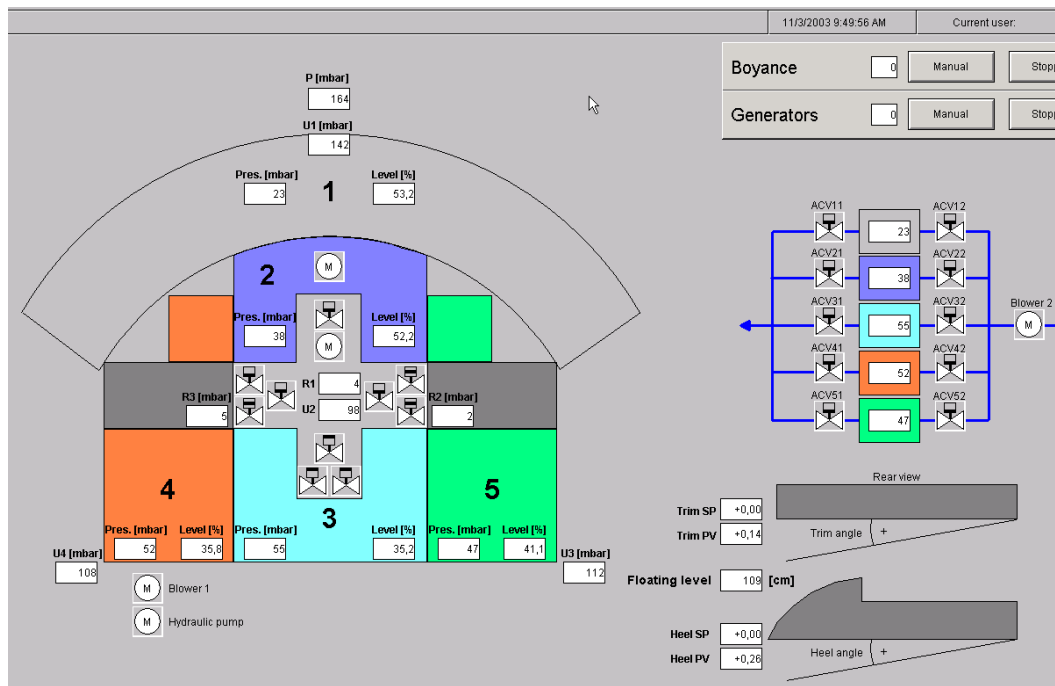
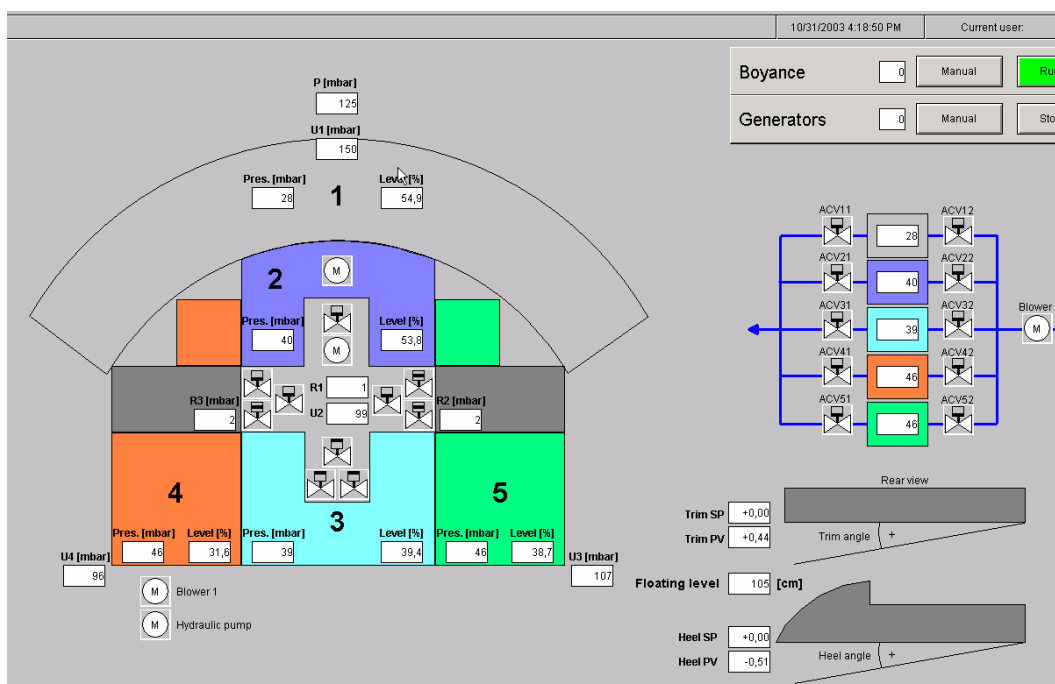
Automatikken har ikke været i drift i perioden mellem ovenstående screen dumps – d.v.s. i 65½ timer. Der har i perioden været bølgehøjder op til 0,7 m significant. Ved periodens start var ballastkamrene på dækket kun delvis fyldt, og der var væsentlig mere ballast i højre side.

Det fremgår, at platformen i perioden er krænget 0,77° bagover (Heel), hvilket kan tilskrives fyldning af ballastkamrene på dækket. Samtidig ses det, at platformen har rettet sig 0,3° op i tværetningen (Trim). Trykket i luftkamrene er ændret i god overensstemmelse hermed, d.v.s. luftmængderne i kamrene 1, 2, 3 og 5 er stort set konstante. Imidlertid viser tryk-/level indikeringen, at der er tilført en vis luftmængde til kammer 3 - luftmængden er øget ca. 9%. Denne lufttilførsel kan kun stamme fra luft, der rives med i vandstrømmen gennem dummy turbinerne. Ved forholdsvis store opskylsmængder, som der her må have været tale om (på trods af, at flydehøjden har været 50% større end den største registrerede søtilstand) er der så stor inert i vand-/luftblandingen, at noget af luften bevæger sig under skottene omkring dummyturbine-sektionen og op i kammer 3.

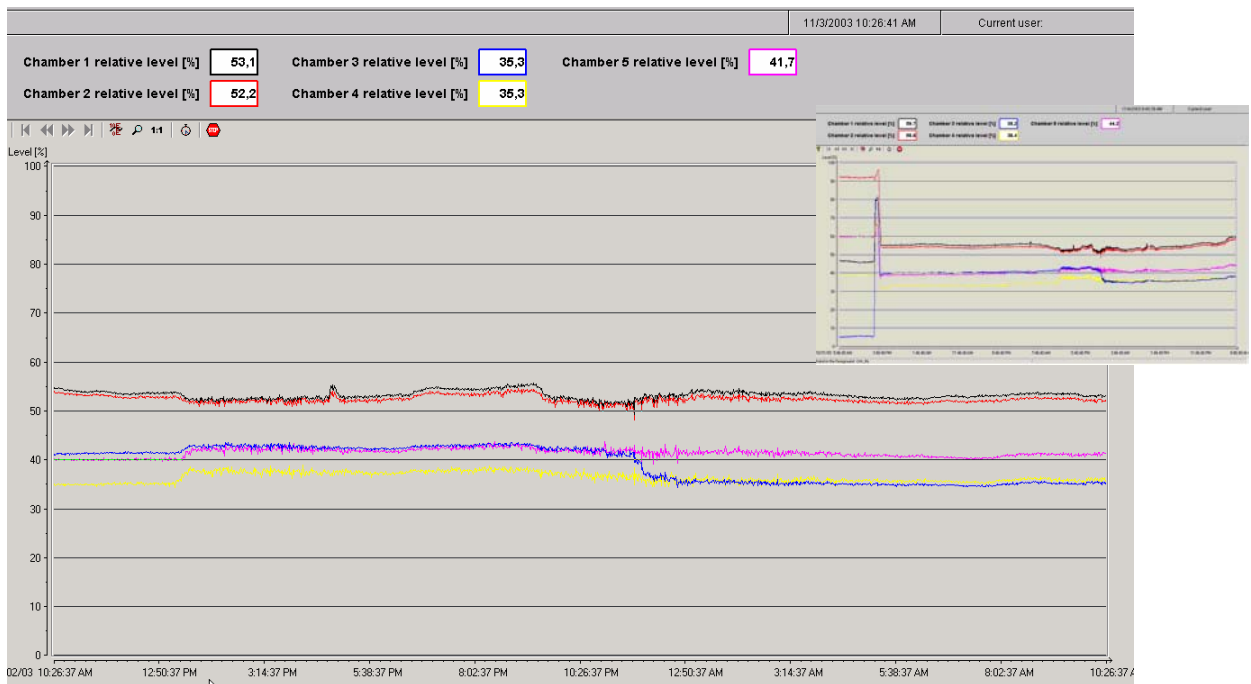
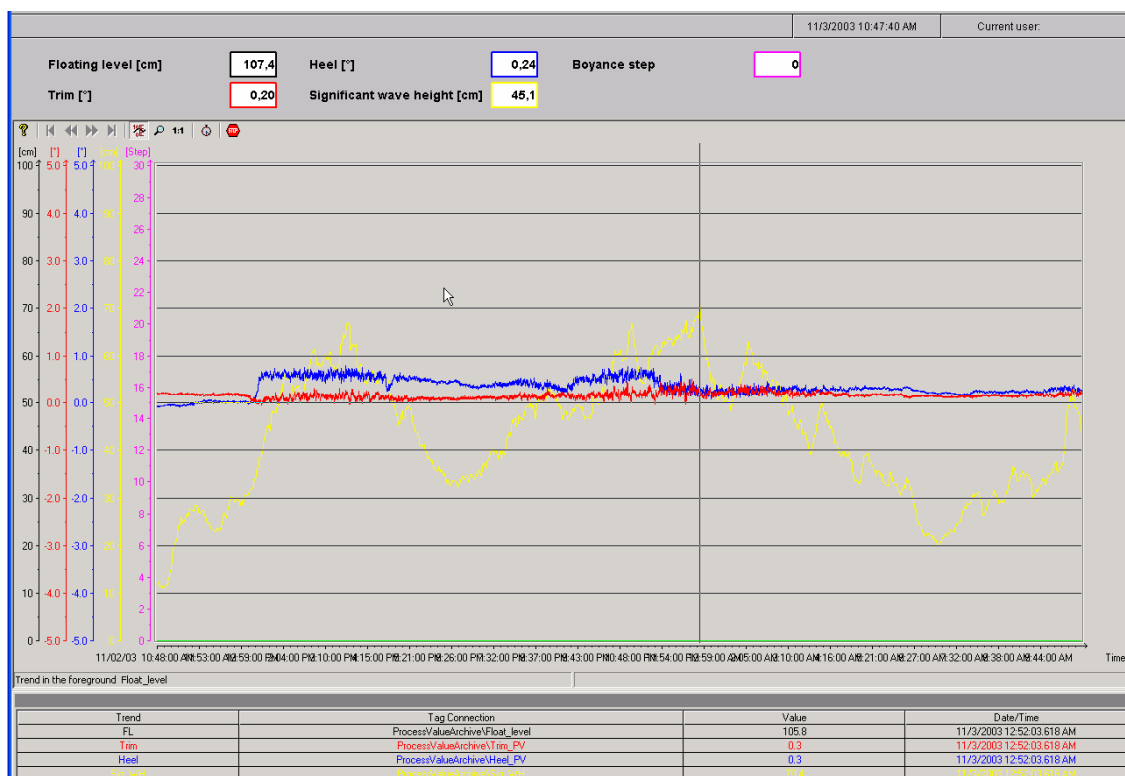
Det fremgår tydeligt af ovenstående skærm-dumps, at der ved den aktuelle flydehøjde bliver et så stort opskyl, når bølgehøjden overstiger ca. 0,3 m, at ballastkamrene fyldes og WD krænger lidt bagover. Denne krængning er en tilsigtet effekt af fyldningen af ballastkamrene/reservoiret og skyldes, at tyngdepunktet af vandet i reservoiret er placeret længere bagud end platformens tyngdepunkt. Det fremgår ligeledes, at den ovenfor omtalte tilførsel af luft til kammer 3 sker på et tidspunkt, hvor bølgehøjden er større end 0,6 m. I løbet af en halv time falder vandstanden i kammer 3 betydeligt, mens vandstanden og dermed luftmængden er næsten konstant i de øvrige kamre. Over en længere periode – her vist 4 døgn på det indsatte formindskede diagram – forsvinder ca. 10% af luftmængden i alle kamre bortset fra kammer 3. Denne reduktion svarer kun til halvdelen af iltindholdet i den friske luft. Det er således sandsynligt, at tabet af luft skyldes at en væsentlig del af ilten i luften forsvinder fra kamrene dels på grund af forrådnelsesprocesser dels på grund af korrosion af stålpladerne. Der bør foretages en iltmåling i kamrene for at få en bedre viden om dette forhold.

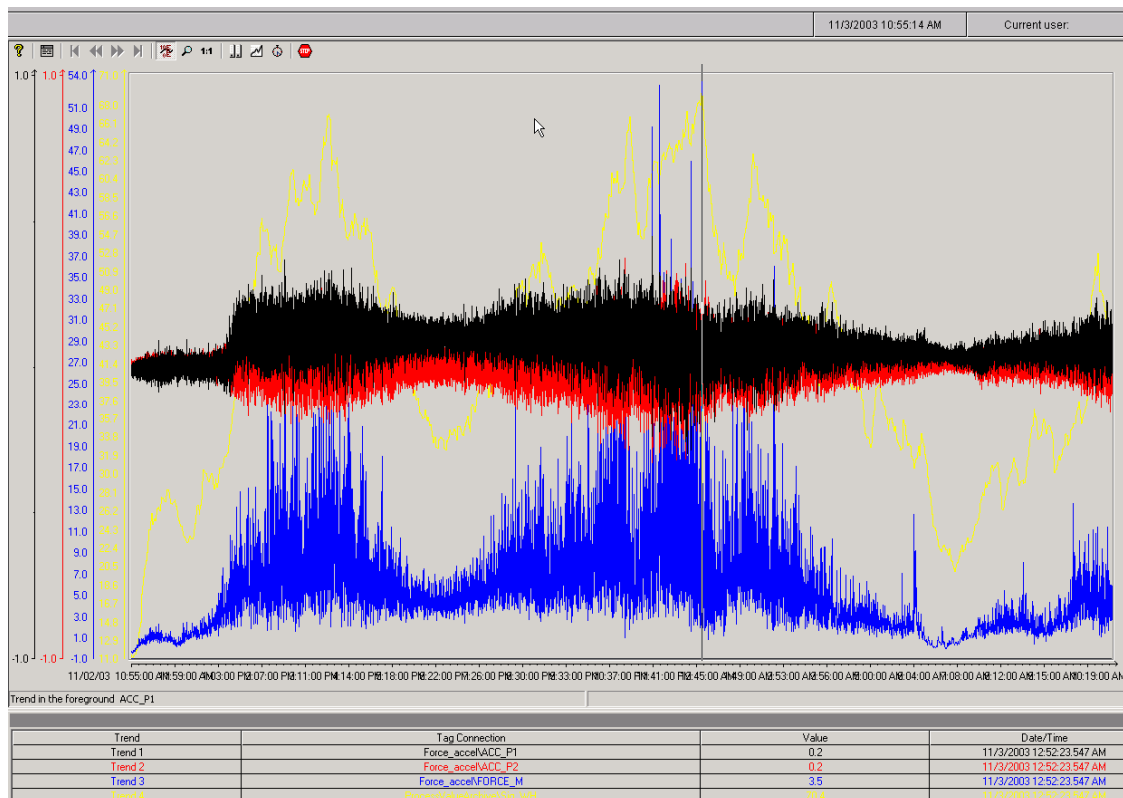
Denne skærm-dump viser accellerometrenes registreringer (platformens bevægelser) og kraften i ankertrossen. Det ses, at der er målt en kraft på 53 kN. Det skal bemærkes, at bølgehøjden beregnes ud fra målinger over et kvarter og derfor plottes senere end de tilhørende kraftmålinger etc.

Det er bemærkelsesværdigt, at der forekommer en markant stigning i bølgehøjden til mere end 0,6 m significant med kulmination kl. ca 15.30, hvorefter bølgehøjden forholdsvis hurtigt igen falder. Registreringerne fra WD's vejstation viser ikke en tilsvarende variation i vindhastigheden på dette tidspunkt, idet hastigheden var stigende indtil kl. 17.00. Derimod toppede den målte max, vindhastighed, "wind gust", allerede kl. 15.00. Vindretningen var næsten konstant. Sammenhængen mellem registreret vindhastighed og signifikant bølgehøjde er således ikke åbenbar. De målte vindhastigheder og vindretningen vil senere blive lagt ind i SCADA-systemet, hvilket skulle give et bedre overblik over sammenhængen mellem vinden og bølgerne.

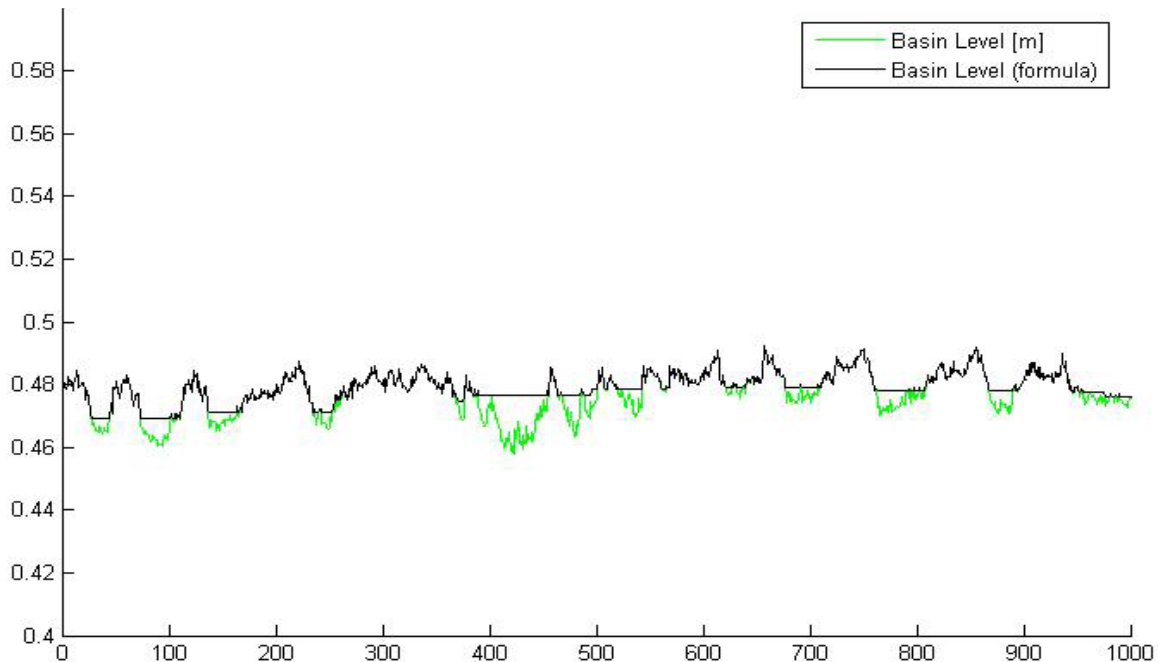
Figure 1

It’s important to observe that the measured and calculated Basin Level can differ (cfr. Fig 1). The higher the pitch, the bigger the departure. This deviation is neglected in this program although it can be quite significant.
