# Failure Analysis of a Degraded 1.2 kV SiC MOSFET after Short Circuit at High Temperature

Paula Diaz Reigosa, Francesco Iannuzzo, Lorenzo Ceccarelli

Department of Energy Technology, Aalborg University, Pontoppidanstraede 111 DK-9220, Denmark  
pdr@et.aau.dk, fia@et.aau.dk, lce@et.aau.dk

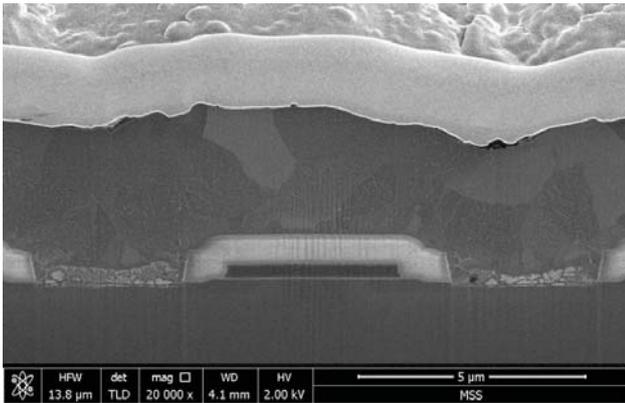
The results can be observed in Fig. 7, where the vertical structure of three cells is presented. It is interesting to compare Figs. 4 and 7, showing that a number of differences can be observed between the new and the degraded device. First, the cracks found in the degraded device between the poly-silicon gate and the aluminium source are not detected in the new device, as it is observed in Fig. 8. Second, the particles seen in the degraded SiC MOSFET near the salicide are not visible for the new device. This indicates that they could have originated as a consequence of the short-circuit stress and not from defects originating from the device process. A more detailed inspection of this region can be observed in Fig. 9. It can be confirmed that the particles cannot be observed and it is also worth to note that the granular structure is significantly altered when compared with the new device. Finally, the shape of the interface between the upper Aluminium layer and

Fig. 8. Zoomed view of the FIB cross-section of a new SiC MOSFET.

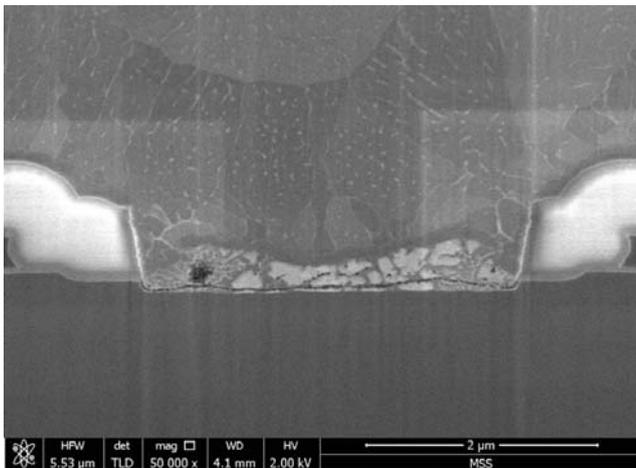
Furthermore, the salicide which is the technology that is used to form the electrical contact between the semiconductor substrate and the source terminal appears severely degraded, as pointed out in Fig. 5. This region is further magnified in Fig. 6, where it can be observed that solid particles accumulate in the aluminium source region between the salicide and the gate oxide. So far, the origin of these particles is not clear and it is not possible to provide the relevant information about the failure mechanism due to the short circuit stress. To better understand whether these particles may come from a process defect or could have originated after the applied short circuit stress, a cross-section of a new 1.2-kV/90-A SiC MOSFET will be presented in the next section.

Fig. 9. Magnified Focused Ion Beam (FIB) of the salicide region of a new SiC MOSFET.
