Timber-Frame Walls: Feasible with a Damaged Vapor Barrier?

Ernst Jan de Place Hansen, PhD

Erik Brandt

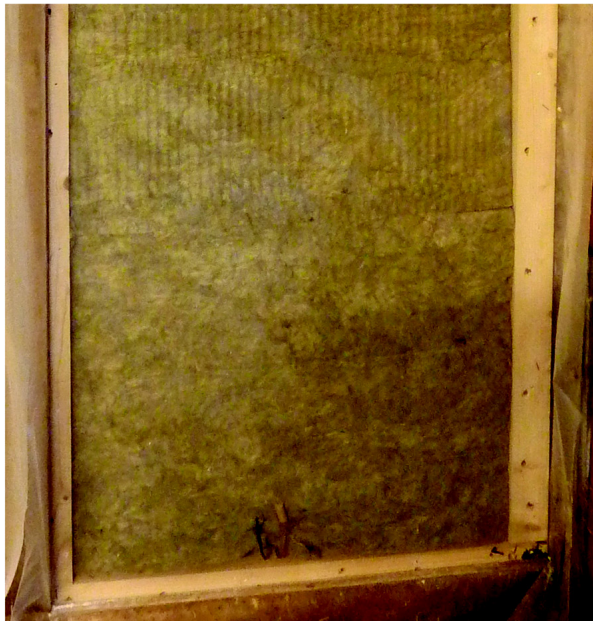
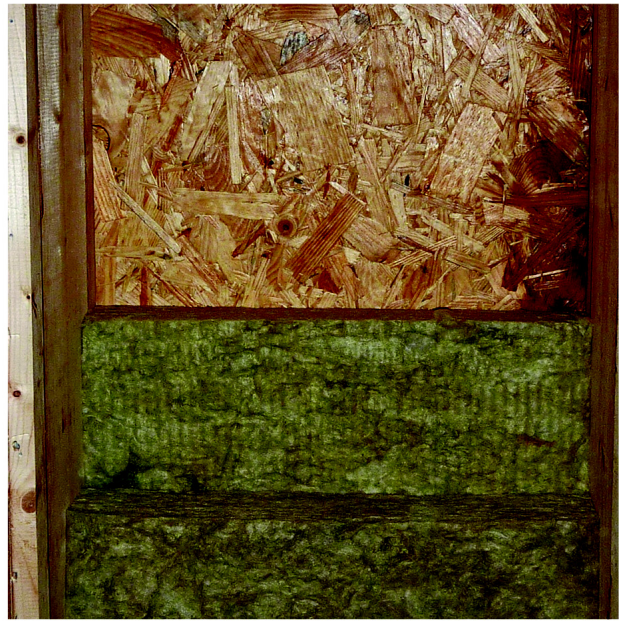
Some of the elements were inspected from the inside in order to study the moisture conditions at the wind barrier. Elements with an intact vapor barrier were the prime targets, because they were supposed not to show moisture damages. The inspection took place in November 2009 after about four years of exposure. Before inspection, the inner cladding, the vapor barrier and part of the thermal insulation were removed (Figure 2).

Figure 2 Inspection of element (A) after removing the inner cladding showing the vapor barrier, and (B) after removing part of the thermal insulation material showing the wind barrier.

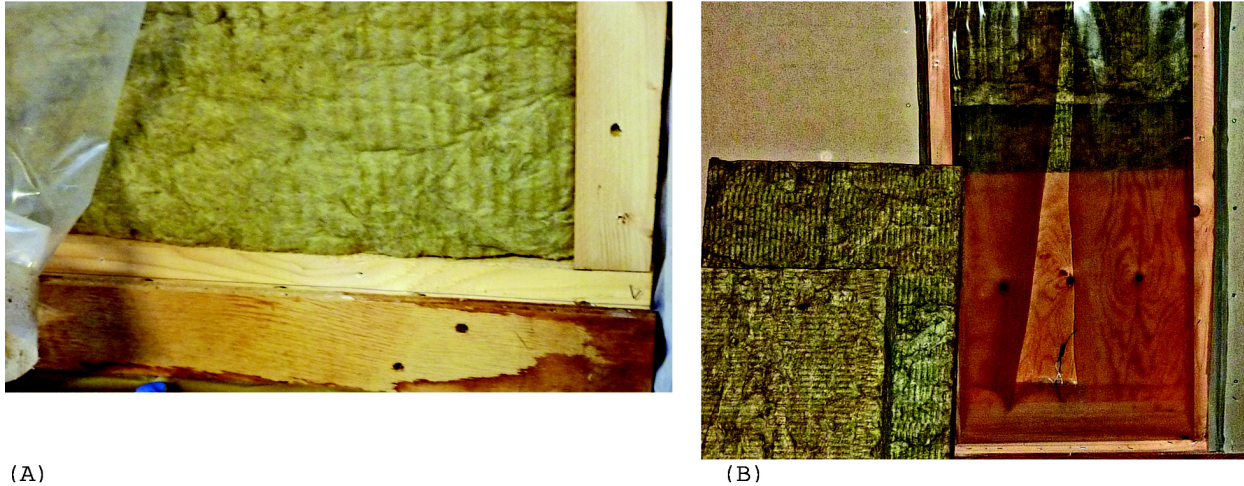
The vapor barrier was completely removed for two elements in order to study how the elements would behave without a vapor barrier during the winter 2009/2010 (one element with a nonventilated cavity facing north and one element without a cavity facing south). In the other cases, only a part of the vapor barrier was opened along the edge of the element (Figure 3A) or cut open (Figure 3B). After the inspection, the openings were sealed with special vapor barrier tape to restore the elements for the continued measurements.

Figure 3 Elements where the vapor barrier was opened (A) along the edge, or (B) by making a cut.

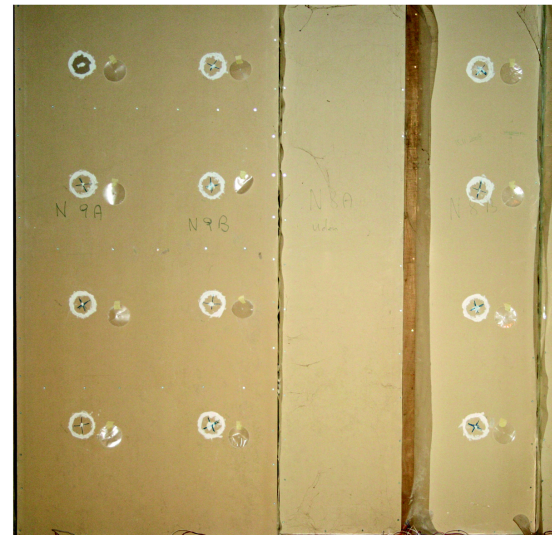
In each element, four holes with a diameter of 110 mm were made, which equalled $1/40$ of the area of an element. The holes were placed along the centre line of the element, with an internal distance of about 500 mm and with 500 mm to the top and bottom edge of the element. In some cases, only a piece of the inner cladding had to be removed to reach the vapor barrier; in other cases, the vapor barrier was placed in front of or behind a second gypsum board placed behind 45 mm or 95 mm of thermal insulation material (seen from the indoor side; see Figure 1). After removing the vapor barrier, the element was restored (i.e. the thermal insulation material and the pieces of gypsum board were put back in place). The inner cladding was restored by sealing the cut around the pieces of gypsum board as seen in Figure 6.

Figure 6 Elements with restored inner cladding after removing four pieces of vapor barrier.
