## **Refurbishing roof systems and roof terraces on a major residential building complex**

## **Refurbishing Roof Systems and Roof Terraces on a Major Residential Building Complex**

**Tommy Bunch-Nielsen, Danish Roofing Advisory Board  
Erik Brandt, Danish Building Research Institute  
Denmark**

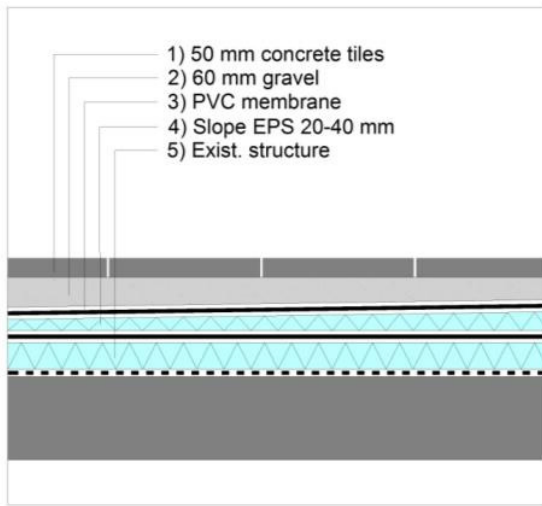
As previously mentioned, the original slope of the roofs was nearly zero, and to improve the drainage, a slope of 1:100 for the membrane was established. This was achieved by adding a tapered expanded polystyrene (EPS) insulation directly on the original bitumen membrane as underlayment for the new loose-laid membrane. Consequently, it changed the construction of the roof terraces as shown in Figure 4.

Figure 4: Roof terraces after the first renovation

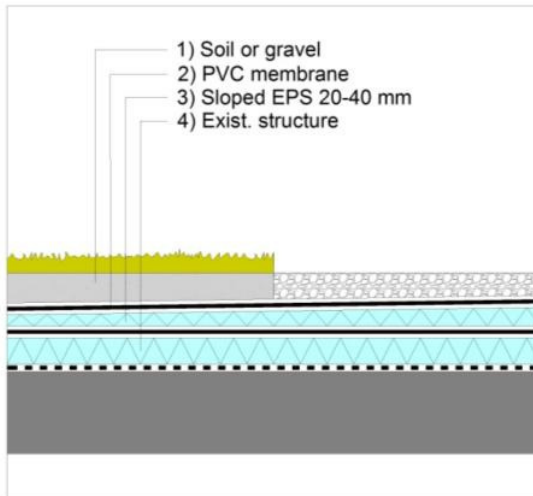
The vegetative roof systems and ballasted roof systems were changed as shown in Figure 5.

Figure 5: Green roofs after the first renovation

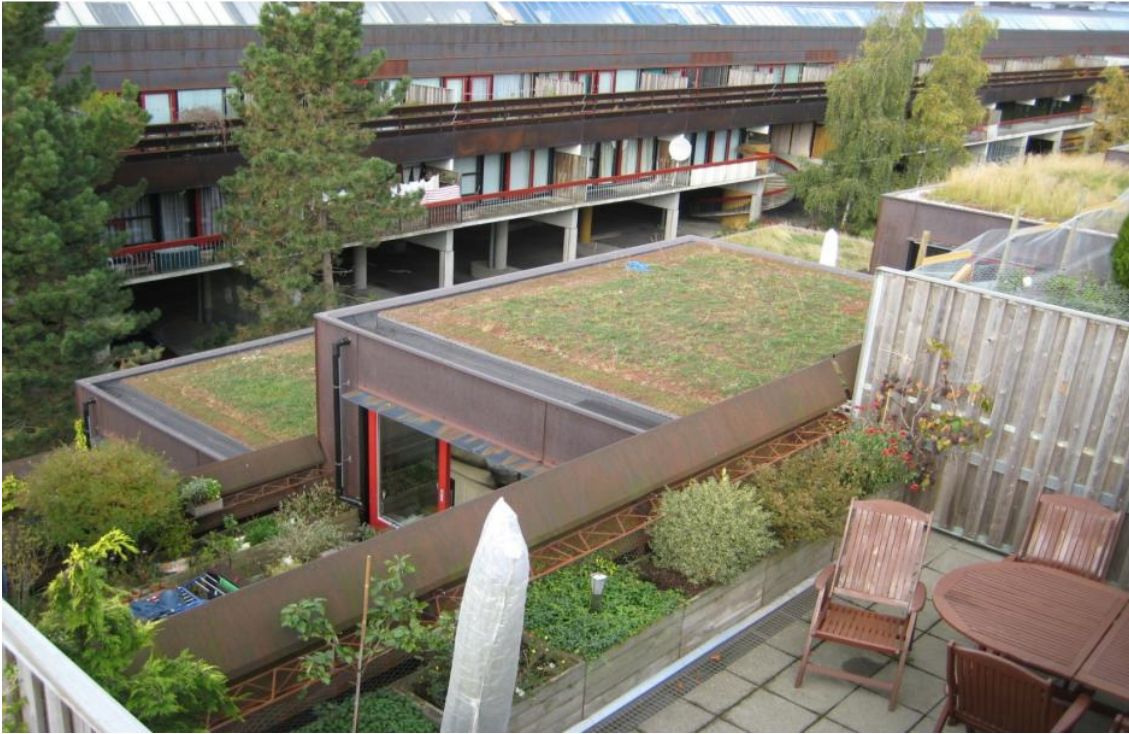
The small vegetative roof systems in the lower levels were not changed during the second renovation because the membrane was not damaged at the time. However, during the past few years, a number of problems have emerged, and the roof systems gradually are being changed to new vegetative roof systems because they have become an important part of the architecture.

Figure 14: Small vegetative roof systems are visible from the terraces in the apartments above.

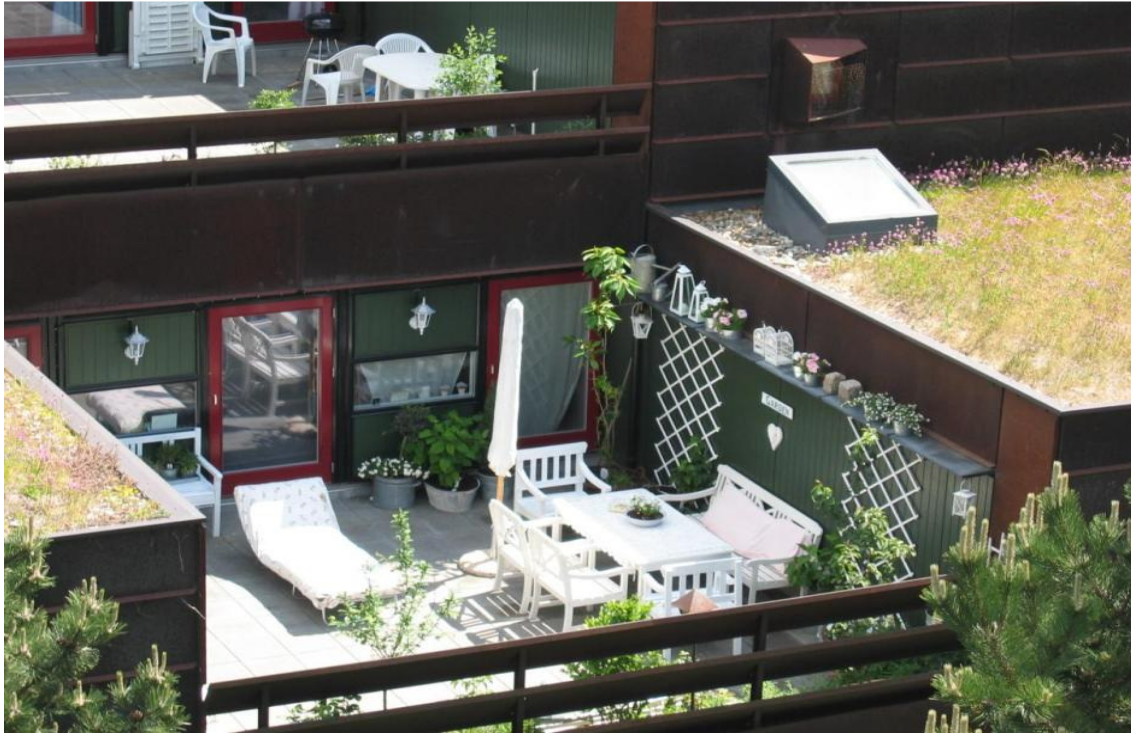
So far, only up to three leaks have occurred in one year, allowing the contractor his fee every year.

Figure 15: A cozy roof terrace without leaks
