Failure analysis of a degraded 1.2 kV SiC MOSFET after short circuit at high temperature

Proceedings of the IPFA 2018 - 25th International Symposium on the Physical and Failure Analysis of Integrated Circuits

Failure Analysis of a Degraded 1.2 kV SiC MOSFET after Short Circuit at High Temperature

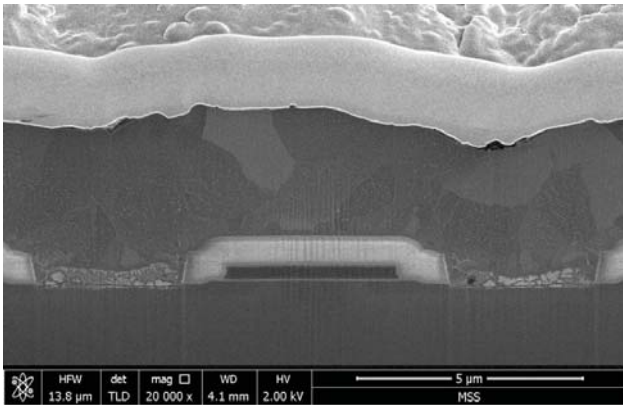
The results can be observed in Fig. 7, where the vertical structure of three cells is presented. It is interesting to compare Figs. 4 and 7, showing that a number of differences can be observed between the new and the degraded device. First, the cracks found in the degraded device between the poly-silicon gate and the aluminium source are not detected in the new device, as it is observed in Fig. 8. Second, the particles seen in the degraded SiC MOSFET near the salicide are not visible for the new device. This indicates that they could have originated as a consequence of the short-circuit stress and not from defects originating from the device process. A more detailed inspection of this region can be observed in Fig. 9. It can be confirmed that the particles cannot be observed and it is also worth to note that the granular structure is significantly altered when compared with the new device. Finally, the shape of the interface between the upper Aluminium layer and

Fig. 8. Zoomed view of the FIB cross-section of a new SiC MOSFET.

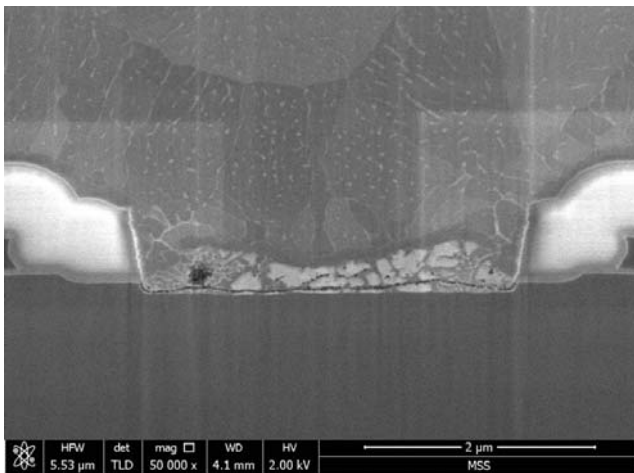
Furthermore, the salicide which is the technology that is used to form the electrical contact between the semiconductor substrate and the source terminal appears severely degraded, as pointed out in Fig. 5. This region is further magnified in Fig. 6, where it can be observed that solid particles accumulate in the aluminium source region between the salicide and the gate oxide. So far, the origin of these particles is not clear and it is not possible to provide the relevant information about the failure mechanism due to the short circuit stress. To better understand whether these particles may come from a process defect or could have originated after the applied short circuit stress, a cross-section of a new 1.2-kV/90-A SiC MOSFET will be presented in the next section.

Fig. 9. Magnified Focused Ion Beam (FIB) of the salicide region of a new SiC MOSFET.
