## **Effect of short-circuit stress on the degradation of the SiO<sub>2</sub> dielectric in SiC power MOSFETs**

Reigosa, Paula Diaz; Iannuzzo, Francesco; Ceccarelli, Lorenzo

*Published in:*  
Microelectronics Reliability

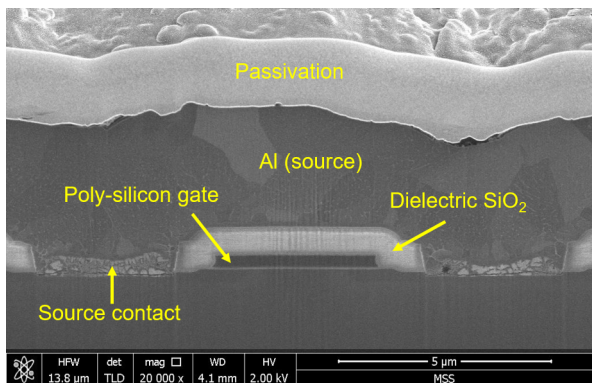
Fig. 2: Focused Ion Beam (FIB) cross section of the new 1.2-kV/90-A SiC MOSFET showing one cell.

The experimental investigations have been conducted on a commercial 1.2-kV/ 90-A SiC MOSFET having a TO-247 package and a planar technology (C2M0025120D). A Focused-Ion Beam (FIB) cut has been performed on the new SiC MOSFET first, which serves as a reference for later comparing the cell differences between the new and the degraded SiC MOSFET after applying the short circuit stress. The vertical cross section of the new device is presented in Fig. 2, where the gate structure of a single cell is observed. The cut has been performed on an arbitrary region of the device active area, showing no abnormalities or process defects.

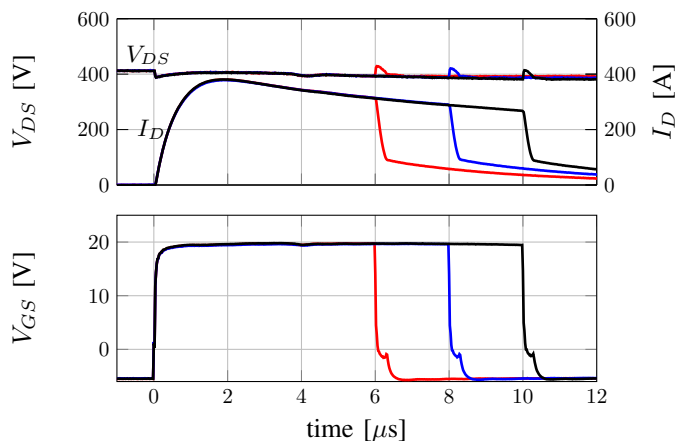
Fig. 3: Short-circuit tests with increasing time of a 1.2-kV/90-A SiC MOSFET:  $V_{DC} = 400\text{ V}$   $T_j = 150^\circ\text{C}$ .

results at low bias voltage and high temperature do not show any degradation on the gate voltage, and therefore, it can be concluded that the SiC MOSFET is able to survive this condition.
