Effect of short-circuit stress on the degradation of the SiO₂ dielectric in SiC power MOSFETs

Reigosa, Paula Diaz; Iannuzzo, Francesco; Ceccarelli, Lorenzo

Published in:
Microelectronics Reliability

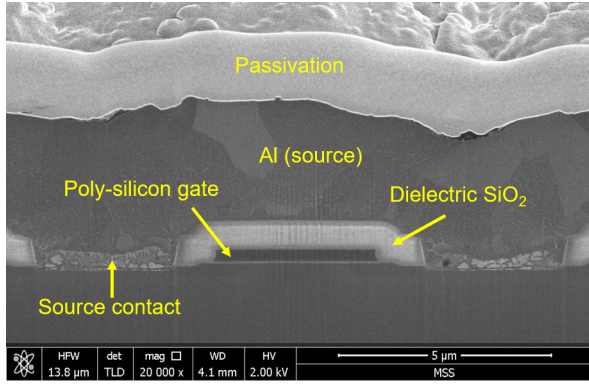
Fig. 2: Focused Ion Beam (FIB) cross section of the new 1.2-kV/90-A SiC MOSFET showing one cell.

The experimental investigations have been conducted on a commercial 1.2-kV/ 90-A SiC MOSFET having a TO-247 package and a planar technology (C2M0025120D). A Focused-Ion Beam (FIB) cut has been performed on the new SiC MOSFET first, which serves as a reference for later comparing the cell differences between the new and the degraded SiC MOSFET after applying the short circuit stress. The vertical cross section of the new device is presented in Fig. 2, where the gate structure of a single cell is observed. The cut has been performed on an arbitrary region of the device active area, showing no abnormalities or process defects.

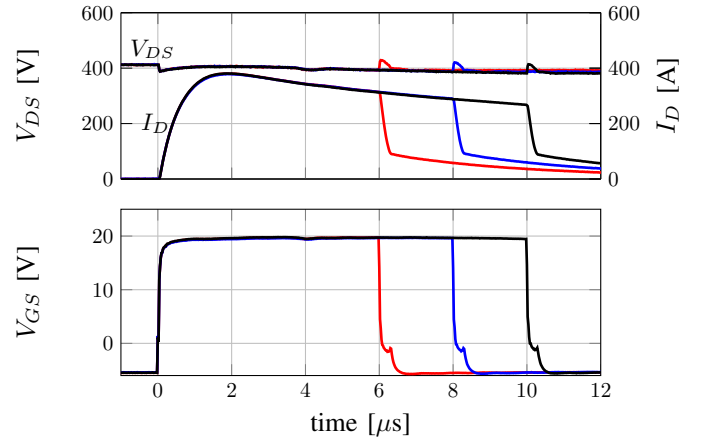
Fig. 3: Short-circuit tests with increasing time of a 1.2-kV/90-A SiC MOSFET: $V_{DC} = 400\text{ V}$ $T_j = 150^\circ\text{C}$.

results at low bias voltage and high temperature do not show any degradation on the gate voltage, and therefore, it can be concluded that the SiC MOSFET is able to survive this condition.
