A Study on Damage Detection Using Output-Only Modal Data

Kharrazi, M. K. H.; Ventura, Carlos E.; Brincker, Rune; Dascotte, Eddy

Published in:
Proceedings of IMAC 20

Publication date:
2002

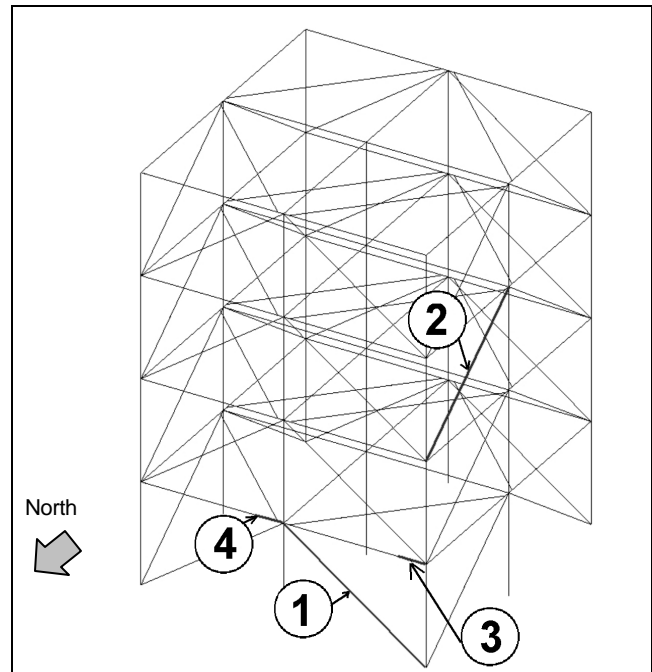
Fig. 3. Damage introduced to the steel frame in different cases

Case III, Damage was introduced to the frame by removing one brace from the northwest corner of the frame. The eliminated brace was attached to the steel base of the column and the first floor. The removed brace is shown in Fig. 3, indicated with the number 1.

Case IV, In the next damage case a second brace was removed. This brace was eliminated from the northwest side bay between the 2nd and 3rd floors. The removed brace is shown in Fig. 3, number 2.

Case V, The third damage condition was introduced to the frame by disconnecting the beam-column connection in the north west corner of the first floor in addition to the previous removals. The disconnected connection is indicated with number 3 in Fig. 3.

Case VII, Damage was induced on the same beam disconnected in case V. The beam to column connection of the 1st floor in the northwest corner was disconnected. This location is displayed as point 3 in Figure 3.

Case VIII, In addition to the damage in case VII, the beam to column connection in the north side of the 1st floor was partially loosened. This was done on the next bay to the damage created in case VII. The loosened joint is shown in Fig. 3 as number 4.

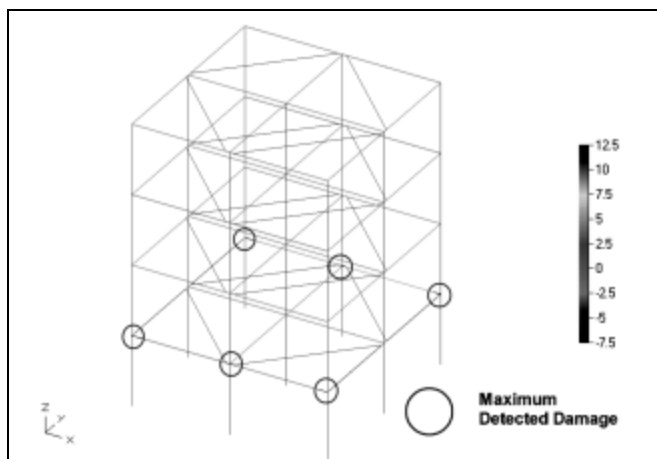
Fig. 9. Detected damage in case VIII, determined in the first floor and in the connections.

The damage shown in Figs 8 and 9 were detected in the beam and connection elements. Since the induced damage was insignificant, many parameters (such as column properties) were not permitted to change throughout the model updating of the benchmark model. As shown in figures 8 to 9 the member with actual damage was not directly identified. But what was identified is the portion of the structure where the likelihood of damage is the highest.
