Comprehensive energy renovation of two Danish heritage buildings within IEA SHC Task 59

Rose, Jørgen; Thomsen, Kirsten Englund

Published in:
Heritage

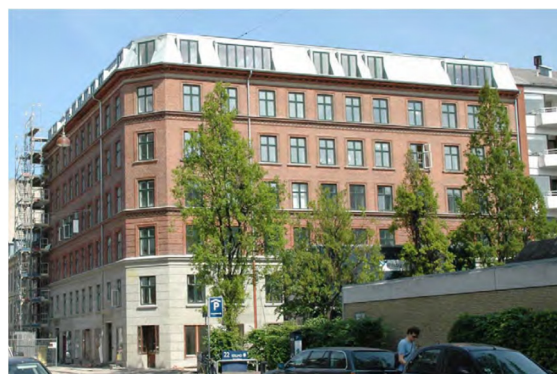
Figure 1. Façade of Ryesgade 30 after renovation, including new roof and penthouse apartments. Ground floor has commercial premises.

Ryesgade 30 is a multi-storey apartment building located in Copenhagen, Denmark. It was built in 1896 and has six floors with 32 apartments divided in three different stairwells (block A, B and C) and a total heated area of 2760 m². On the ground floor, the building has commercial premises. The building has an unheated basement and an unheated attic. Ryesgade 30 has a heritage value corresponding to Class 4 in the SAVE classification system [15], which means that the façade of the building cannot be changed (the period masonry with horizontal cornices and bands are protected). Figure 1 shows the façade of the building and Figure 2 shows a horizontal cross section of the apartment layout.

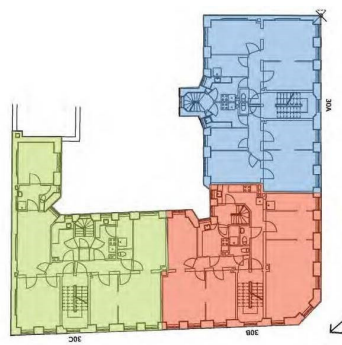
Figure 2. Horizontal cross section showing the apartment layout of the building. Blue is stairwell A, red is stairwell B and green is stairwell C.

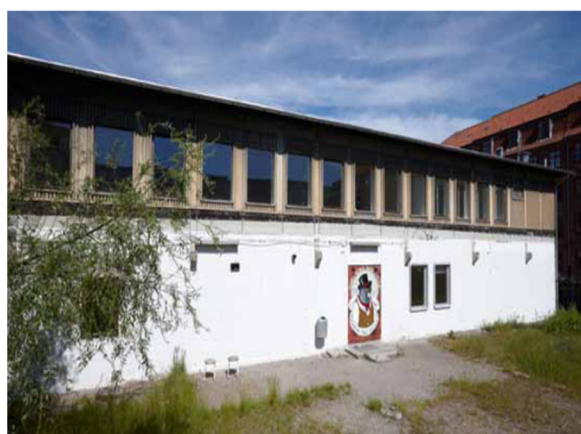
Figure 5. Façade facing the garden before renovation. The façade was originally the division between the office area (existing) and the factory area (which was torn down many years ago). The façade is not protected.

The walls were a mix of prefabricated concrete elements, concrete columns and uninsulated brick walls, and 380 mm insulation was added on the inside. The lower part of the back façade was insulated on the outside (see Figures 5 and 6).

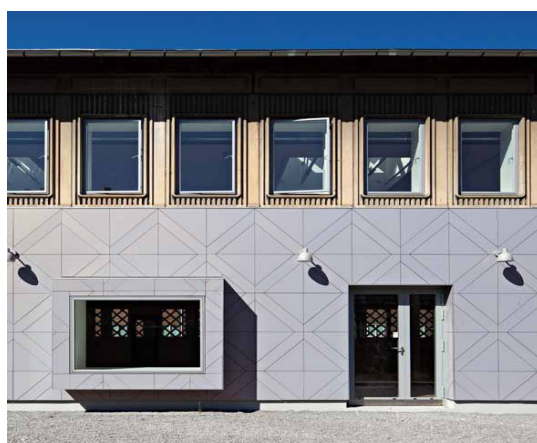
Figure 6. Façade facing the garden after renovation.

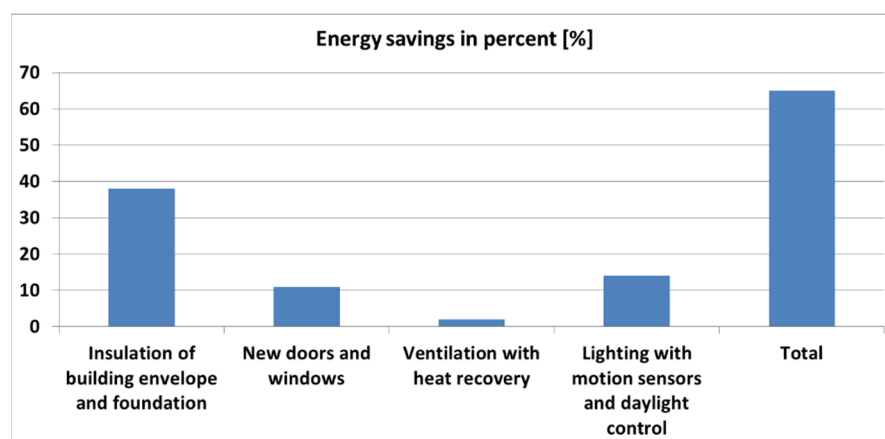
Figure 8. Energy savings in percent divided into the different parts of the renovation.

The energy savings for the building is 9500 and 181,000 kWh per year for electricity and heating, respectively. The savings from the façade insulation and the windows account for 150,000 kWh per year, and the rest are from the heating and lighting systems, the controls and the solar panels (see Figure 8).

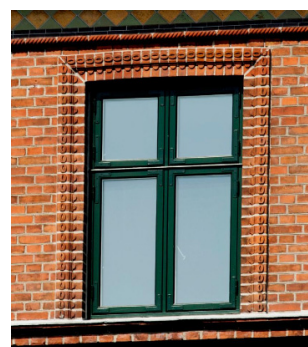
(b)

Figure 9. New windows from the inside (left) and from the outside (right). Source: Leif Rönby.

The fourth solution was a complete replacement of the window with a replica of the original. This was a 1 + 2 solution with two energy glasses (inner and outer panes) and energy panes with “warm” pane edge and krypton filling.

Based on this information, it was concluded that solution 4 was the cheapest, while at the same time being highly energy efficient. The solution was also very user friendly, i.e., all the glass was fitted in one frame, and they had been manufactured to replicate, from the outside, the originals. Project participants presented these findings to the municipality who gave permission to replace the windows of the building. The new windows are shown in Figure 9.

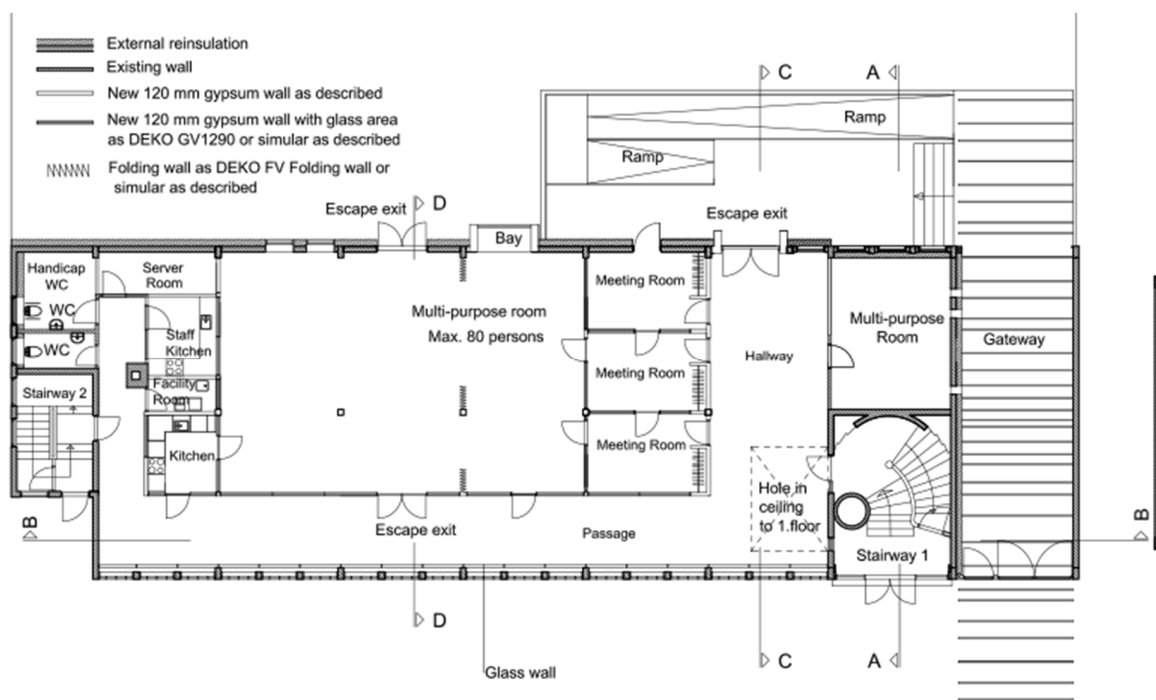
Figure 10. Ground floor layout.

In connection with the renovation, a new and more appropriate layout of the ground floor was considered. There are two main entrances; the new one from the courtyard includes a gate in the access/escape route. In the large entrance hall, penetration of the ceiling creates double room height in part of the room. From the entrance hall, a passage along the street facade gives access to two large flex rooms and three smaller activity rooms. The large rooms open towards the garden, and the activity rooms have glazing placed high in the walls, allowing “used” daylight to enter, while prohibiting seeing in from the other rooms. Lavatories and a bathroom are located in the eastern corner. In the southern corner, there is an office facing the garden and new window slits to the gateway (see Figure 10).

This layout of the building presents several advantages. The passage along the facade is a partly heated room, which will reduce the heat loss through the facade. As this facade symbolizes the house architectonically, it would be hard to insulate it without damaging the present expression. By replacing insulation with a room-high double wall of energy efficient glass, the architectonic expression will be maintained and the heat loss reduced, though somewhat less than by traditional, external insulation.

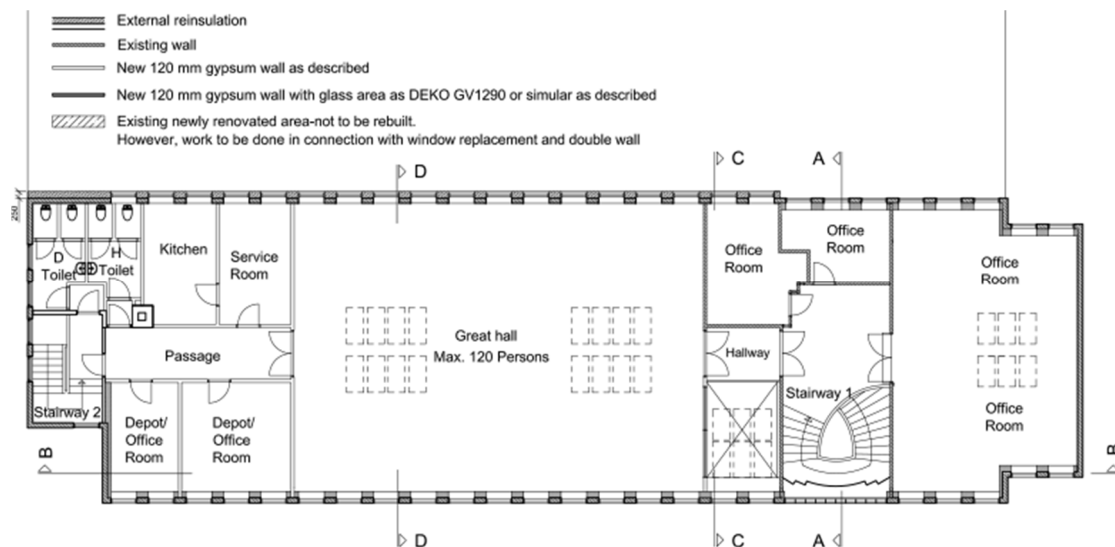
Figure 11. First floor layout.

On the first floor, there is access to the great hall and the three offices making up the primary rooms on this floor. Roof windows are installed above the great hall, the offices and the hallway and are fitted with electrically-operated sun screening and opening devices for natural ventilation (see Figure 11).

The roof windows in the hallway will contribute significantly to creating a lighter and more inviting entrance area and to make the passage more open. The windows in the great hall are relatively small, but the roof windows will improve the daylight conditions considerably in this area. At the same time, the roof windows will contribute actively to adjusting the indoor climate when a large amount of people are gathered for activities such as folk dancing, lectures or private parties.

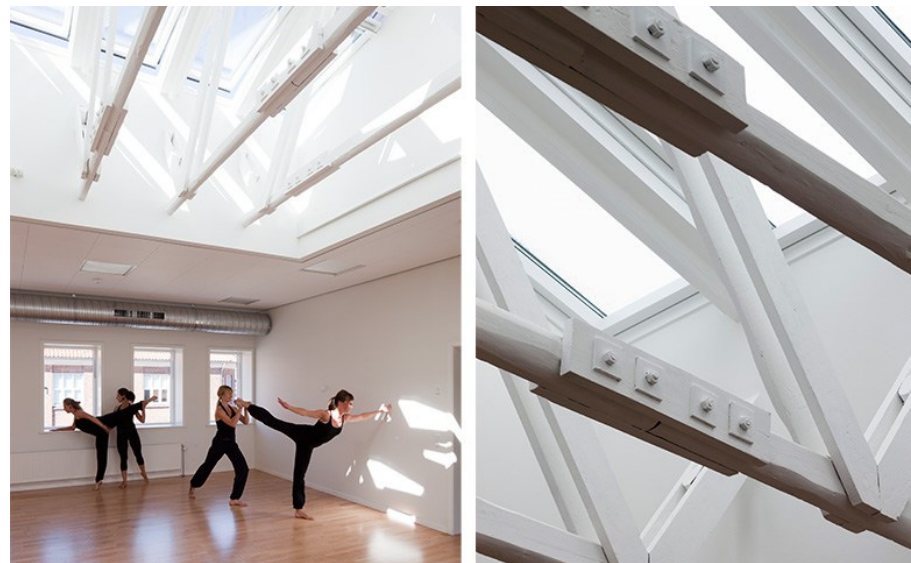
Figure 16. The roof lights provide a significant amount of daylight to the first floor in the building.

The comparison of results shows the positive effects of adding roof windows on the daylight conditions of the first floor. The roof windows deliver high levels of daylight in the centre part of the main room, as well as in the meeting rooms at the end of the building. The use of roof windows also contributes to raising the daylight levels on the lower floor via a new opening in the existing structural floor situated below the skylights in the hallway, as shown in Figure 16.
