A Study on Damage Detection Using Output-Only Modal Data

Published in:
Proceedings of IMAC 20

A STUDY ON DAMAGE DETECTION USING OUTPUT -ONLY MODAL DATA

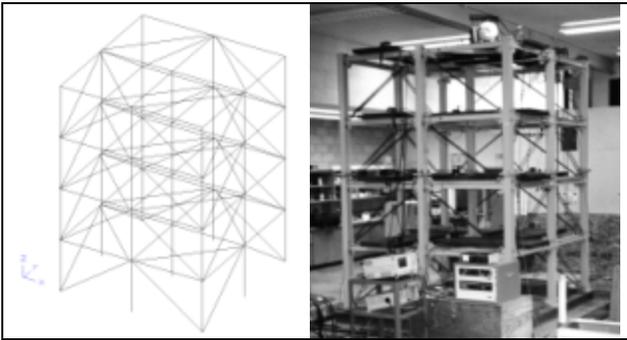
Figure 1. Steel Frame Model, a) FEM wire frame model (left); b) actual unit as tested (right)

The test frame used for this study is a modular four storey, two by two bay, steel frame structure designed and built at the Earthquake Engineering Research Laboratory at the University of British Columbia (Fig. 1). The model is approximately 3.6 m tall with a total width of 2.5 m. Each floor is 0.9 m high and each bay is 1.25 m wide. For more information on the frame see Black and Ventura (1998), (Ref. [1]).

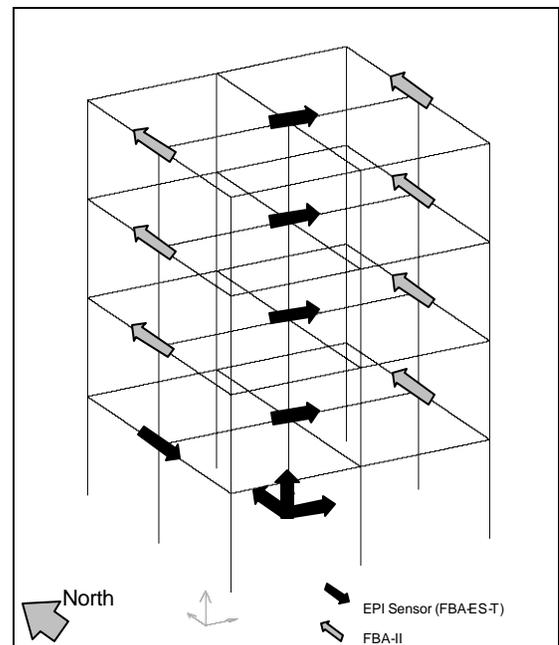
Figure 2. Typical accelerometer locations and directions on the steel frame

every floor beginning from the roof down to the 1st floor. Finally, measurements for all three directions were taken in one location at the base level. Figure 2 shows a typical accelerometer layout of the approximate locations and the directions of accelerometers on each floor level.

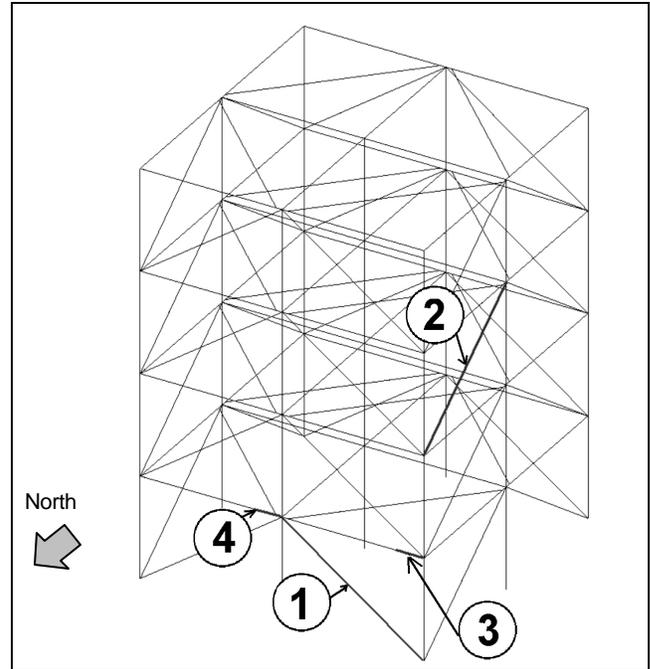
Fig. 3. Damage introduced to the steel frame in different cases

Case III, Damage was introduced to the frame by removing one brace from the northwest corner of the frame. The eliminated brace was attached to the steel base of the column and the first floor. The removed brace is shown in Fig. 3, indicated with the number 1.

Case IV, In the next damage case a second brace was removed. This brace was eliminated from the northwest side bay between the 2nd and 3rd floors. The removed brace is shown in Fig. 3, number 2.

Case V, The third damage condition was introduced to the frame by disconnecting the beam-column connection in the north west corner of the first floor in addition to the previous removals. The disconnected connection is indicated with number 3 in Fig. 3.

Case VII, Damage was induced on the same beam disconnected in case V. The beam to column connection of the 1st floor in the northwest corner was disconnected. This location is displayed as point 3 in Figure 3.

Case VIII, In addition to the damage in case VII, the beam to column connection in the north side of the 1st floor was partially loosened. This was done on the next bay to the damage created in case VII. The loosened joint is shown in Fig. 3 as number 4.

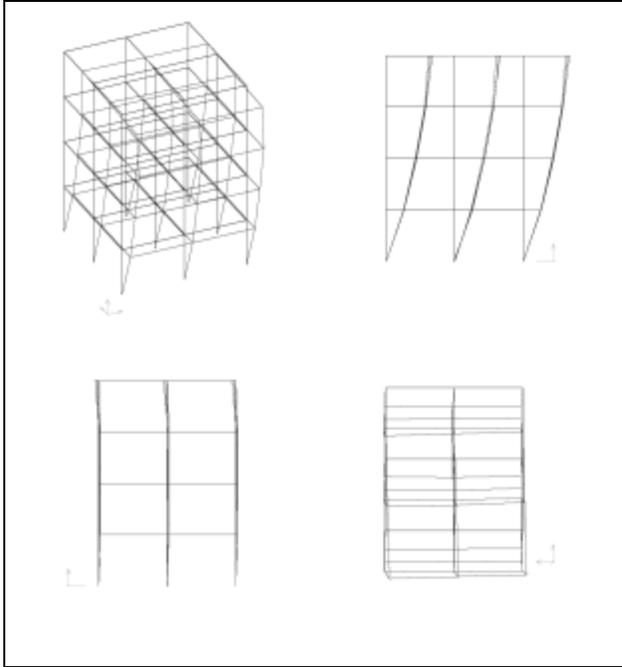
Figure 4 View of 1st mode for case I to V

One of the mode shapes determined to be natural modes of vibration of the frame is shown in figure 4. The mode shape is shown in three views: an isometric view at the top left of the figure, an elevation view at the top right and bottom left and a plan view at the bottom right.

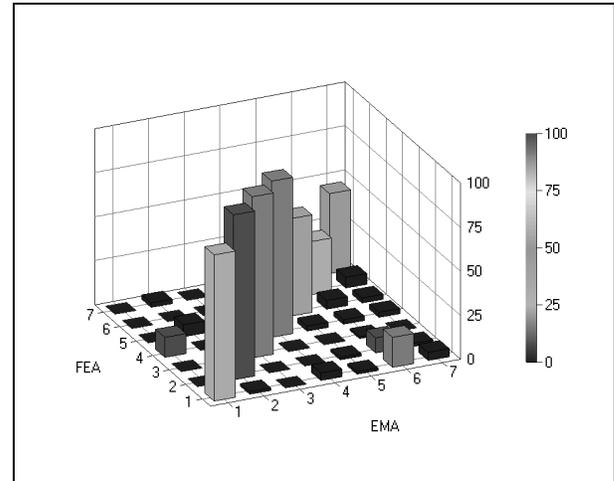
Fig. 5. Modal Assurance Criteria (MAC) for the benchmark finite element model.

To evaluate the correlation of the prepared finite element model with the tested model, Modal Assurance Criteria (MAC), FRF Pairing and Shape pairings options in FEMtools[®] were utilized. Figure 5 shows the final MAC for the updated model. The updated finite element was used as benchmark for comparison with the damaged model in order to detect the damage.

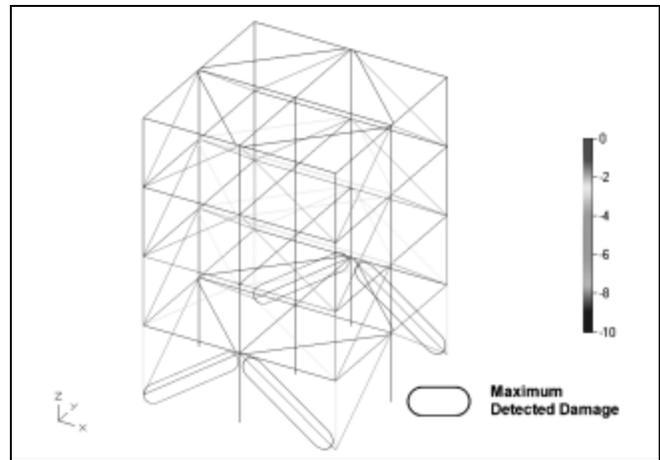
Fig. 6. Detected damage in for case III, determined in the ground storey and in the braces of the north side.

Fig. 6 to 9 shows the updated model of the damaged cases. The members with the maximum reduction in properties are marked in these figures. In Fig. 6, the detected damage was located in the cross-sectional area of the east-west braces of the first storey. In Fig. 7, the detected damage was located in the cross-section area of the north-south braces of the second storey. However, while the damaged element was not determined, the approximate location and element type was in good agreement with the actual damage cases.

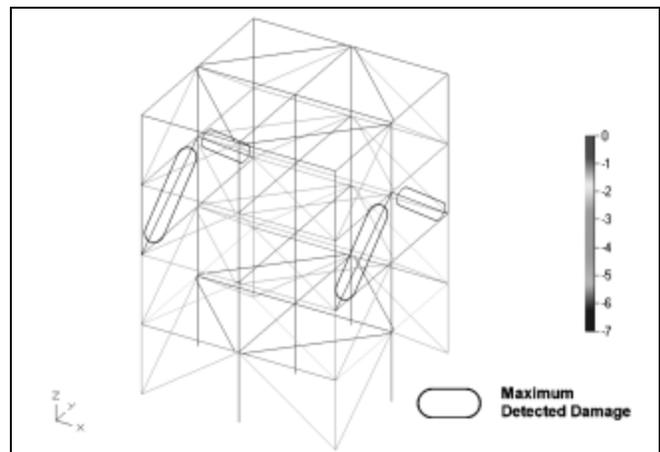
Fig. 7. Detected damage for case IV, determined in the second storey and in the braces of the west side.

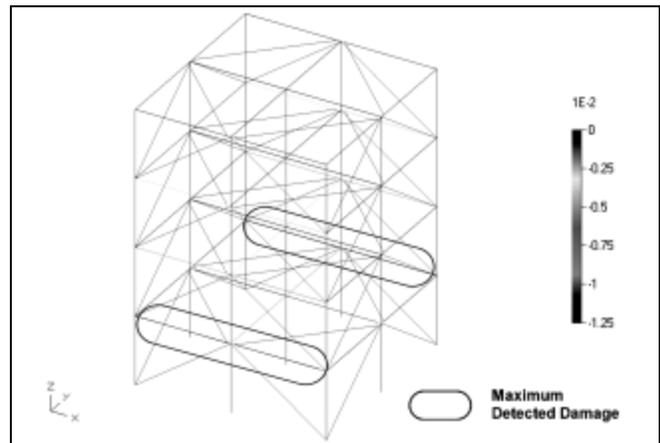
Fig. 8. Detected damage for case V, determined in the first floor and in the beam of the north side.

The damage shown in Figs 8 and 9 were detected in the beam and connection elements. Since the induced damage was insignificant, many parameters (such as column properties) were not permitted to change throughout the model updating of the benchmark model. As shown in figures 8 to 9 the member with actual damage was not directly identified. But what was identified is the portion of the structure where the likelihood of damage is the highest.

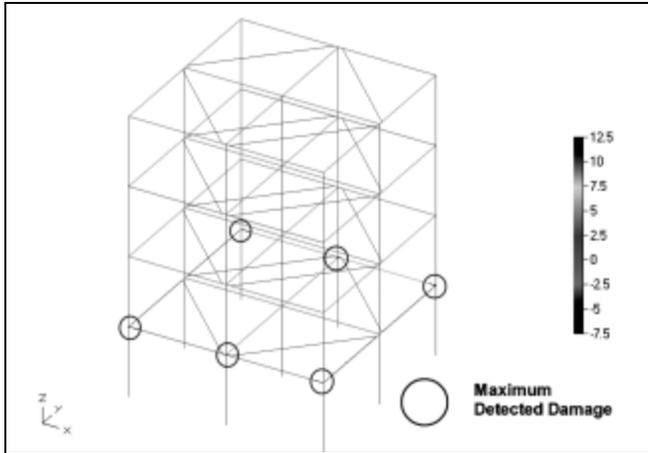
Fig. 9. Detected damage in case VIII, determined in the first floor and in the connections.
