## **Whole Life Carbon Impact of**

### *45 Timber Buildings*

# BUILD REPORT

## Whole Life Carbon Impact of: 45 Timber Buildings

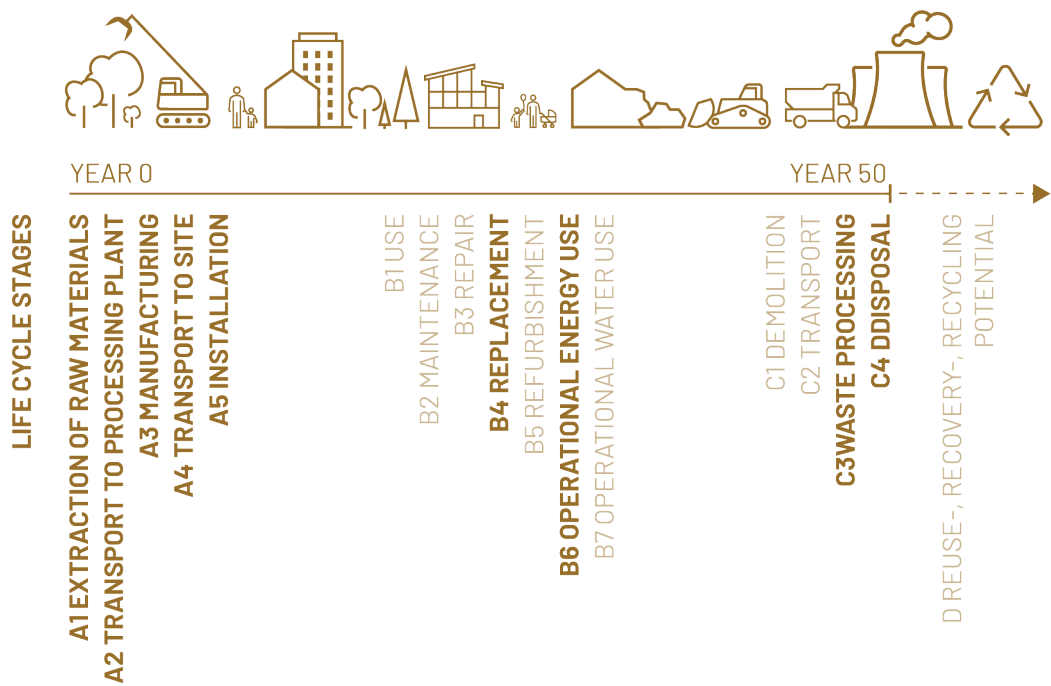
Figure 5. Life cycle stages included in the building case studies

The overall life cycle stages of buildings comprise the stages: Product (A1–A3), Construction Process (A4–A5), Use (B1–B7), End of Life (C1–C4), and Beyond Life Cycle (D), of which the marked life-cycle stages are included in the LCAs of building case studies.

This study includes the life-cycle stages of manufacture and transport of building materials (A1–3), transport to building site and construction process (A4–5), replacement of building parts (B4), operational use of energy (B6), and end-of-life waste disposal (C3–4). Figure 5 illustrates all the modules covered by EN 15798 (CEN, 2012) and indicates the modules included in this study (Andersen et al., 2021, p.16).

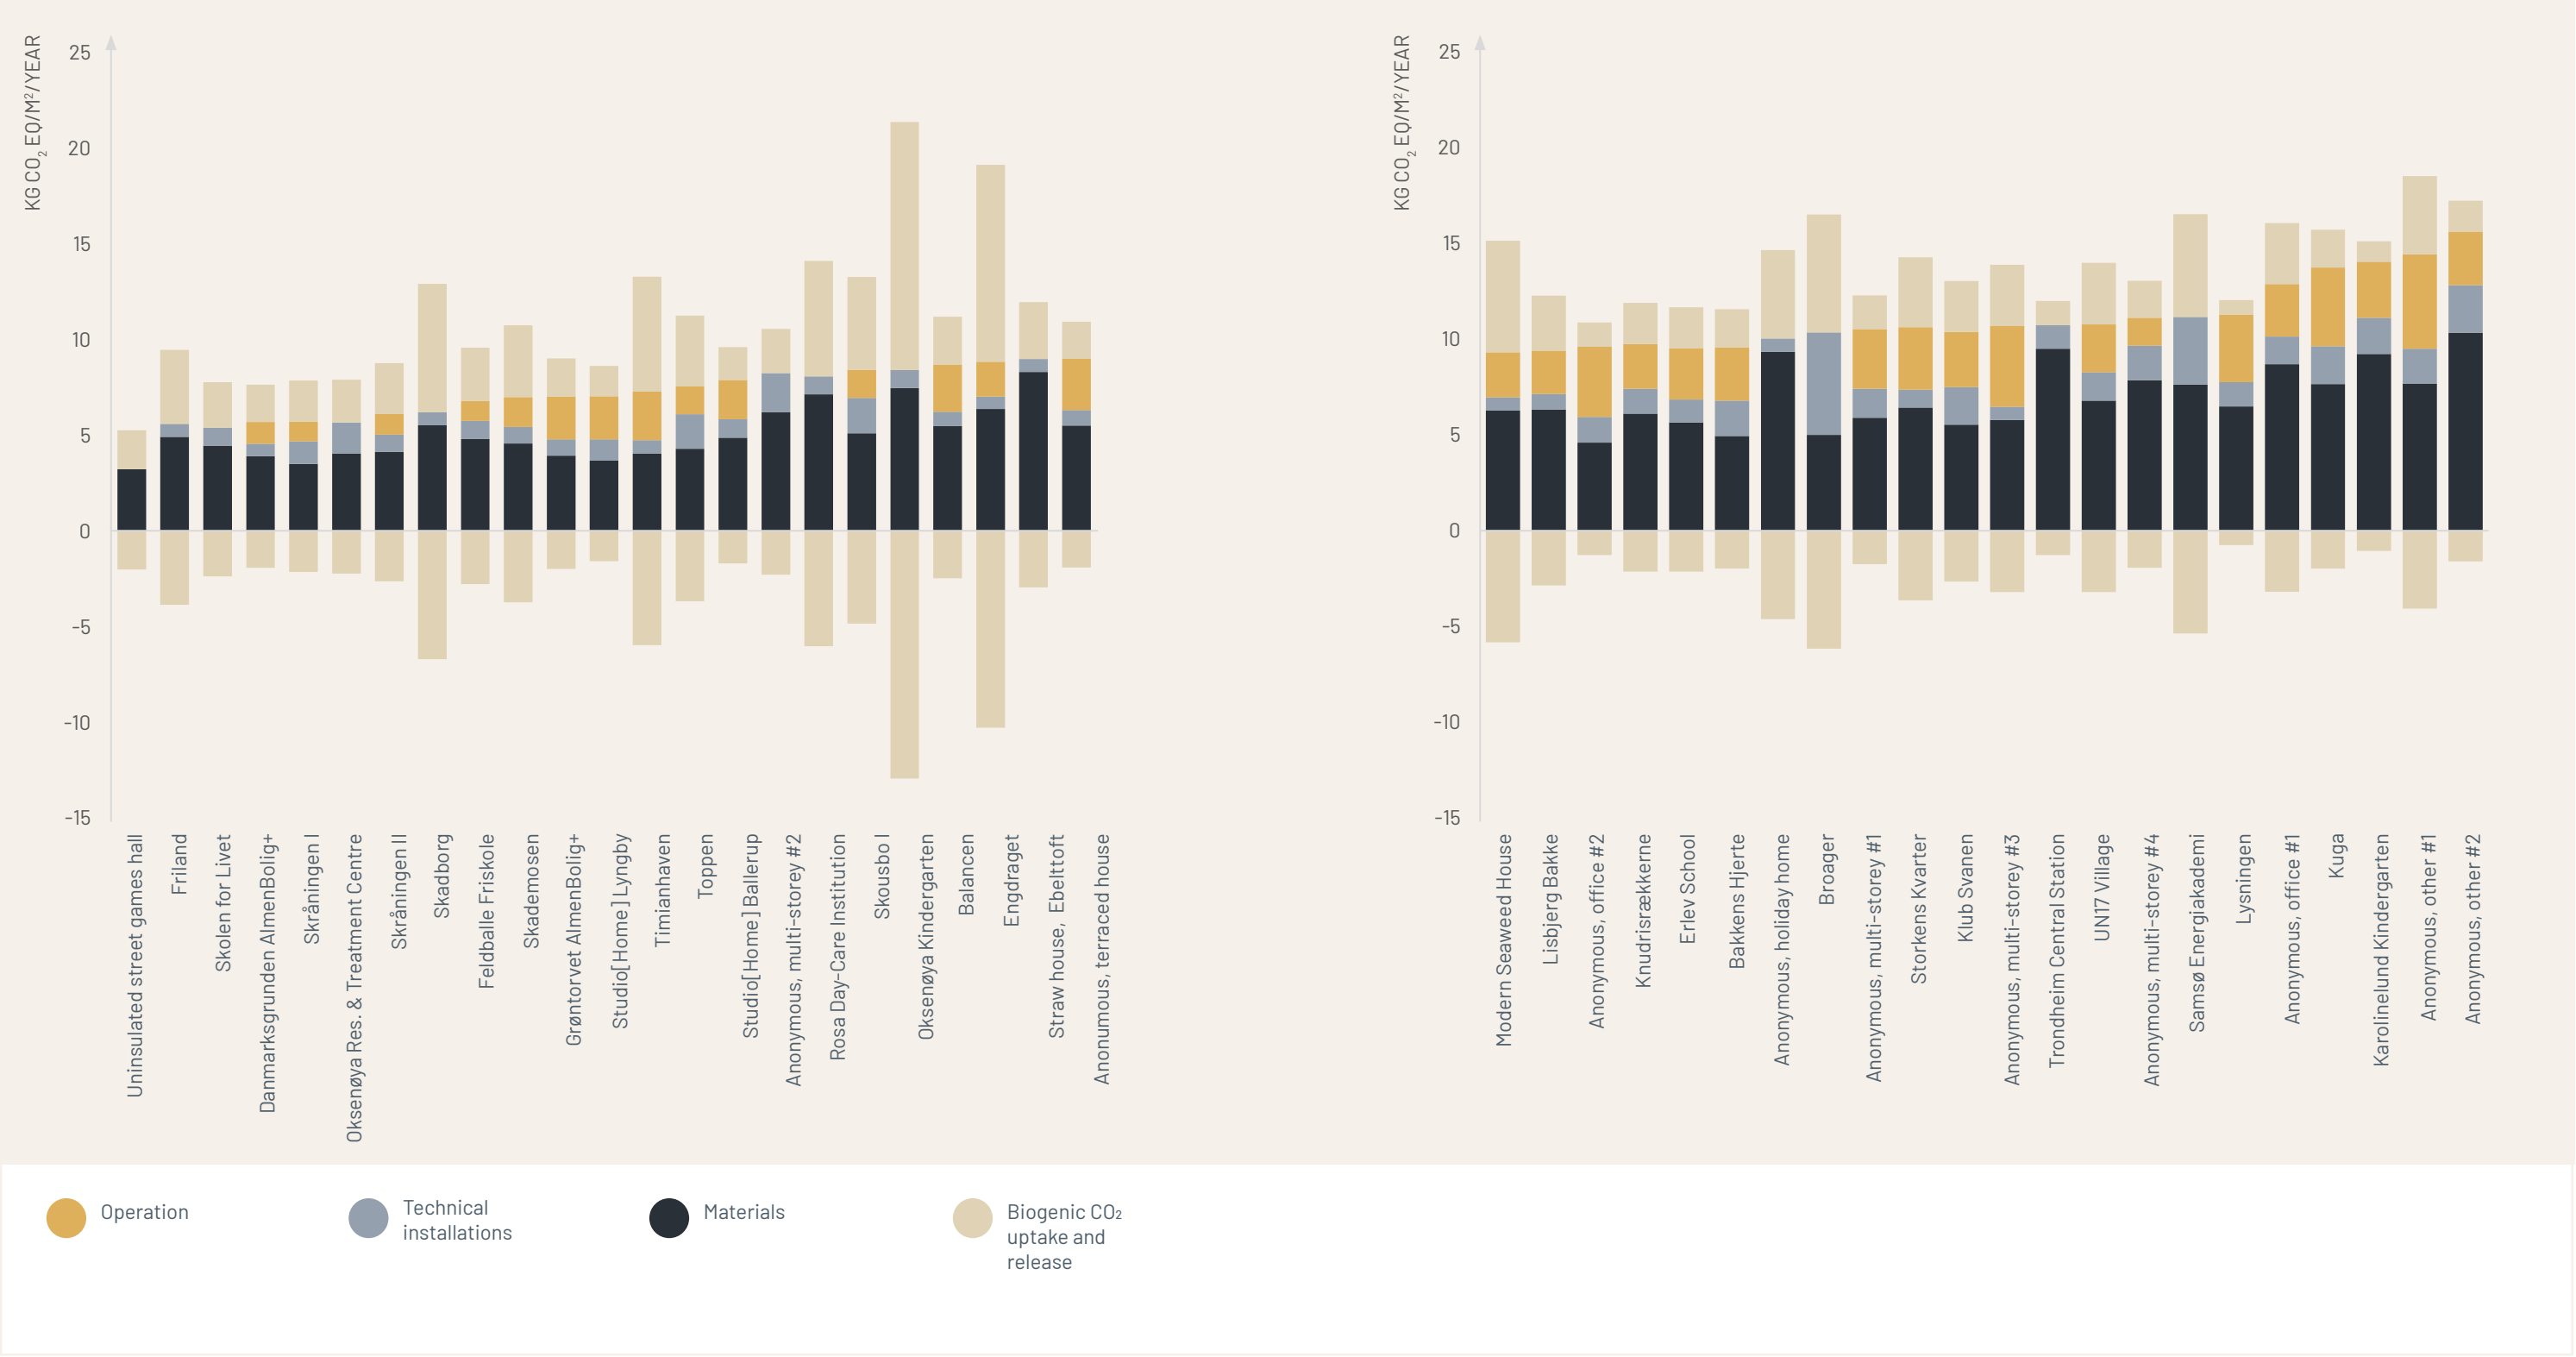
Below, the results of LCAs for all 45 case studies distributed on two graphs. Thus, the guidelines apply to both graphs. The results are specified in kg CO<sub>2</sub> eq/m<sup>2</sup>/year. The results are distributed on impact from materials, technical installations, and usage as well as biogenic CO<sub>2</sub> capture and emission. Please note that the technical installations for drains and water, heating, ventilation, and cooling systems are based on generic values, whereas electricity and mechanical systems are specific values.

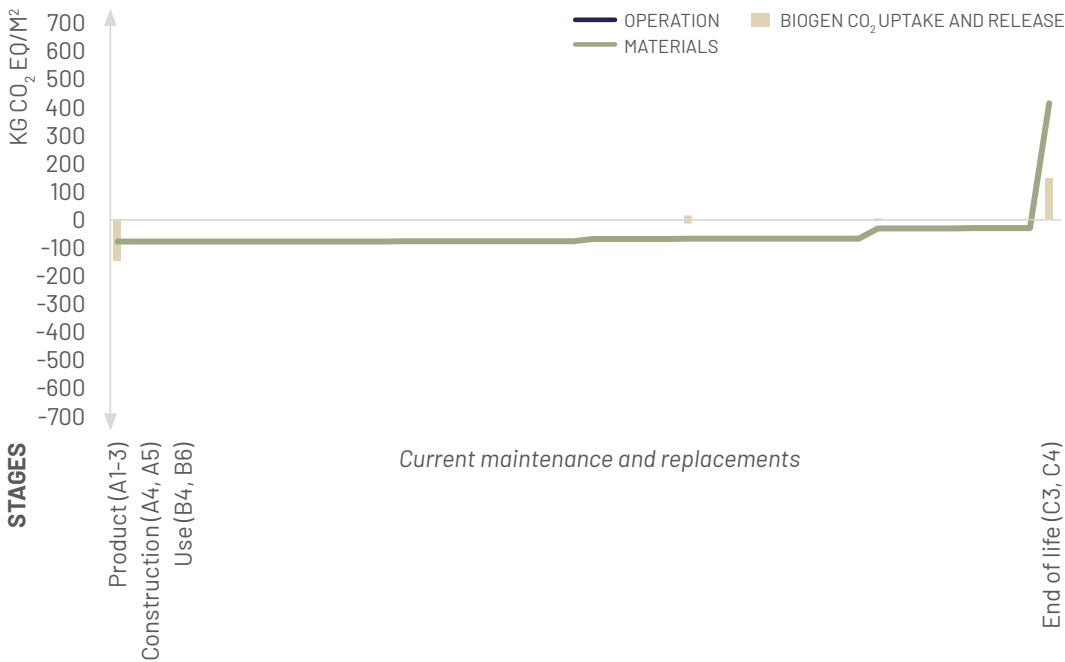
ENVIRONMENTAL IMPACT DISTRIBUTED OVER TIME

**Figure 3. CO<sub>2</sub> accounting: life-cycle stages**  
The horizontal axis shows the distribution of life-cycle stages in the building over a 50-year period. In year 0, there are emissions from the Manufacture and Construction stages (A1-A3 and A4 and A5, respectively). Between years 1-49, there are emissions from the Use stage (B4 and B6). In year 50, there are emissions from the End-of-life stages (C3 and C4). The vertical axis shows the emission of greenhouse gases stated in CO<sub>2</sub> eq/m<sup>2</sup> distributed on materials and use. The biogenic CO<sub>2</sub> content is shown as columns corresponding to the capture and emission of biogenic CO<sub>2</sub> during the reference study period cf. the -1/+1 method.

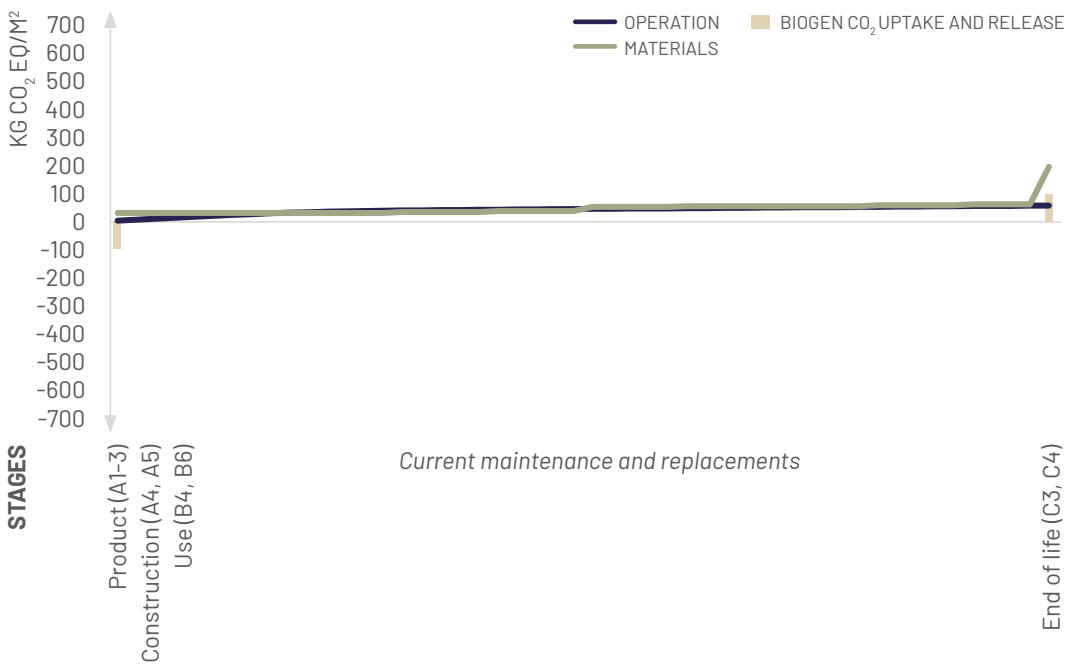
ENVIRONMENTAL IMPACT DISTRIBUTED OVER TIME

**Figure 3. CO<sub>2</sub> accounting: life-cycle stages**  
The horizontal axis shows the distribution of life-cycle stages in the building over a 50-year period. In year 0, there are emissions from the Manufacture and Construction stages (A1-A3 and A4 and A5, respectively). Between years 1-49, there are emissions from the Use stage (B4 and B6). In year 50, there are emissions from the End-of-life stages (C3 and C4). The vertical axis shows the emission of greenhouse gases stated in CO<sub>2</sub> eq/m<sup>2</sup> distributed on materials and use. The biogenic CO<sub>2</sub> content is shown as columns corresponding to the capture and emission of biogenic CO<sub>2</sub> during the reference study period cf. the -1/+1 method.

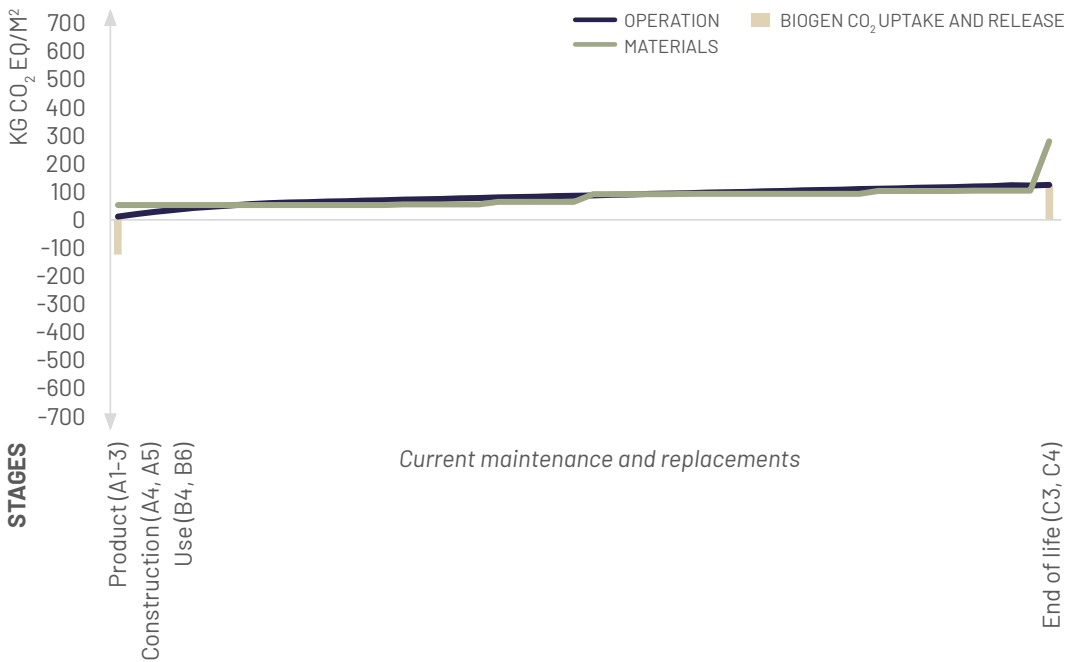
ENVIRONMENTAL IMPACT DISTRIBUTED OVER TIME

**Figure 3. CO<sub>2</sub> accounting: life-cycle stages**  
The horizontal axis shows the distribution of life-cycle stages in the building over a 50-year period. In year 0, there are emissions from the Manufacture and Construction stages (A1-A3 and A4 and A5, respectively). Between years 1-49, there are emissions from the Use stage (B4 and B6). In year 50, there are emissions from the End-of-life stages (C3 and C4). The vertical axis shows the emission of greenhouse gases stated in CO<sub>2</sub> eq/m<sup>2</sup> distributed on materials and use. The biogenic CO<sub>2</sub> content is shown as columns corresponding to the capture and emission of biogenic CO<sub>2</sub> during the reference study period cf. the -1/+1 method.

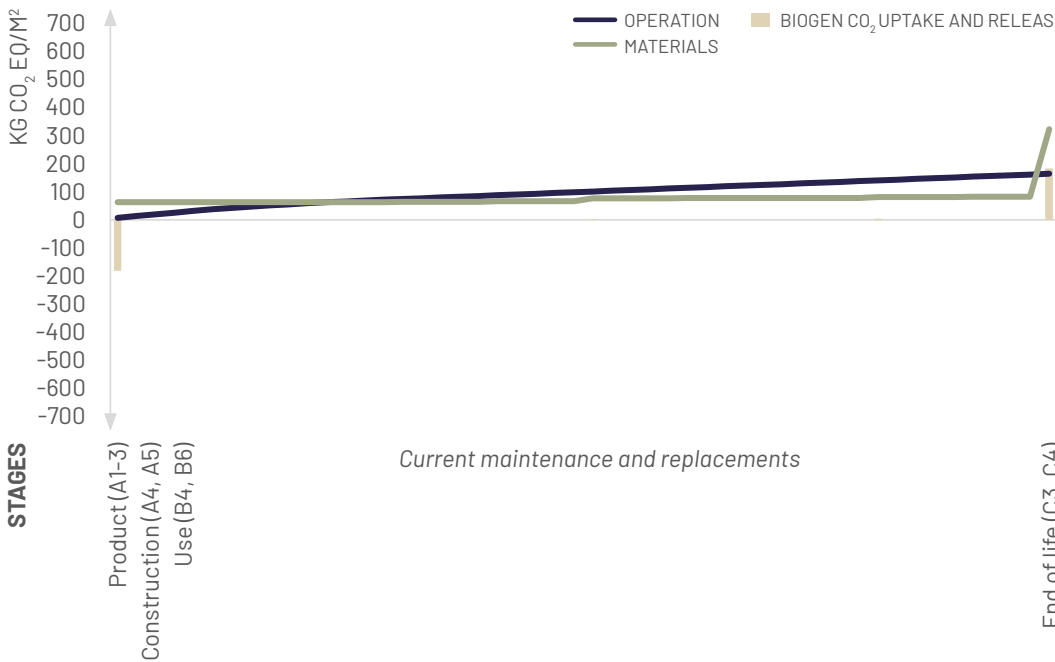
**Figure 3. CO<sub>2</sub> accounting: life-cycle stages**  
The horizontal axis shows the distribution of life-cycle stages in the building over a 50-year period. In year 0, there are emissions from the Manufacture and Construction stages (A1-A3 and A4 and A5, respectively). Between years 1-49, there are emissions from the Use stage (B4 and B6). In year 50, there are emissions from the End-of-life stages (C3 and C4). The vertical axis shows the emission of greenhouse gases stated in CO<sub>2</sub> eq/m<sup>2</sup> distributed on materials and use. The biogenic CO<sub>2</sub> content is shown as columns corresponding to the capture and emission of biogenic CO<sub>2</sub> during the reference study period cf. the -1/+1 method.

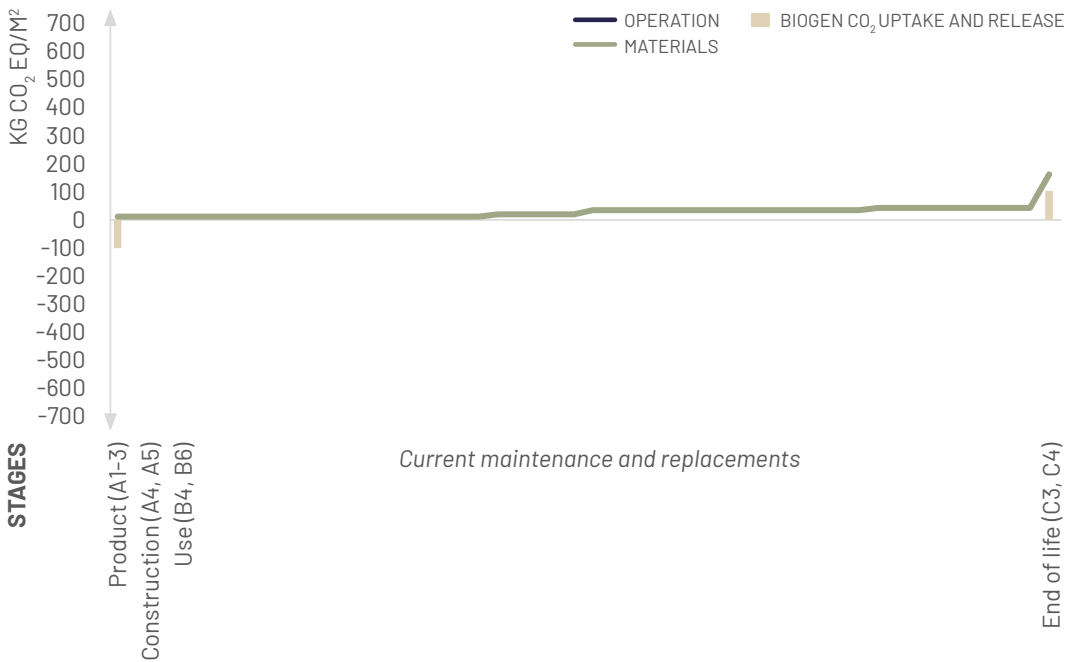
**Figure 3. CO<sub>2</sub> accounting: life-cycle stages**  
The horizontal axis shows the distribution of life-cycle stages in the building over a 50-year period. In year 0, there are emissions from the Manufacture and Construction stages (A1-A3 and A4 and A5, respectively). Between years 1-49, there are emissions from the Use stage (B4 and B6). In year 50, there are emissions from the End-of-life stages (C3 and C4). The vertical axis shows the emission of greenhouse gases stated in CO<sub>2</sub> eq/m<sup>2</sup> distributed on materials and use. The biogenic CO<sub>2</sub> content is shown as columns corresponding to the capture and emission of biogenic CO<sub>2</sub> during the reference study period cf. the -1/+1 method.

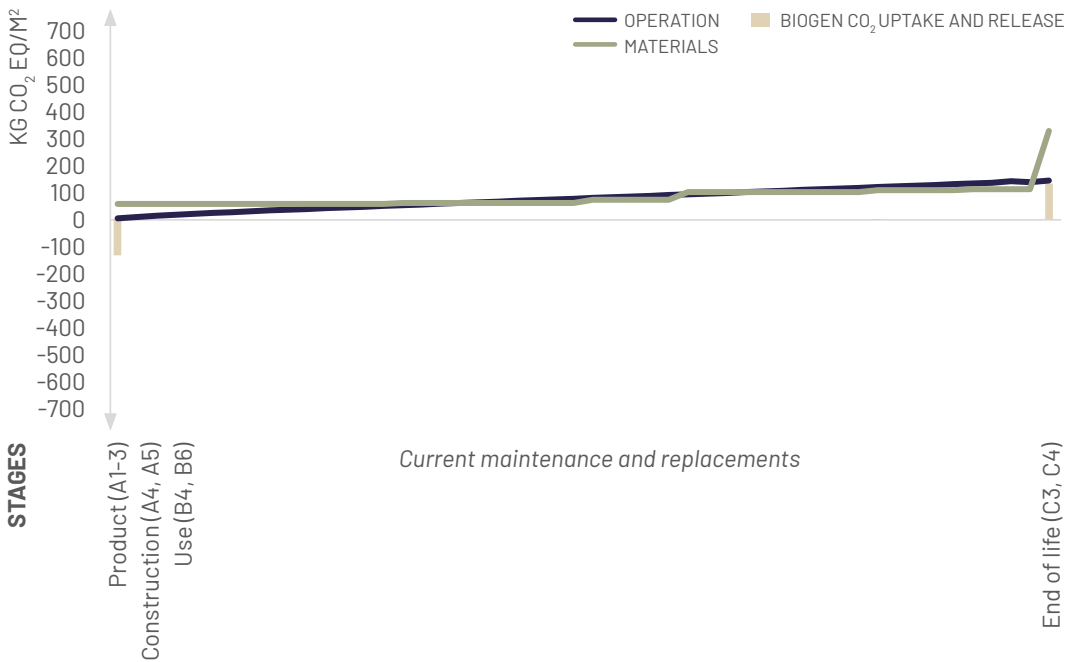
**Figure 3. CO<sub>2</sub> accounting: life-cycle stages**  
The horizontal axis shows the distribution of life-cycle stages in the building over a 50-year period. In year 0, there are emissions from the Manufacture and Construction stages (A1-A3 and A4 and A5, respectively). Between years 1-49, there are emissions from the Use stage (B4 and B6). In year 50, there are emissions from the End-of-life stages (C3 and C4). The vertical axis shows the emission of greenhouse gases stated in CO<sub>2</sub> eq/m<sup>2</sup> distributed on materials and use. The biogenic CO<sub>2</sub> content is shown as columns corresponding to the capture and emission of biogenic CO<sub>2</sub> during the reference study period cf. the -1/+1 method.

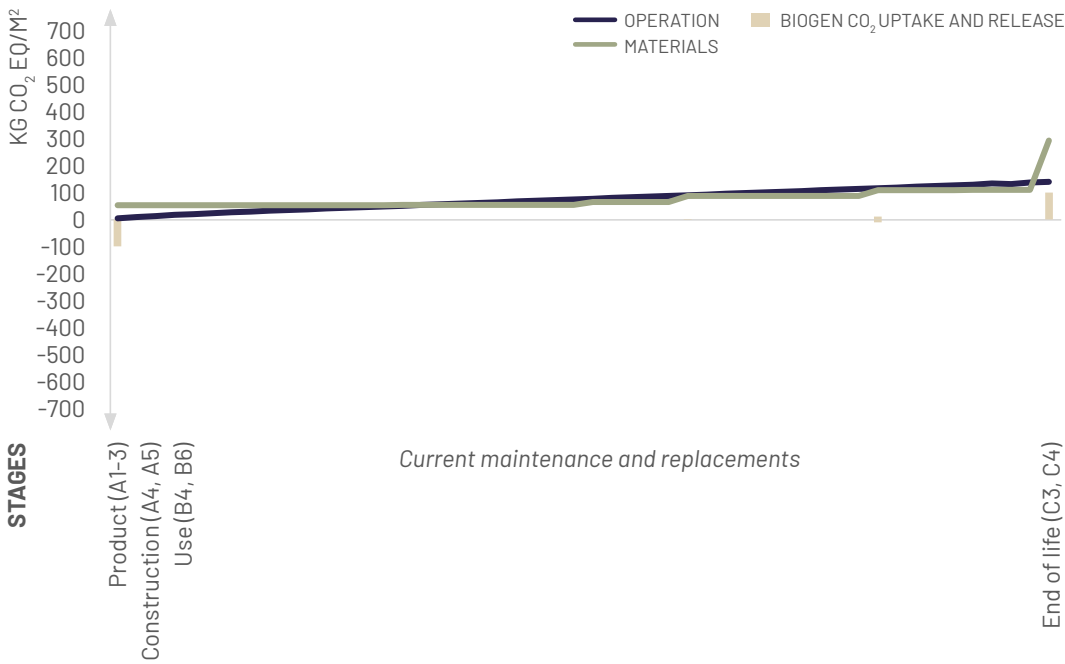
**Figure 3. CO<sub>2</sub> accounting: life-cycle stages**  
The horizontal axis shows the distribution of life-cycle stages in the building over a 50-year period. In year 0, there are emissions from the Manufacture and Construction stages (A1-A3 and A4 and A5, respectively). Between years 1-49, there are emissions from the Use stage (B4 and B6). In year 50, there are emissions from the End-of-life stages (C3 and C4). The vertical axis shows the emission of greenhouse gases stated in CO<sub>2</sub> eq/m<sup>2</sup> distributed on materials and use. The biogenic CO<sub>2</sub> content is shown as columns corresponding to the capture and emission of biogenic CO<sub>2</sub> during the reference study period cf. the -1/+1 method.

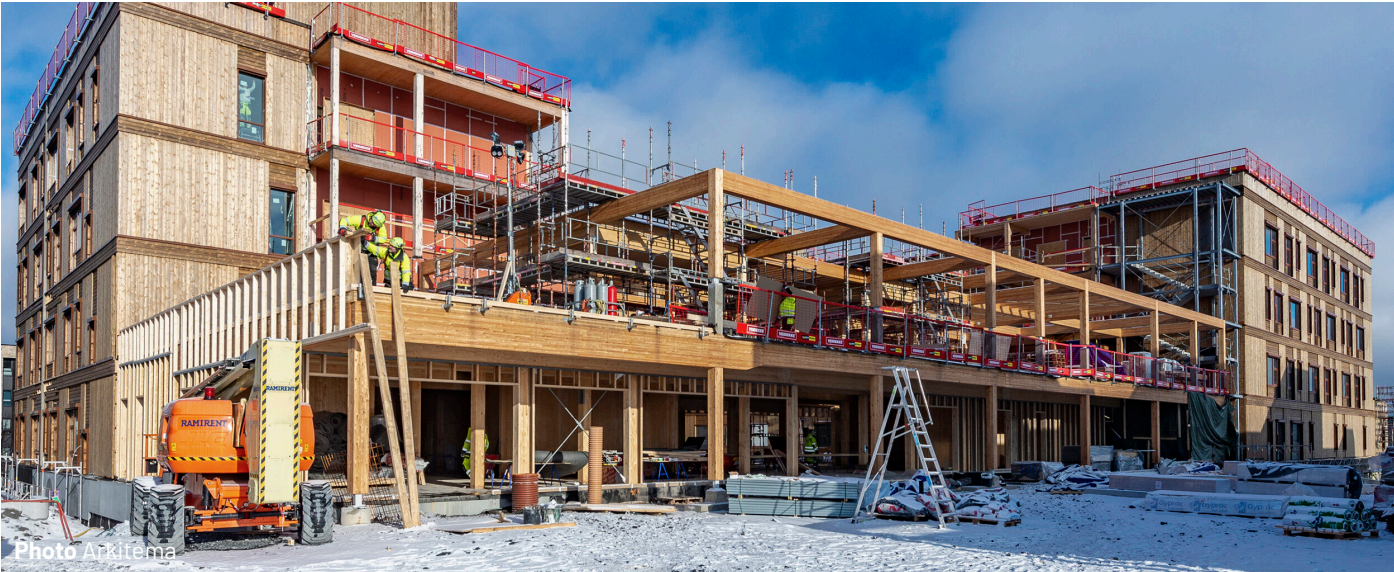
DETAILS OF THE BUILDING'S ENVIRONMENTAL IMPACT

| RESULT IN HIGH IMPACT | Material consumption of 837.9 kg/m <sup>2</sup> is above average due to special needs (average being 684.6 kg/m <sup>2</sup> )<br>Photovoltaic modules on roof<br>EPS insulation in grade deck<br>Concrete in grade deck and foundations<br>Pressure-resistant mineral wool roof insulation<br>Large glazed areas in climate envelope Interior glass walls |

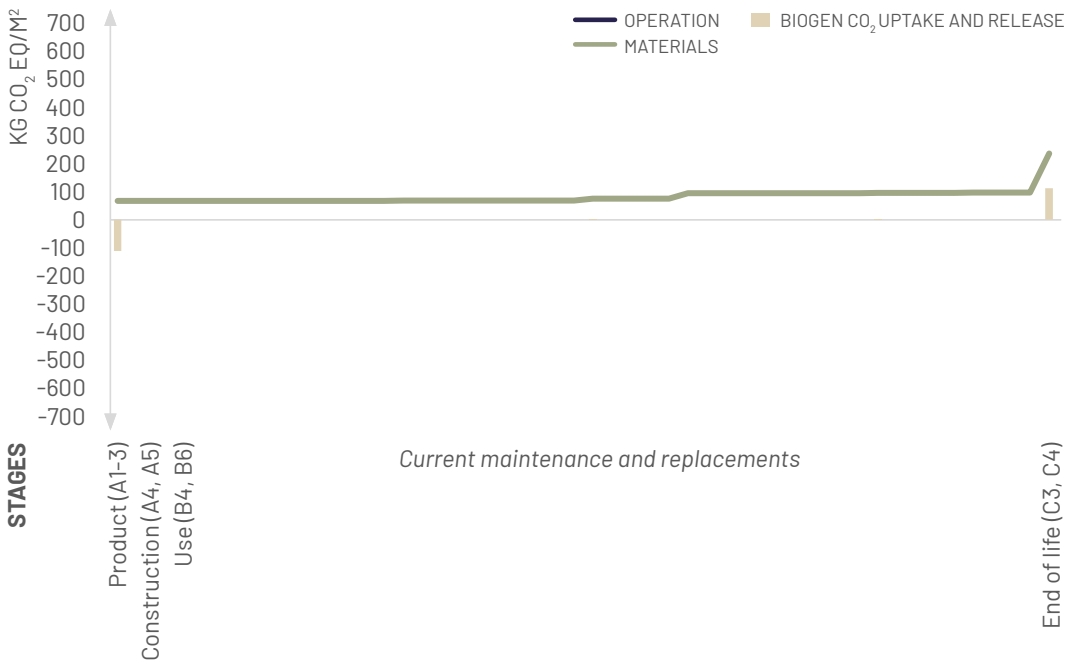
**Figure 3. CO<sub>2</sub> accounting: life-cycle stages**  
The horizontal axis shows the distribution of life-cycle stages in the building over a 50-year period. In year 0, there are emissions from the Manufacture and Construction stages (A1-A3 and A4 and A5, respectively). Between years 1-49, there are emissions from the Use stage (B4 and B6). In year 50, there are emissions from the End-of-life stages (C3 and C4). The vertical axis shows the emission of greenhouse gases stated in CO<sub>2</sub> eq/m<sup>2</sup> distributed on materials and use. The biogenic CO<sub>2</sub> content is shown as columns corresponding to the capture and emission of biogenic CO<sub>2</sub> during the reference study period cf. the -1/+1 method.

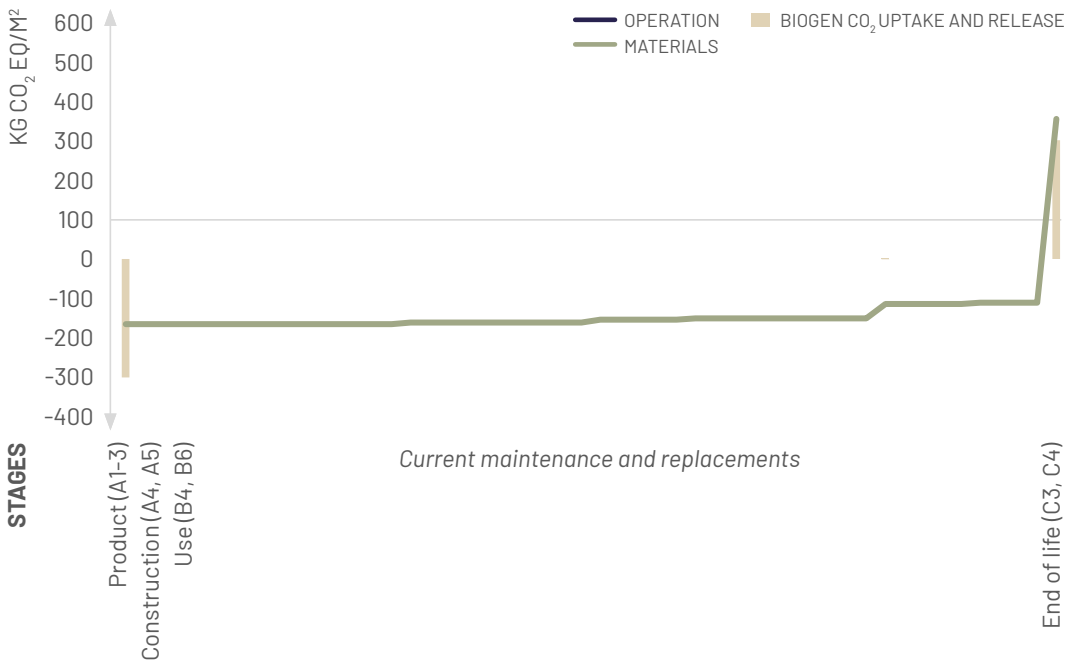
**Figure 3. CO<sub>2</sub> accounting: life-cycle stages**  
The horizontal axis shows the distribution of life-cycle stages in the building over a 50-year period. In year 0, there are emissions from the Manufacture and Construction stages (A1-A3 and A4 and A5, respectively). Between years 1-49, there are emissions from the Use stage (B4 and B6). In year 50, there are emissions from the End-of-life stages (C3 and C4). The vertical axis shows the emission of greenhouse gases stated in CO<sub>2</sub> eq/m<sup>2</sup> distributed on materials and use. The biogenic CO<sub>2</sub> content is shown as columns corresponding to the capture and emission of biogenic CO<sub>2</sub> during the reference study period cf. the -1/+1 method.

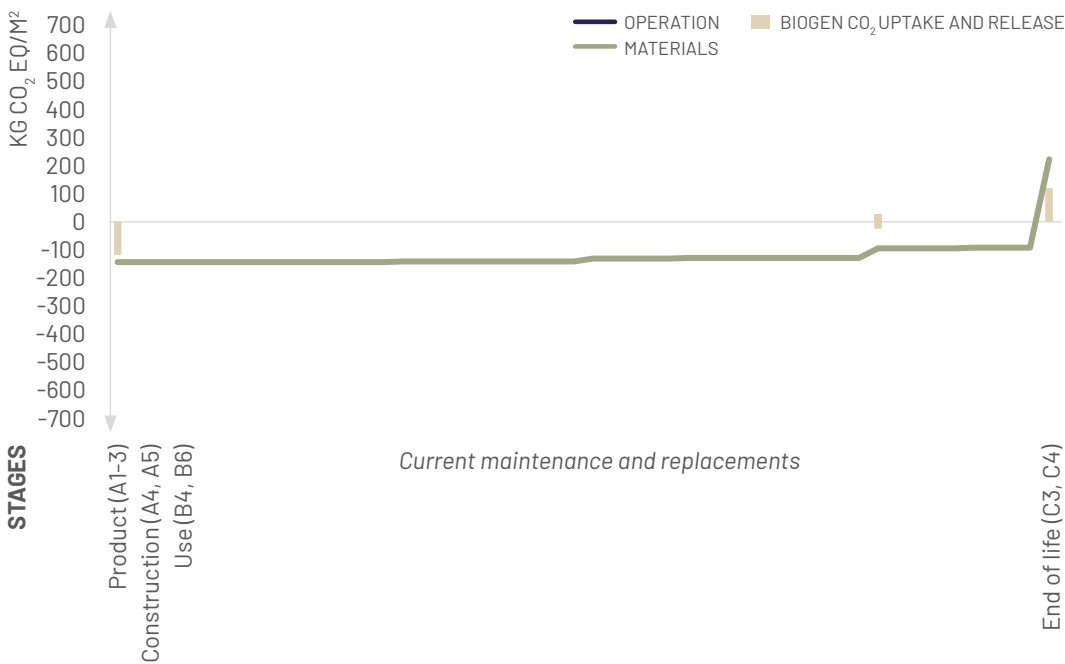
**Figure 3. CO<sub>2</sub> accounting: life-cycle stages**  
The horizontal axis shows the distribution of life-cycle stages in the building over a 50-year period. In year 0, there are emissions from the Manufacture and Construction stages (A1-A3 and A4 and A5, respectively). Between years 1-49, there are emissions from the Use stage (B4 and B6). In year 50, there are emissions from the End-of-life stages (C3 and C4). The vertical axis shows the emission of greenhouse gases stated in CO<sub>2</sub> eq/m<sup>2</sup> distributed on materials and use. The biogenic CO<sub>2</sub> content is shown as columns corresponding to the capture and emission of biogenic CO<sub>2</sub> during the reference study period cf. the -1/+1 method.
