Published in: NSB 2023 - Book of Technical Papers: 13th Nordic Symposium on Building Physics

Influence of Energy-saving Renovation Plan on the Hygrothermal Distribution Inside Kyo-machiya Soil Walls Considering their Moisture Buffering Effect

Abstract. Kyo-machiya are traditional townhouses in Kyoto that represent an important aspect of cultural heritage preservation. Because of the poor thermal insulation performance, they require energy-saving renovations. However, their unique soil walls possess a moisture-buffering effect that can be strongly influenced by the applied renovation plan and are expected to remain functional even after renovation. Conventional renovation methods apply an inside vapor barrier to the interior insulation to prevent condensation between the insulation and wall; however, applying this barrier may hinder the buffering effect and deteriorate the unique interior appearance of the soil wall. Therefore, we conducted a case study on the hygrothermal environment of a typical Kyo-machiya structure in winter when the moisture generated by indoor activities was adsorbed by soil walls. We used the finite difference method to divide the various renovated envelope

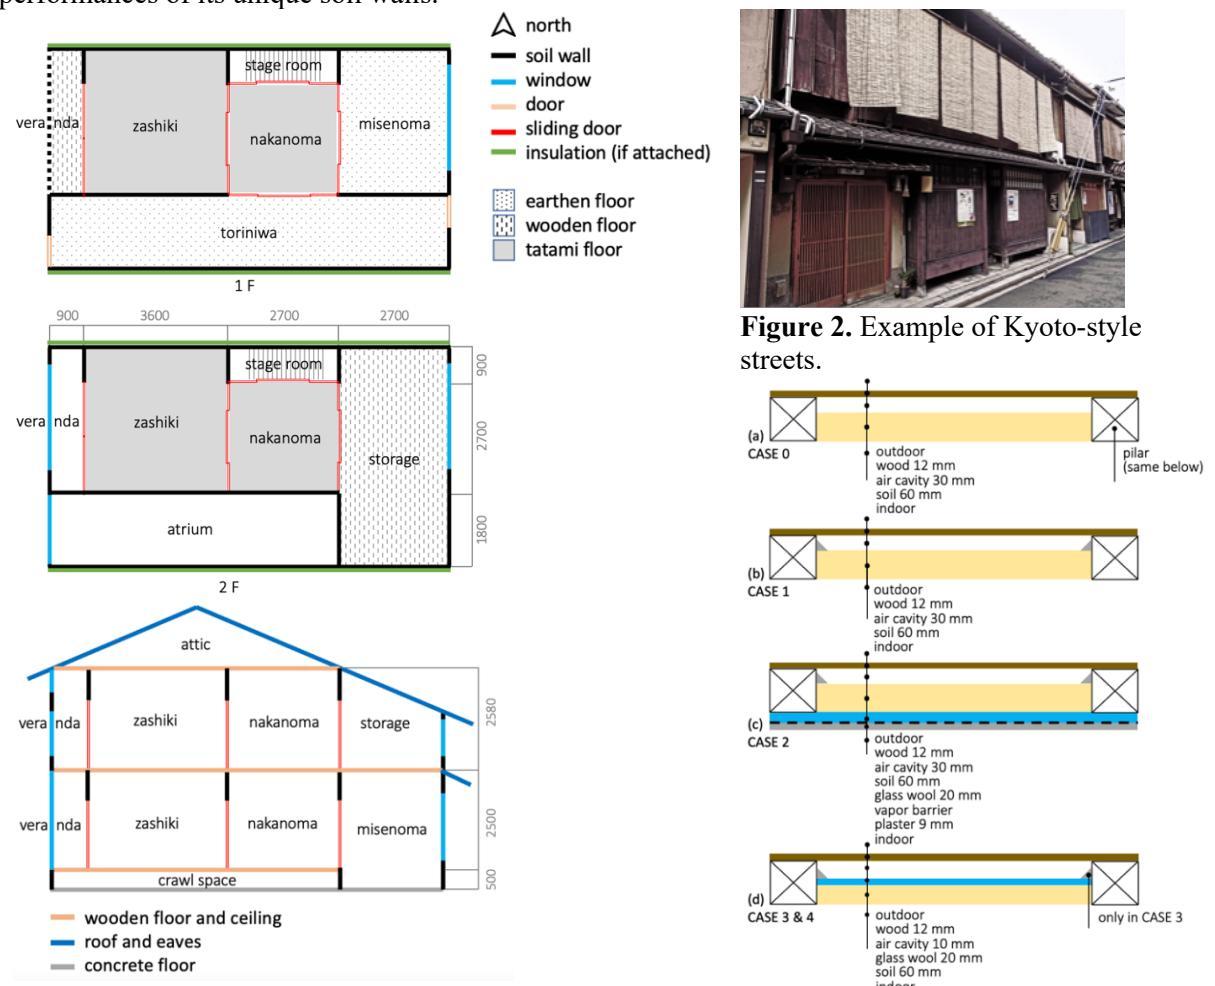
Figure 1. Layout of a model of a Kyo-machiya (unit: mm). Figure 1.

Kyo-machiya (Figure 1) are traditional townhouses in Kyoto that represent a significant part of Kyoto-style streets. They are not only used as residential homes but also as a part of the regional cultural heritage. The preservation of Kyoto City streets as prominent tourist destinations relies on the maintenance of their integrity, with Kyo-machiya serving as the primary architectural features (Figure 2). However, ensuring the longevity of these structures for future generations presents a challenge, given the deterioration they have endured over the past seven decades [1].

Intermittent heating was assumed to be provided only to the nakanoma and zashiki on the first floor (Figure 1). The calculation was performed from October to January using the December and January results as outputs. Standard Expanded AMeDAS Weather Data based on the years 2011–2020 (provided by the Meteorological Data System Co., Ltd.) were used as outdoor boundary conditions. The heating temperature and schedule were set based on a field survey conducted from 2015 to 2019 in a real Kyomachiya, whose layout and envelope composition were similar to those of the model used in this study [10]. The preferred heating temperature was set as 20 °C, the heating time for the nakanoma (working space) was set to 6:00–9:00 during weekdays with no heating on weekends, and the heating time for the zashiki (bedroom) was set to 17:00–22:00 during weekdays and 6:00–22:00 during weekends. Nakanoma and zashiki were equipped with 1000 and 1500 W heaters, respectively. The initial temperature and humidity conditions of all envelope materials were set as 7 °C and 80%, respectively.

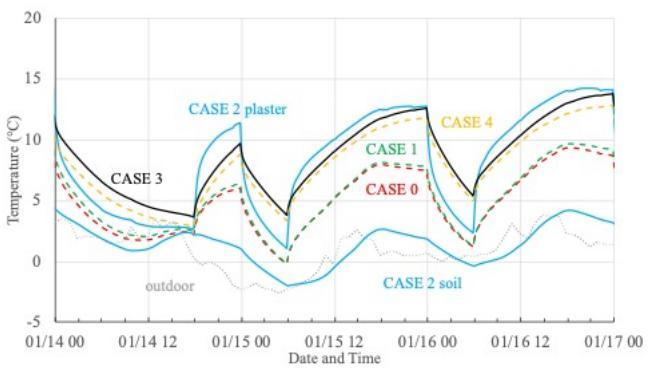
Figure 4. Surface temperature on the northern soil wall of the zashiki.

Figure 4 shows the surface temperature changes in the northern soil wall of zashiki for each case during the coldest period (1/14–1/16). In Case 2, the temperature is shown for the surface between the insulation and soil wall and for the interior surface of the plaster layer; in all other cases, it is shown for the surface in contact with the indoor air. The temperature in Case 4 was similar to that in Case 3, although the former exhibited a lower peak value and a slightly slower rate of increase over time. Cases 0 and 1 exhibited similar trends; the difference between the two cases indicated that the enhanced airtightness slightly increased the peak temperature and its rate of increase. Case 2 exhibited the lowest soil wall temperature, and its change trend closely followed the outdoor air temperature. However, the corresponding interior temperature (plaster surface) exhibited the highest peak value and fastest rate of increase, although it also exhibited the fastest rate of decrease. The Case 3 results indicated that the use of interior insulation could keep the entire wall warm, whereas the Case 2 results indicated that the use of interior insulation left the wall at extremely low temperatures that even dropped below 0 °C. Thus, even if no condensation occurs on the interior surface of the soil wall (according to the results presented in Section 3.2), penetrated rainwater can freeze and damage its exterior surface.

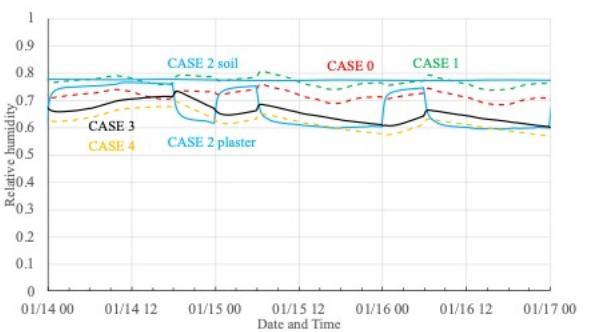
Figure 5 shows the change in surface relative humidity on the northern soil wall of the zashiki for each case. Similar to the surface temperatures in Figure 4, Case 2 shows the relative humidity of the surface between the insulation and soil wall, and of the interior surface of the plaster layer; in all other cases, it is shown for the surface in contact with indoor air. In all the cases, the relative humidity remained below 80%, indicating that no condensation occurred. For the Case 2 soil wall surface, the relative humidity remained constant because the soil wall was isolated by a vapor barrier.

Figure 5. Relative humidity on the northern soil wall of the zashiki.

As Figure 5 indicates, the use of a vapor barrier would prevent the soil wall from adsorbing and releasing moisture; therefore, we evaluated an additional case, Case 5, in which the vapor barrier used in Case 2 was removed. Figure 6 shows the resulting moisture content and relative humidity on the northern soil wall of zashiki. The figure demonstrates that without a vapor barrier, the moisture content on the interior surface of the soil wall changed dramatically, indicating that the soil adsorbed and released moisture. However, when the relative humidity was lower than 100%, no condensation occurred.

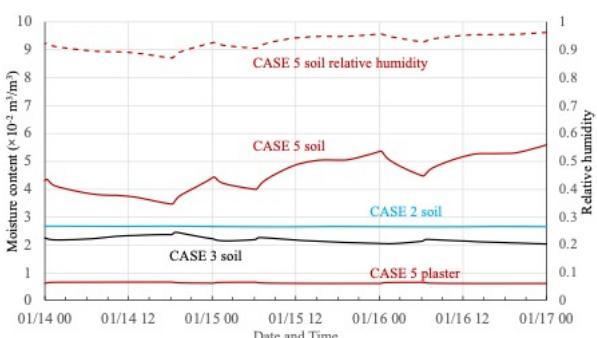
Figure 6. Moisture content and relative humidity on the northern soil wall of the zashiki with and without the vapor barrier.
