Proceedings of the 5th International Conference on Building Physics (ICBP)

# Interior insulation of solid brick walls in cold climates

Erik Brandt <sup>1</sup>, Tommy Bunch-Nielsen <sup>2</sup>, and Georg Christensen <sup>3</sup>

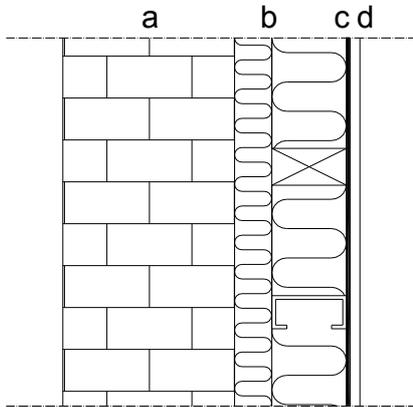
Fig. 1a. Interior insulated brick wall.  
 a. Solid brick wall  
 b. Insulated stud wall (or insulating panel)  
 c. Vapour barrier  
 d. 13 mm gypsum board

Traditionally stud walls are constructed as seen in fig. 1a. A vapour barrier is placed on the warm side of the insulation material. In fig. 1b is shown the distribution of the water vapour pressure under winter conditions in the ideal situation if the vapour barrier has a high water vapour resistance as e.g. a 0,15mm PE-foil. Theoretically there is no risk of condensation on the old brick surface since the partial vapour

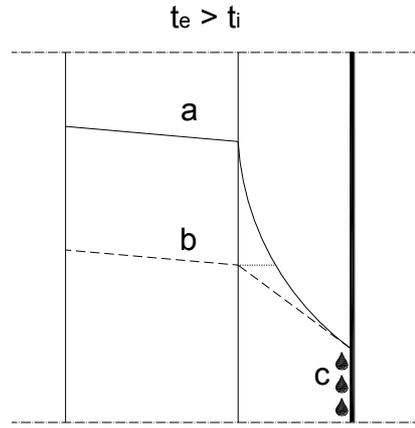
Fig. 1d. Vapour pressure distribution, sun.  
 a. Saturated vapour pressure  
 b. Actual vapour pressure  
 c. Condensation

A brick wall may under summer conditions be wet due to absorption of driving rain. In this case capillary action and thermal forces caused by sunshine may transport water from the exterior to the interior part of the wall. The moisture will condensate on the outside of the vapour barrier. This phenomenon is called "summer condensation". This is shown in fig. 1d. If a steel stud system is used this will in most cases not give any mould problems in the first place. However when the heat flow again goes outwards, moisture may condensate on the brick surface and a risk of mould growth will exist. It could be argued, that if no nutrient existed at this place mould growth would not occur. However practice has shown that complete absence of nutrient at this place is not possible – and mould will occur.

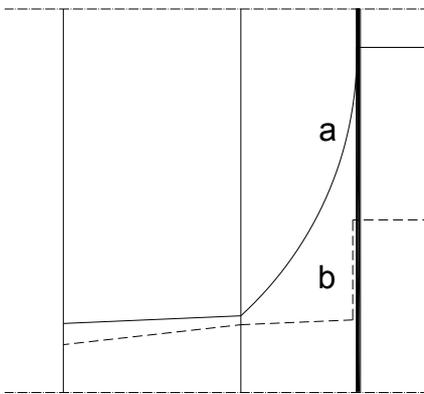
Fig. 1b. Vapour pressure distribution, PE-foil.  
 a. Saturated vapour pressure  
 b. Actual vapour pressure (no interstitial condensation)

pressure is lower than the saturated vapour pressure at this place. The calculation of water vapour pressure through a multilayer wall has been explained by H. Glaser many years ago (Glaser 1958) and (Glaser 1959) and the theory behind will for this reason not be repeated here.

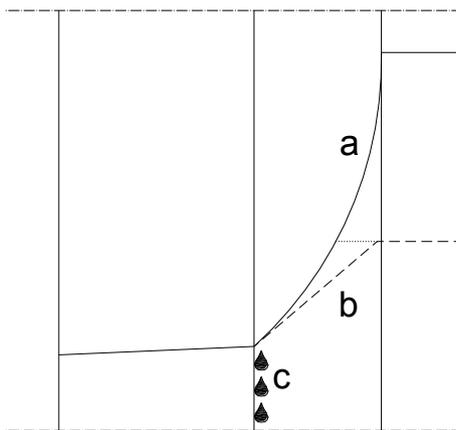
Fig. 1c. Vapour pressure distribution, air leakage  
 a. Saturated vapour pressure  
 b. Actual vapour pressure  
 c. Interstitial condensation

However, if the vapour barrier is not absolutely air tight especially at the top and the bottom indoor warm and humid air may circulate behind the insulation due to convective forces. In this case condensation is unavoidable. This is shown in fig. 1c. (For clarity the vapour barrier is omitted in the figure).

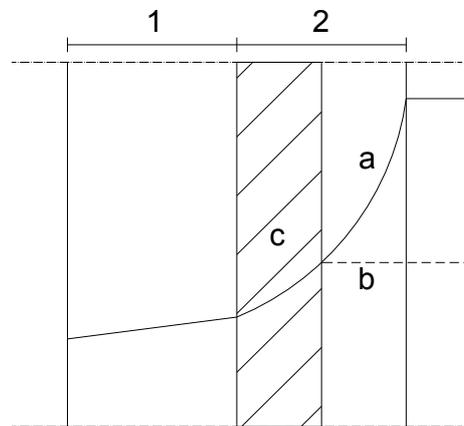
Fig. 1e. Zone with critical moisture content.  
 1. Solid brick wall  
 2. Calcium silicate boards  
 a. Saturated vapour pressure  
 b. Actual vapour pressure  
 c. Area with critical moisture content

situation will be established. This phenomenon B. Voss (Voss 1967) has been explained many years ago by. In fig. 1e is shown the zone which is partly saturated when an equilibrium situation is established. However the saturation only comes to a certain point called the “critical moisture content”. This is a situation when the meniscuses are just no longer connected which means, that moisture transport in the form of water is not possible. This is shown in fig. 2 where it can be seen how the meniscuses are just separated. In popular terms it could be stated that moisture transported into the wall by diffusion is transported away from the zone with critical moisture content by means of capillary forces as no vapour barrier is used.

This partly wetted zone has of course a smaller thermal resistance (may be one third) but even with a moderate insulation thickness the total thermal resistance is in most cases acceptable – especially if the problem mainly is to avoid condensation and mould growth on the surface.

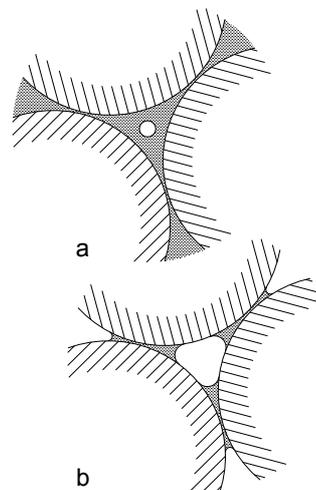
Fig. 2. Critical moisture content.  
 a. Menisci filled, moisture transport possible  
 b. Menisci not filled, moisture transport not possible
