Performance of the Low-energy House in Sisimiut.

Published in:
COLD CLIMATE HVAC 2009

Performance of the Low-energy House in Sisimiut

SUMMARY

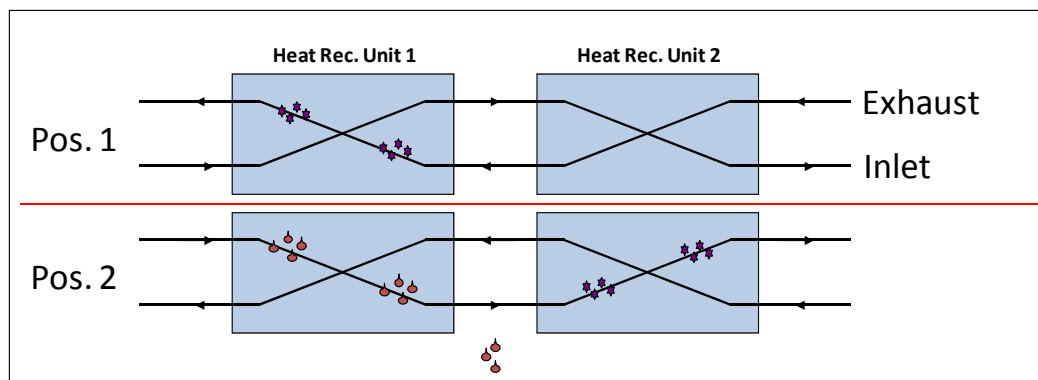
Figure 2. Diagram of the heat recovery unit with two heat exchangers.

A new heat recovery unit was developed for the low-energy house in Sisimiut in cooperation between EXHAUSTO A/S and the Technical University of Denmark. The dimensions of the unit are: Length 1,760 mm, width 930 mm and height 660 mm. The unit consists of two highly efficient aluminium counter flow heat exchangers coupled in a serial connection. A valve is able to switch the air flow direction through the units. When ice formation starts to reduce the airflow in the coldest exchanger the air flow direction is switched. The exchangers, valve and filters are mounted in a cabinet with 50 mm insulation, although the unit is recommended to be placed in a heated place to minimize risks of frost damages from the condensing water. The theoretical temperature efficiency of the heat recovery unit is approximately 90 %. A diagram of the system is shown in Figure 2.

The heat recovery system has in some periods been blocked by ice. Beginning ice formation in the system has had the effect to impair the cyclic change of the order of the two parts of the heat recovery system, so the defrosting function has not been fully functional, and the frosting situation has gotten worse. In October 2006, an insulated box was built around the heat exchanger unit, and an electric heater ensured heating of the air around the box to a temperature that approaches normal indoor air temperature. However this initiative has not eliminated the problem, and the temperature efficiency of the heat exchanger remains around 50% (in some periods only 30%), while the system was expected to have an efficiency of 80% (Rode et al., 2007 and 2008). Wasted energy by insufficient heat recovery (estimate): 30% of ventilation heat loss = approximately 25 kWh/m².

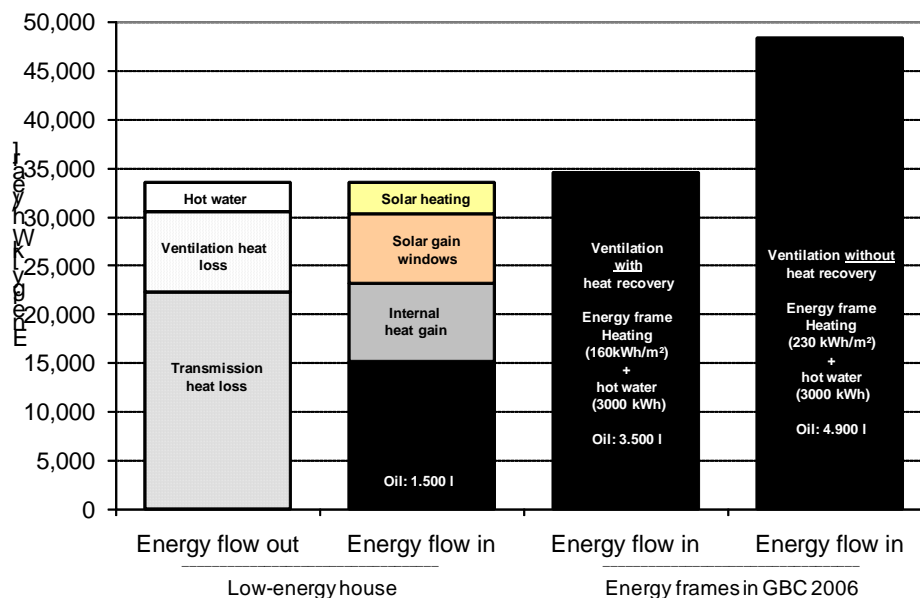
Figure 3. Energy balance of the 197 m² low-energy house compared with the demands of the Greenlandic building code.

A calculation model has been set up in the thermal building analysis tool *B_{Sim}* (B_{Sim} 2009) to analyse the energy performance of the house. As the low-energy house is a double house made of two equal houses with common scullery/boiler room and entrance hall, the calculation model is simplified to only one of the two halves. Figure 3 shows the calculated contributions to the energy balance of the low-energy house. In the calculations, the heating set point temperature was 21 °C in all rooms except the two bathrooms where 23 °C were used. The assumed internal heat gain was 5 W/m² and the infiltration was 0.1 h⁻¹. The total ventilation rate was 45 l/s as required by the building code.

The results are compared with the expected energy frame demands in the building code of Greenland. For a house with a mechanical ventilation system with or without heat recovery the energy frame demands are set to 160 and 230 kWh/m² respectively. It is seen that the energy consumption is simulated to be approximately 1,500 litres of oil per year. Compared with the energy frames of the building code it is seen that more than 3,000 litres of oil are saved every year. The simulation results show that the annual energy consumption of the low-energy house is below the target of 80 kWh/m² (Kragh et al., 2005).

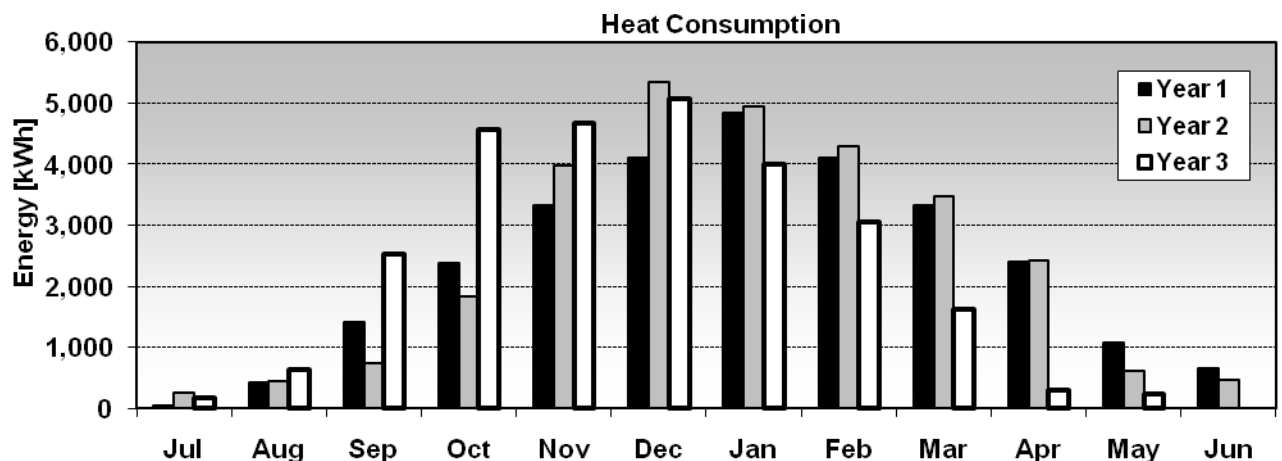
Figure 4. Heat consumption during the months of the first three full years of operation.

Figure 4 shows the monthly energy consumption for heating (exclusive of domestic hot water), where year 1 is for the period July 2005 – June 2006. The house has not been inhabited during the period July 2007 – April 2008 during which period the house underwent some renovation activities: A separation wall was erected in the boiler room, and the wooden floor of the living rooms was changed because of a failure with the first delivered floor. The house was heated during the construction period, although in a somewhat unusual pattern.

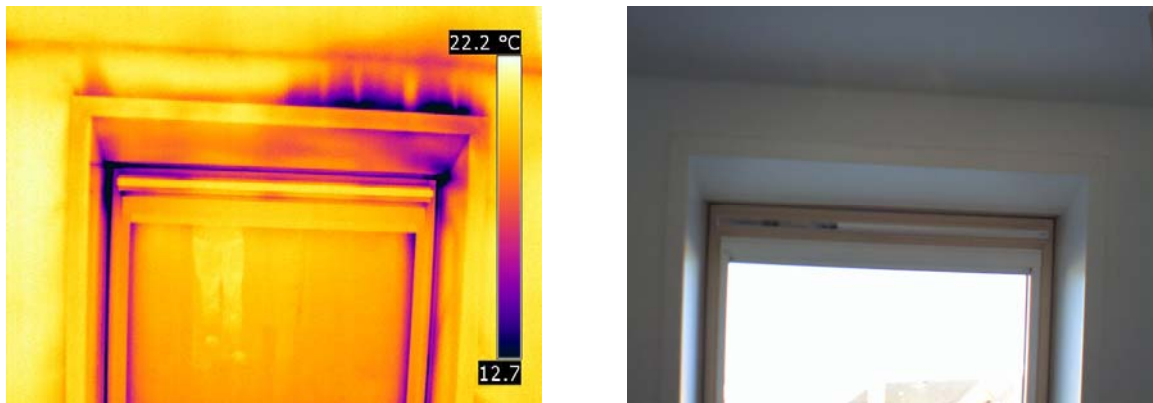
Figure 5. Infrared and normal picture of north-west facing window taken during blower door test.

A so-called blower door test has been carried out on February 7, 2009. The test showed an average leakage of 3.2 h^{-1} measured at 50 Pa over- and under-pressure. While this air leakage is not too high compared to the Greenlandic Building Code, since there are no requirements, it is significantly above the requirement imposed since 2006 in the Danish Building Code, that the air change must not exceed 1.5 h^{-1} when measured at 50 Pa pressure difference. Problem areas were identified around windows, at floor joints, at electrical outlets, and possibly under the floor (see Figure 5).

For a building which is not in a sheltered environment, it can be expected that the free air change due to infiltration/exfiltration, n_{inf} is around 10% of n_{50} (DIN, 2003) and thus infiltration/exfiltration in the house can be expected to be around 0.32 h^{-1} . The volume of air in the building is 530 m^3 , and thus the annual ventilation heat loss associated with this air change can be estimated to be 68 kWh/m^2 (based on the average outdoor temperature: -3.9°C). The assumption when designing the house was that the infiltration/exfiltration air flow would be only 0.1 h^{-1} , and thus the annual extra energy consumption due to poor air tightness of the building envelope, amounts to approximately 45 kWh/m^2 .
