To upgrade or not to upgrade

Issues for consideration upgrading old apartment buildings

Published in:
Proceedings of 8th Nordic Passive House Conference PHN17

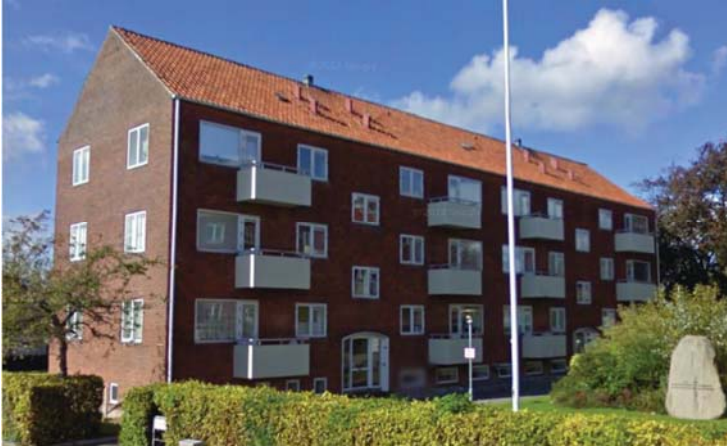
Figure 1. Multi-storey building with apartments constructed between 1945 and 1955.

the basement, 2.8 m at the ground floor and 1st floor and 2.75 m at the 2nd floor. There are 34 windows, each 1.45 m wide and 1.21 m high; 24 windows, each 1.65 m wide and 1.35 m high and 24 windows, each 0.88 m wide and 2.14 m high. The basement has 12 windows, each 0.65 m wide and 0.65 m high, 12 windows, each 1.45 m wide and 0.65 m high, 2 doors with double doors with windows, each 2.7 m wide and 2.14 m high, 2 lift doors, each 1.45 m wide and 2.14 m high and 2 basement doors, each 1.01 m wide and 2.14 m high, see Fig. 1.

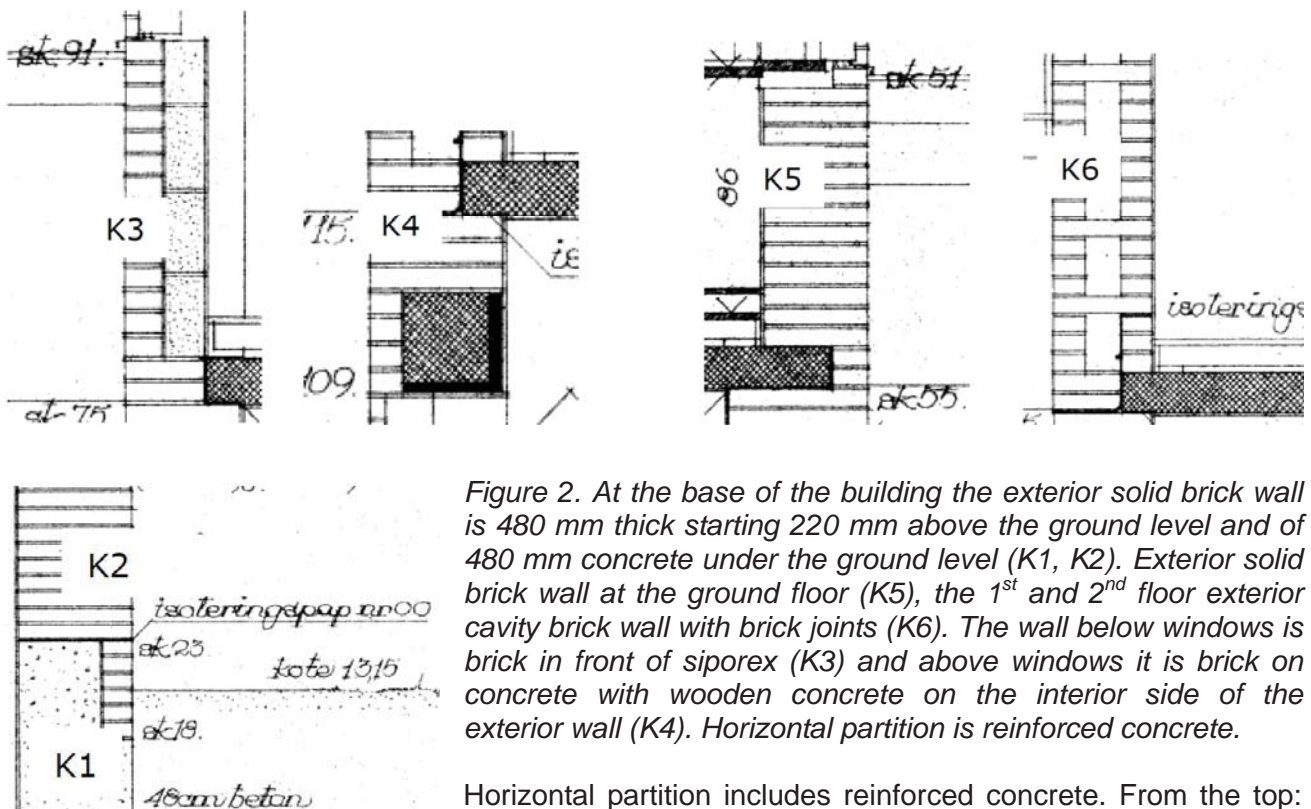
Figure 2. At the base of the building the exterior solid brick wall is 480 mm thick starting 220 mm above the ground level and of 480 mm concrete under the ground level (K1, K2). Exterior solid brick wall at the ground floor (K5), the 1st and 2nd floor exterior cavity brick wall with brick joints (K6). The wall below windows is brick in front of siporex (K3) and above windows it is brick on concrete with wooden concrete on the interior side of the exterior wall (K4). Horizontal partition is reinforced concrete.

solid brick wall at the ground floor, the 1st and 2nd floors have an exterior cavity brick wall with brick joints and a cavity of 144 mm. Horizontal partition consists of reinforced concrete that is 150 mm thick. The brickwork of the exterior wall is three bricks in thickness. At the base of the building, the exterior solid brick wall is 480 mm thick starting 220 mm above the ground level and of 480 mm concrete under the ground level. The reinforced concrete deck reaches into the brick wall. The wall below the windows is one brick in front of 125 mm siporex and the wall above windows consists of 80 mm brick on 240 mm concrete with 30 mm wooden concrete on the interior side of the exterior wall, see Fig. 2.

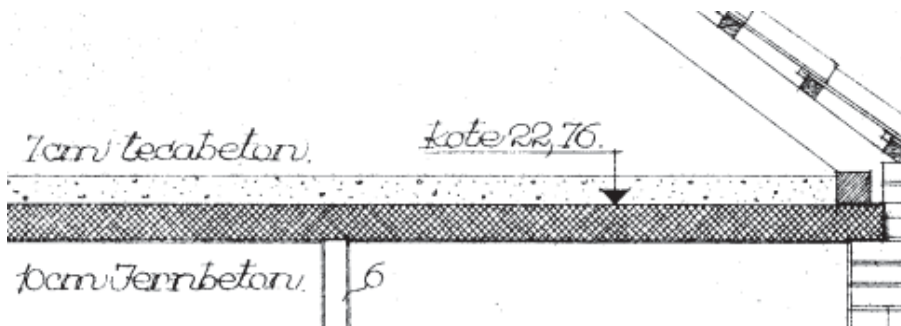
Figure 3. Horizontal partition towards the attic room. From the top: Thermal insulation consisting of Leca concrete, reinforced concrete and a layer of plaster.

and a layer of plaster. The building has a cold attic room. The roof is a double-pitched roof with a 35 degree angle. The vertical section of the junction between the bases of the roof at the load-bearing exterior wall at the facade is shown in Fig. 3. Horizontal partition towards the attic room includes reinforced concrete. From the top: Thermal insulation consisted of 70 mm Leca concrete, 100 mm reinforced concrete and a layer of plaster.

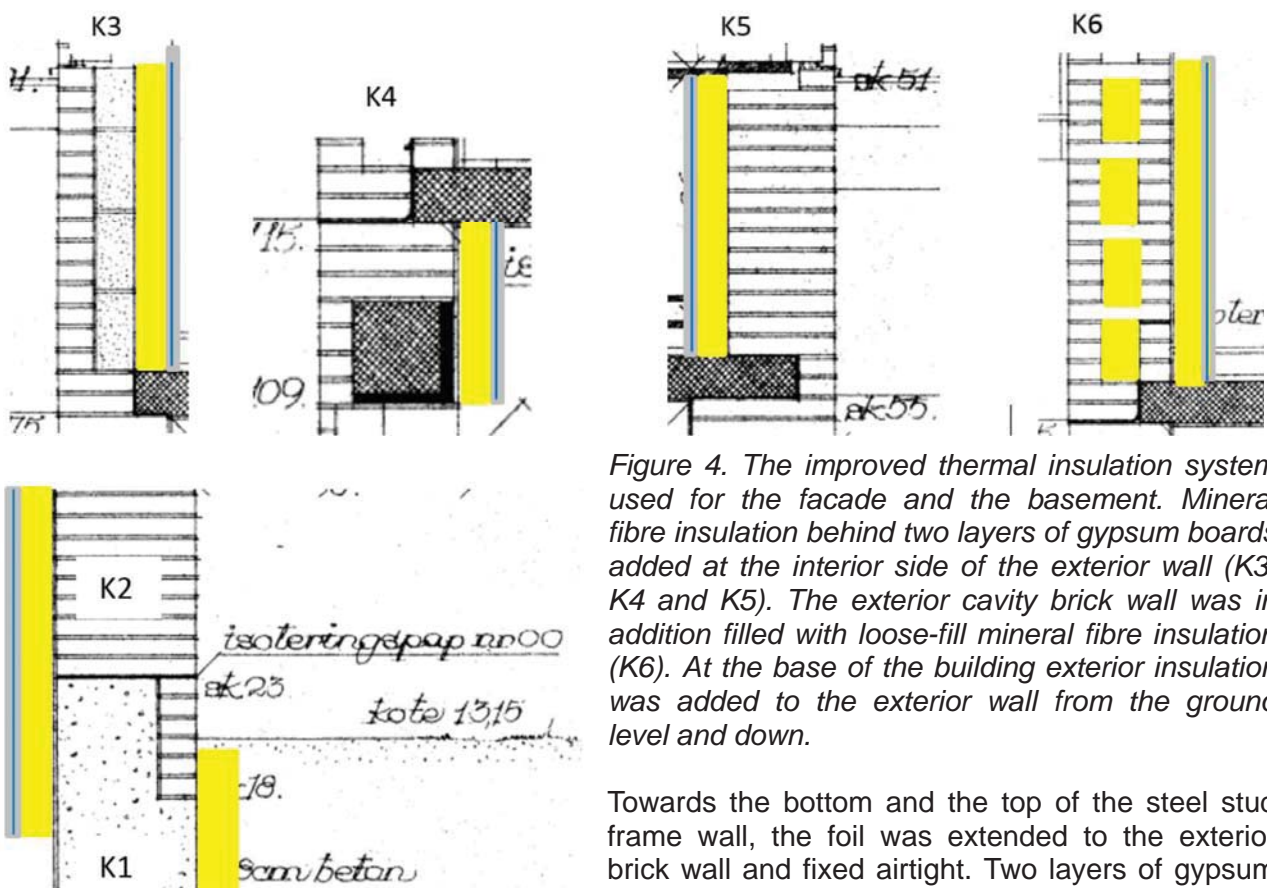
Figure 4. The improved thermal insulation system used for the facade and the basement. Mineral fibre insulation behind two layers of gypsum boards added at the interior side of the exterior wall (K3, K4 and K5). The exterior cavity brick wall was in addition filled with loose-fill mineral fibre insulation (K6). At the base of the building exterior insulation was added to the exterior wall from the ground level and down.

Fig. 4 shows the improved thermal insulation system that was used for the facade, which consisted of a steel stud frame with 50 mm mineral fibre insulation. The thermal conductivity of the mineral fibre insulation was 0.030 W/mK. The thermal conductivity of the steel stud was 55 W/mK. The steel stud frame was attached to the exterior wall between the individual floors of the building with a distance of 450 mm. The cavity between the steel stud frame and the exterior wall was filled with mineral fibre insulation. To prevent air and moisture from penetrating into the insulated exterior wall from the inside, an airtight shell was established by a 0.2 mm polyethylene foil that also served as a vapour barrier. It was crucial that the foil was located on the warm side of the dew point and that the joints between the sheets of foil and joints were airtight and securely fixed [10].

Towards the bottom and the top of the steel stud frame wall, the foil was extended to the exterior brick wall and fixed airtight. Two layers of gypsum boards 12.5 mm thick were added as the new interior side of the exterior wall (K3, K4 and K5). The plaster at the ceiling was intact and without cracks. The exterior cavity brick wall was filled with loose-fill mineral fibre insulation (K6). The thermal conductivity of the loose-fill mineral fibre insulation was 0.038 W/mK. At the base of the building, 150 mm thermal insulation was added at the exterior side of the exterior wall from ground level and down. The thermal conductivity of the insulation material used under the ground was 0.041 W/mK (K1, K2). Improvement of the thermal insulation towards the cold attic room was carried out by adding 500 mm mineral fibre insulation on top of the leca-concrete. The thermal conductivity of the insulation was 0.030 W/mK. To prevent air and moisture from penetrating into the insulated attic room from the inside, an airtight shell was established using a 0.2 mm polyethylene foil that also served as the vapour barrier at the sealing. It was crucial that the foil was located at the warm side of the dew point and that the joints between the sheets of foil and joints were airtight and securely fixed [10]. One layer of gypsum boards 12.5 mm thick was mounted as

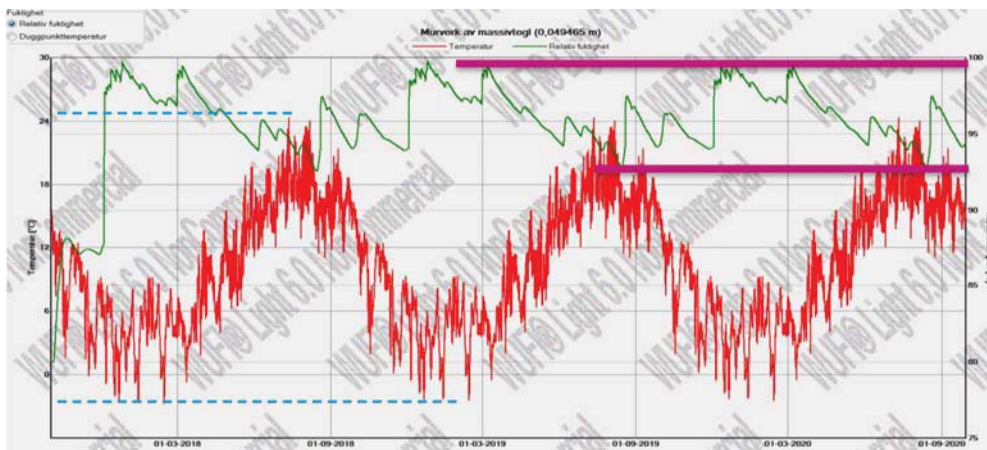
Figure 5. A WUFI Light calculation of the moisture content in the original exterior wall denoted, K3.

Results are shown for calculations at a point located 50 mm into the brick wall, measured from the outside. Markings of the highest and the lowest relative air

humidity, RH are shown as thick red lines and the highest and the lowest temperature are marked with dotted blue lines. The relative air humidity is seen to stabilise between 92% RH and 99% RH; the temperature ranges between -3 degrees Celsius and 24 degrees Celsius. Further into the wall, 180 mm, the relative air humidity stabilises between 92% RH and 95% RH with a temperature ranging between 4 and 22 degrees Celsius. Even further into the wall, 50 mm from the inside, the relative air humidity stabilises between 88% and 92% RH with a temperature ranging between 11 and 22 degrees Celsius.

WUFI Light was used to determine the moisture content in the exterior walls. Figure 5 shows the result of calculations over a 3-year period on the original exterior wall denoted K3. Simulations included load from driving rain. Simulations were carried out for the southern facade.

Surprisingly, the improvement of the indoor climate by upgrading the building is seen to cause concerns for the original construction shown by the WUFI Light [13] calculations. The moisture content and temperature was calculated with the PC program WUFI Light. The driving rain was taken into account for the calculations and they were carried out for the southern facade. Calculations show that for all the types of walls K3, K4, K5 and K6 used in the building, the moisture content increases in the masonry with the upgrading initiatives. The moisture level was seen to increase and reach a level over 90% RH, even reaching 100% RH. Combined with the decreases in drying potential and a colder exterior wall the risk of frost damage will increase. Upgrading will increase the risk of degradation of the exterior side of the exterior wall.
