ICCCM'07 : Proceedings of the 2nd International Conference on Coastal Conservation and Management in the Atlantic and Mediterranean

A HOLISTIC EVALUATION OF A TYPICAL COAST NOURISHMENT ON THE DANISH WEST COAST

The case described in this article regards 4.7 km of beach in Ferring, situated approx. 5 km south to the mouth of the Limfjord strait on the west coast of Denmark. In 2005, this section of the beach was nourished with 721,000 m³ of material in order to protect backshore properties, natural heritages and the recreational value of the beach. After the nourishment, the beach was monitored by levelling profiles on four dates to monitor and track the evolution of the nourished material. Furthermore, laboratory tests involving different gradations of nourishment material are shown which indicate solutions to different kinds of coastal protection strategies, estimate the time in between two nourishments and evaluate the cost of maintaining a beach with a high recreational value for the public.

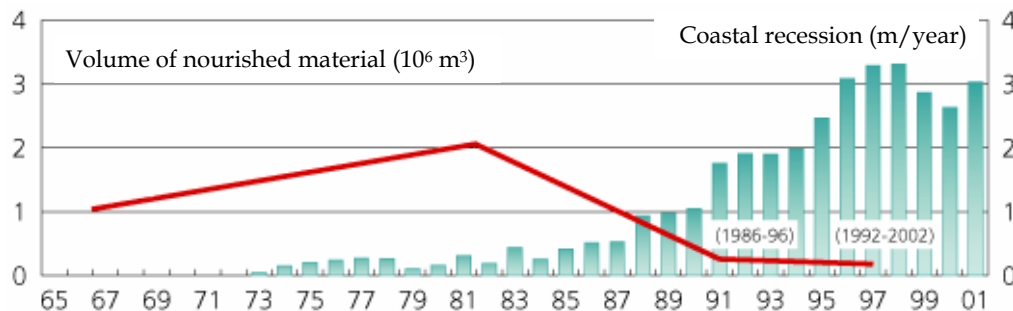
Figure 1. Effect of volume of coast nourishment (bars) applied on coastal erosion (red line) 1966-2001 (Danish Coastal Authority 2007).

Parts of the Danish West Coast are severely eroded and are at present undergoing coastal erosion. Starting in 1875 around 100 groins has been placed in order to protect the coast line (Kystdirektoratet 2005). This kind of system has not been working to well, so new ways of battling coastal recession, together with a change in the common perception of Nature, were invented and applied. This resulted in the realization of the first coast nourishment back in the early 1970'ies (Figure 1).

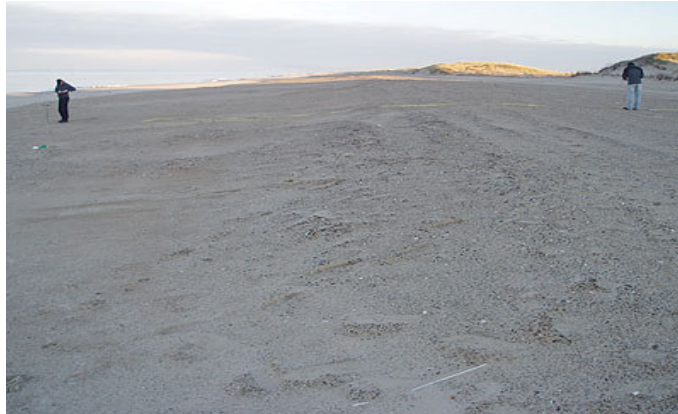
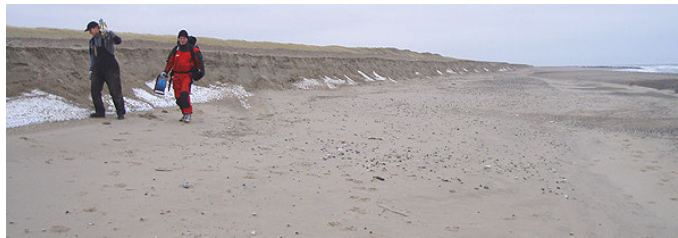
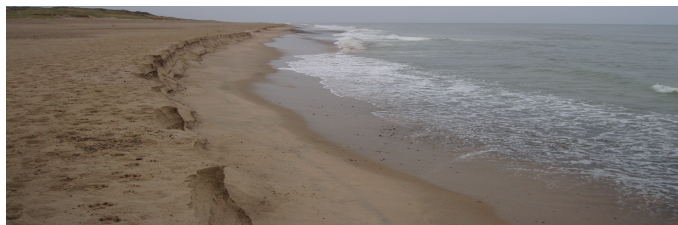
Figure 2. Beach development: gentle slope leading to the shore generates in a dangerous and ugly cliff.

Figure 2 gives examples of the development of the coast nourishment at Ferring. The top photo shows a nice gentle slope beach with characteristics as wanted, while the 2 other photos show an example of the unwanted local cliffs and progressing degradation of the beach. The stick is indicating 1 m height, as much as the vertical extension of the specific slope.

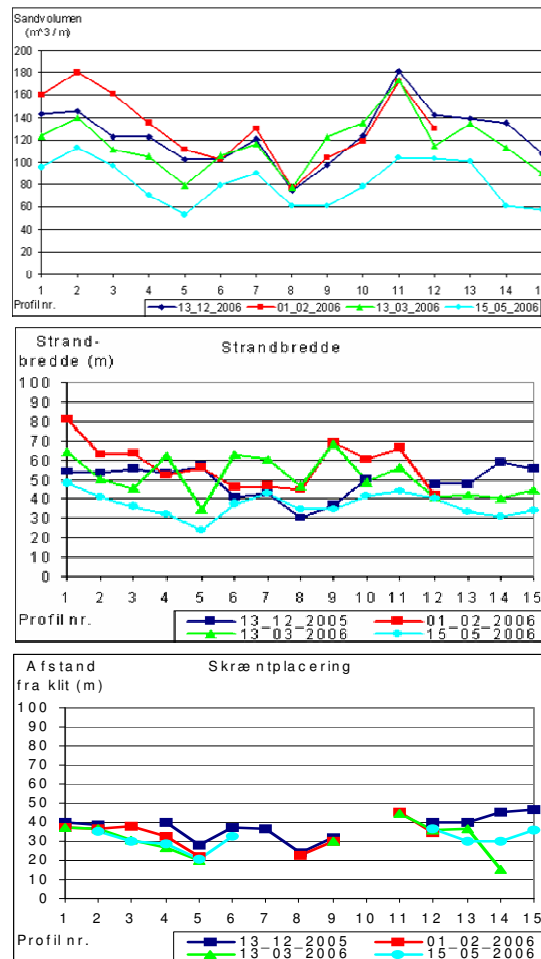
Figure 3. Behavior of the nourishment with regard to the eroded volume in m³/m (top), regression of the shore line (middle) and the movements of the cliff (bottom).

The data presented in figure 3 show a considerable regression of the shore line and a reduction of the beach volume of approx. 40 m³/m after the winter (Figure 3, top). In a condition where 32% of the initial nourishment is lost after a typical winter, its life time is expected to be only 3- 5 years. In fact, the beach becomes more and more narrow (Figure 3, middle) and after such a period, a new nourishment must be planned. The development of a cliff occurs immediately and the cliff then moves further inland with the protruding regression of the beach (Figure 3, bottom).

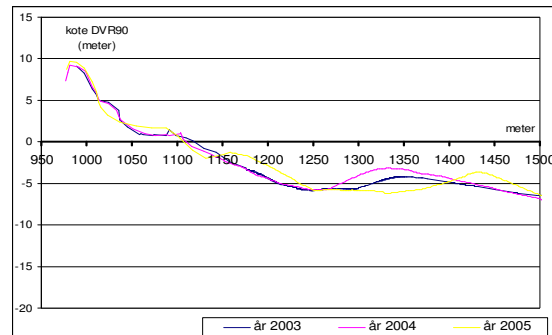
Figure 4. Scanned profiles of the beach at Ferring site (Holmgren et al. 2006b).

In the year of the nourishment (2005) the profile of the beach has been scanned and compared to the profile of the beach of 2004 and 2003 (Figure 4). It is obvious that the eroded volumes deposit just a few meters in the water, creating a very close to shore bank and probably moving the 1,300 m bank to 1,430 m. In this way the bathymetry of the littoral has been changed by the coastal nourishment

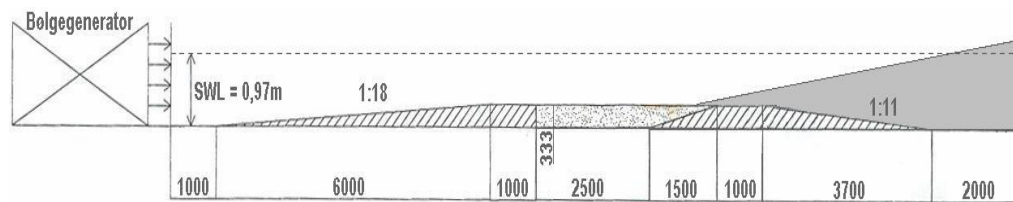
Figure 5. Flume equipped with wave generator (left) and beach settings (right) for the experiments (Holmgren et al. 2006a).

The tests have been realized in an 18 m long and 1 m deep flume equipped with wave generator (Figure 5). At and end of it the desired profile of the beach was reproduced using layers of different sands in order to Laboratory tests have been made in order to investigate the life time of nourishments exhibiting different gradation at Ferring. This was made by changing the medium grain size distribution (d_{50}) of the sand and the profiles volumes (i.e. initial beach slope). For different wave conditions corresponding to small waves, medium and storm waves, and the damage of the protection was been measured and monitored.

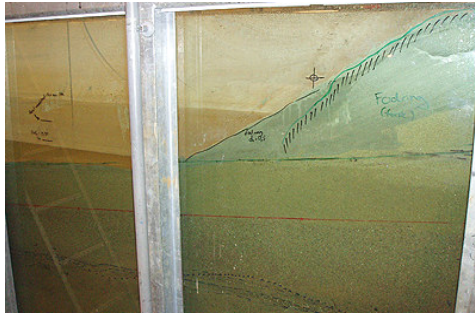
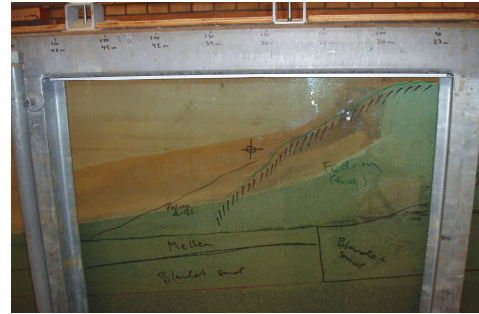
Figure 6. Profile of the beach before (left) and after (right) the test, (Holmgren et al. 2006a).

Measurements have been done at the beginning and at the end of each test (Figure 6). A laser profiler mounted on rails on the flume enabled the estimation of the damage to the protection (Figure 7 left). The laser profiler can plot the results of the profile measurements in real time and constitutes a user friendly interface with the EPro software. In a second time it is possible to calculate the damage in terms of lost volumes to the protection (Figure 7 right). Waves have been measured by wave gauges and generated by AwaSys 5.

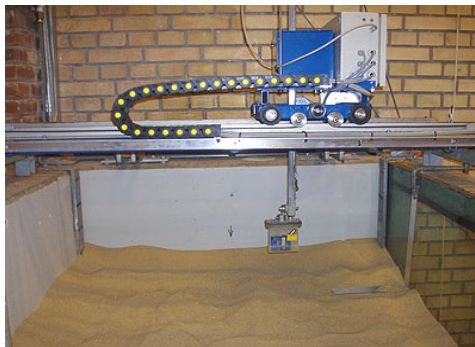
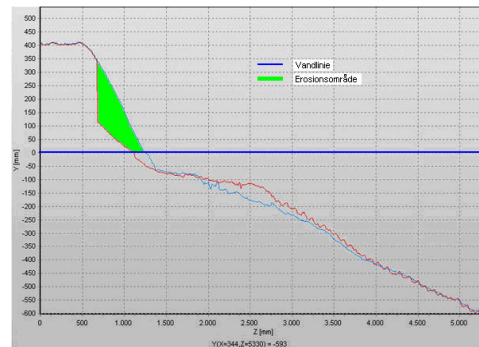
Figure 7. The laser profile and a measurement of the eroded area (section). (Holmgren et al. 2006a).

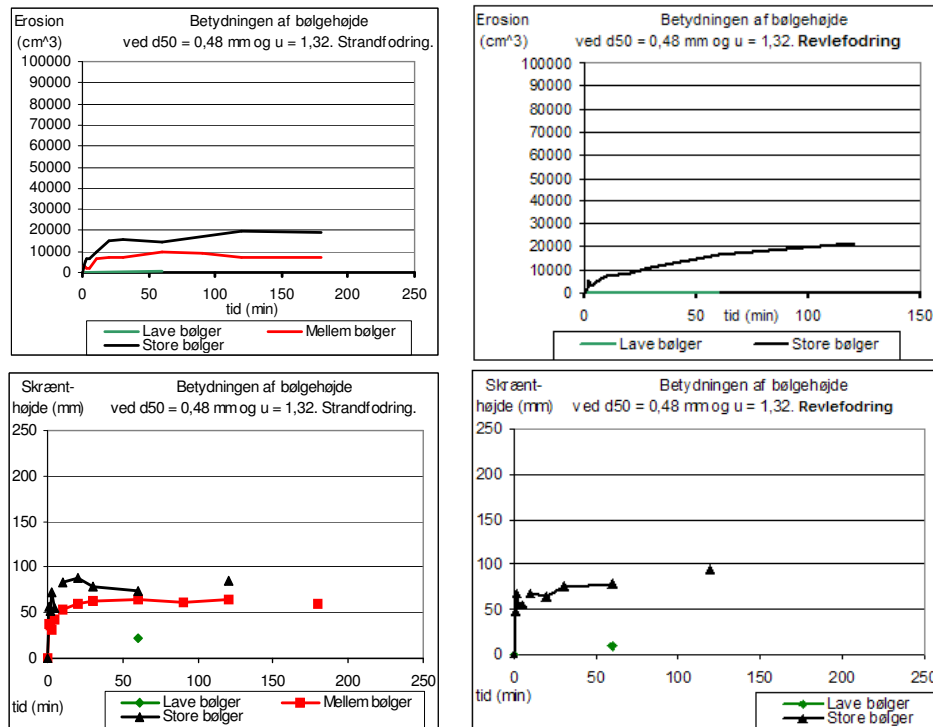
Figure 8. Laboratory results of erosion in volumes (top) and height (down) for the beach (left) and for the sandbanks (right) for a mix sand.

In figure 8 the erosion of the nourishment on the beach (left) and on the sandbanks (right) is reported. On the top, the eroded volumes under small, medium and storm wave regimes for the mixed sand nourishment ($d_{50} = 0.48$ mm and $d_{50} = 1.32$ mm in equal parts) appear to increase constantly on the beach. As it is obvious, the higher erosion occurs for storm waves. On the lower graphics, the height of the erosion is plotted against time. It seems as if the erosion of the sandbank reaches the equilibrium before the erosion on the beach.

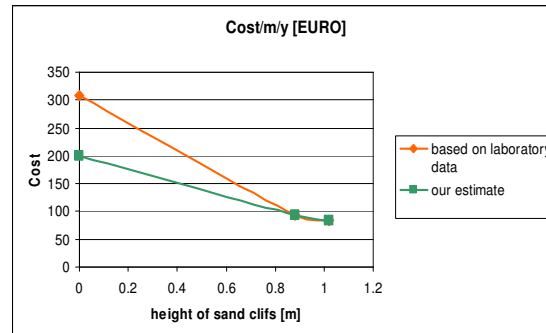
Figure 9. Cost per meter per year for a more efficient nourishment taking into account scale effects.

In figure 9 the cost per meter per year of different nourishments is plotted; the upper curve represents the cost of nourishment works derived from laboratory measurements of eroded volumes of sand, while the lower one is the estimation that takes into account a correction for scale effects on experimental measured eroded volumes.

It appears that in order to avoid the formation of the cliff, the investment on the nourishment work should be twice the actual investment that actually allows the formation of the cliff up to 1 m height. This cost is estimated to be around 200 Euro par meter par year.
