## **CLIMA 2016 - proceedings of the 12th REHVA World Congress**

# Humidity Control to Reduce the Degradation Risks of Manuscripts in Necip Paşa Library Tire-İzmir, Turkey

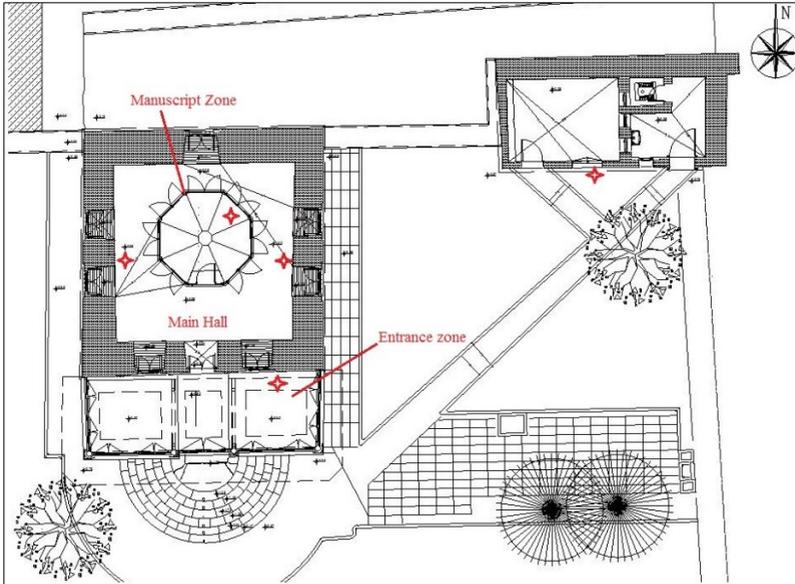
Fig 1. Schematic view of *Necip Paşa Library*

an entrance and a manuscript zone which is located inside of the main hall (Fig 1). The library lies on north-south direction. The thickness of external walls change between 1.08 and 1.25 m. The dome shaped roof was constructed with lead covered brickwork. All windows of the library were single glazed with wooden frames. The main hall and manuscript zone have no HVAC system, while an air conditioner heats and cools the entrance where administrator's office is located. The main hall and manuscript zone receive a small number of visitors on weekdays (Fig 1).

Indoor and outdoor microclimates of *Necip Paşa Library* were monitored via automatic sensors from 1 September 2014 to 31 August 2015. Five data loggers, which record data with ten minutes intervals, were used to measure T and RH during one year period. Four of them were placed inside of the library while the last one was placed to outside. Locations of the data loggers are given in Fig 1.

The building was modelled by using a BEP tool, DesignBuilder (v 4.2.054). Three zones, which are given in Fig 1, were defined for the BEP model. The library lies on north-south direction and was built 1.5m above from ground. Airtightness value for the library was measured by blower door and found as  $0.5 \text{ h}^{-1}$ . The thickness of external walls, which consist of limestone and brickwork, changes between 1.08 and 1.25 m. The overall heat transfer coefficients are  $1.64 \text{ W/m}^2\text{K}$ ,  $1.76 \text{ W/m}^2\text{K}$  and  $1.89 \text{ W/m}^2\text{K}$  for the south/north, west and east wall, respectively. The roof had a shape of dome, was constructed a lead covered brickwork with the heat transfer coefficient of  $1.51 \text{ W/m}^2\text{K}$ . All windows were modelled as wooden frame single glazing, of which heat transfer

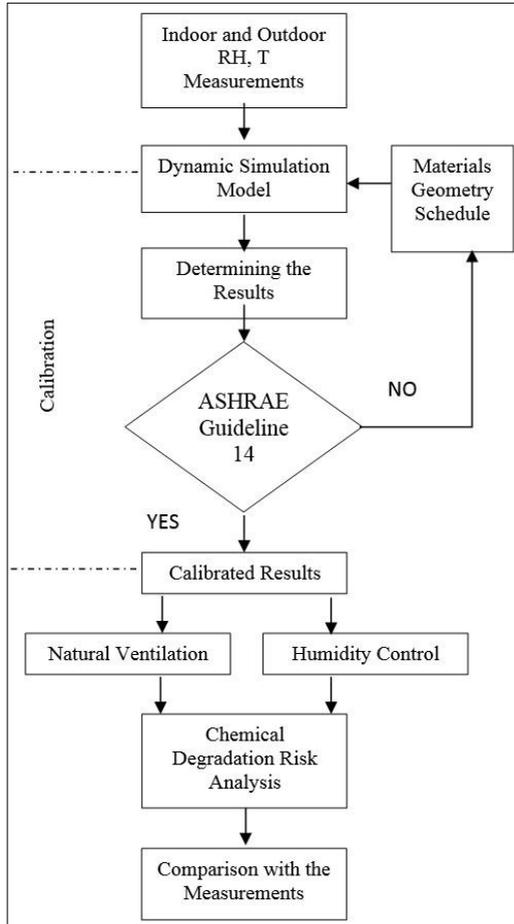
Fig 2. Methodology

In this study, the effect of humidity control and natural ventilation control systems on reducing the chemical degradation risk of manuscripts stored in *Necip Paşa Library* will be investigated. The flow diagram of the methodology is given in Fig 2.

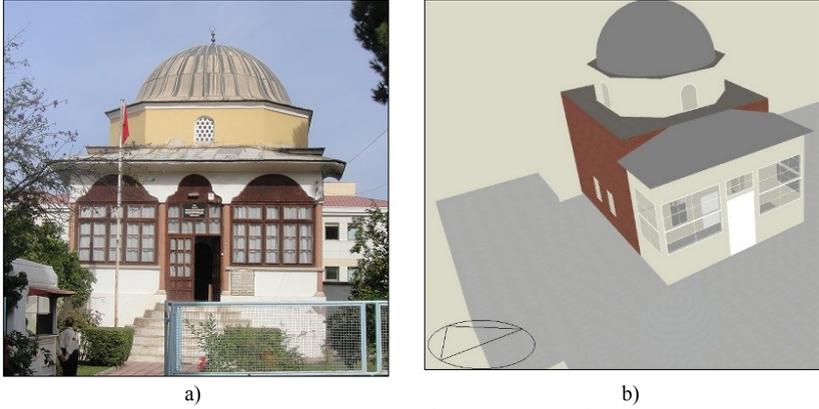
Fig 3. a) South façade and b) BEP model of *Necip Paşa Library*

coefficient is  $5.89 \text{ W/m}^2\text{K}$ . The sections of ground floor for the manuscript zone and main hall are almost same while their heat transfer coefficients are  $1.24 \text{ W/m}^2\text{K}$  and  $1.38 \text{ W/m}^2\text{K}$ , respectively.

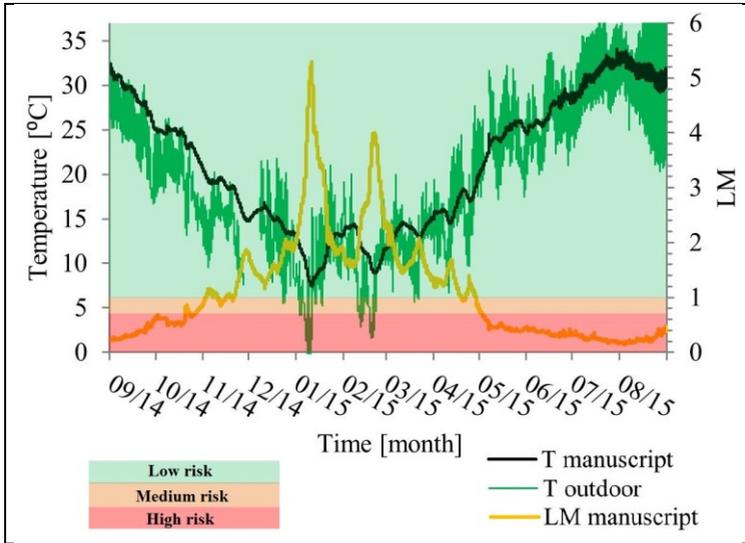
Fig 4. Results of the preliminary study

Fig 4 shows the yearly trend of manuscript zone and outdoor temperature. LM values of manuscripts were calculated using (3) and thermo-hygrometric parameters of manuscript zone and superimposed into the Fig 4 in order to better evaluate the results from the perspective of risk levels of which limits were indicated with representative colors. Therefore, LM values within the green, orange and red area indicate that the manuscripts are under low, medium and high risk of chemical degradation, respectively.

According to the results, the manuscripts are under medium risk of chemical degradation in months; November and April while high risk between May and October. Maximum and minimum temperatures, in the manuscript zone, were measured as 34 °C and 7 °C, respectively while daily T difference above 2K is 2%. Besides, the outdoor T values below the T trend of manuscript zone indicate that the library has a great cooling potential which can be benefited using natural ventilation system.

Humidity control and natural ventilation systems were introduced to the BEP model. Both systems were designed taking into account of the preliminary results which point out that the manuscripts are under high risk of chemical degradation between the dates April 15 and November 1 (Fig. 4). Chemical degradation risk was investigated by the parameter named Lifetime Multiplier (LM) which corresponds to the number of time spans an object remains usable when compared to indoor climate of 20 °C and 50 %RH [4,5]. LM values below 0.75 and over 1 refer to high and low risk, respectively while those are in between correspond to medium risk of degradation [5]. In order to make a general statement over the LM results, an equivalent value (*eLM*) that represents the average of reciprocal values of LM can be used. Equation (3) and (4) can be used to calculate the LM and *eLM*, respectively:

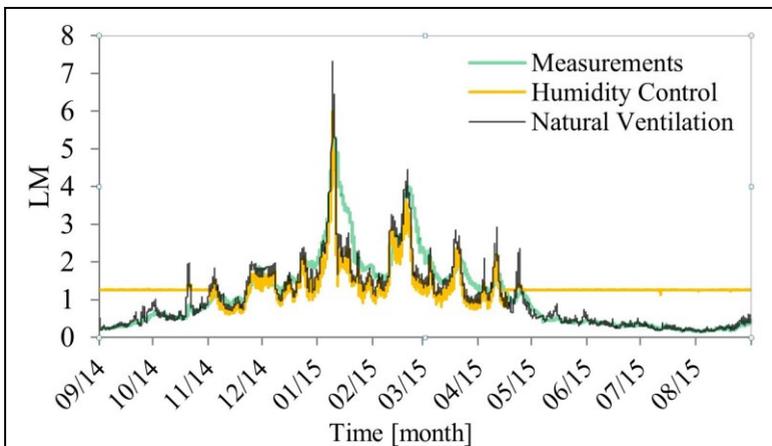
Fig 5. Comparison of the measures

Fig 5 illustrates the results of chemical degradation risk analysis of humidity control and natural ventilation systems. LM values were superimposed to make comparison of each measurements.

For each measures,  $eLM$  values of one year performance were calculated with eqn. (4) and found as 0.54 for measurements, 1.27 for humidity control and 0.55 for natural ventilation system. Results point out that the humidity control system prevents high risk of chemical degradation throughout the risky period (April 15-November 1) while natural ventilation system introduces relatively worse solution to the library.

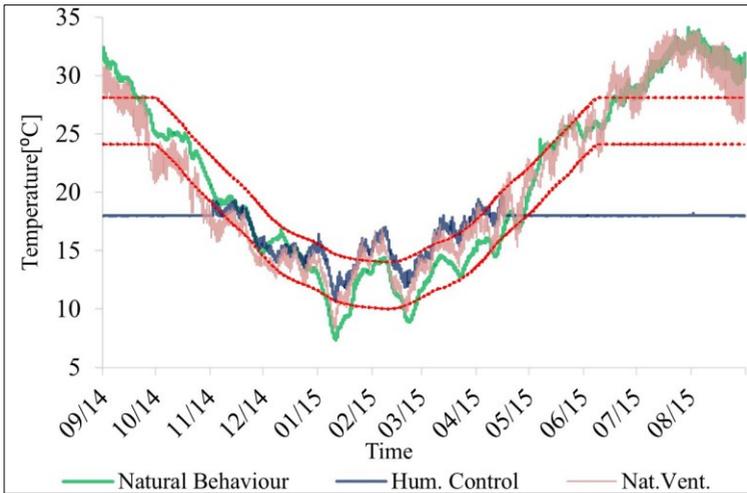
Fig 6. Comparison of the measures according to ASHRAE climate class, As

Fig 6 illustrates the results of indoor climate risk assessment for natural ventilation and humidity control system. The red dotted lines represent the maximum and minimum thresholds of the bandwidth which was calculated according to the ASHRAE climate class of As [5]. It is claimed that temperatures outside of the bandwidth can cause degradations on the manuscripts.

Fig 6 indicates that natural behavior of the microclimate of manuscript zone exceeded the maximum threshold around summer season. The results of natural behavior of manuscript zone show that T trend is within the bandwidth of 63% while natural ventilation and humidity control systems perform with the value of 52% and 35%, respectively.
