High-Resolution Structure-from-Motion for Quantitative Measurement of Leading-Edge Roughness

Published in:
Energies

High-resolution Structure-from-Motion for quantitative measurement of leading edge roughness

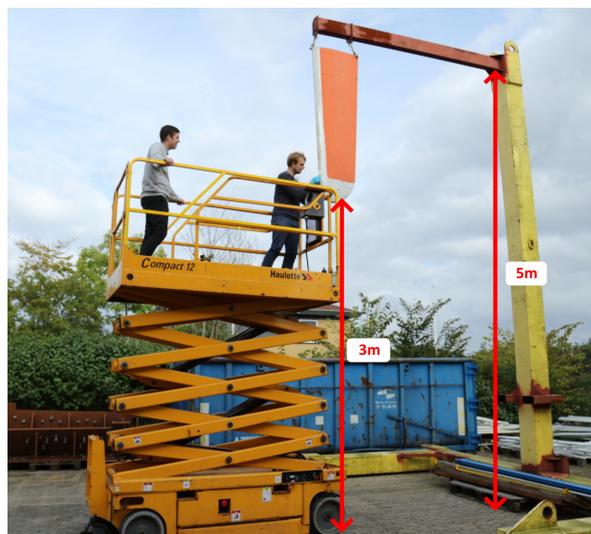
Figure 1. The wind turbine blade segment positioned on the built gantry, together with the scissor lift used for capturing image and replica data.

100 For inspection of a wind turbine in operation, we envision that the turbine is stopped with the
101 inspected blade in a vertical position. To simulate this, the blade was mounted vertically in a gantry,
102 which was welded together for the purpose of this work. To include the effect of oscillations, chain
103 links were used to fix the blade mock-up to the gantry, which let the blade segment move freely in the
104 wind. The height of the gantry was 5 meters, resulting in a distance of 5 meters from the very tip of the
105 blade to the ground. The blade setup on the gantry, together with the scissor lift used to capture all the
106 data for this paper can be seen in Figure 1.

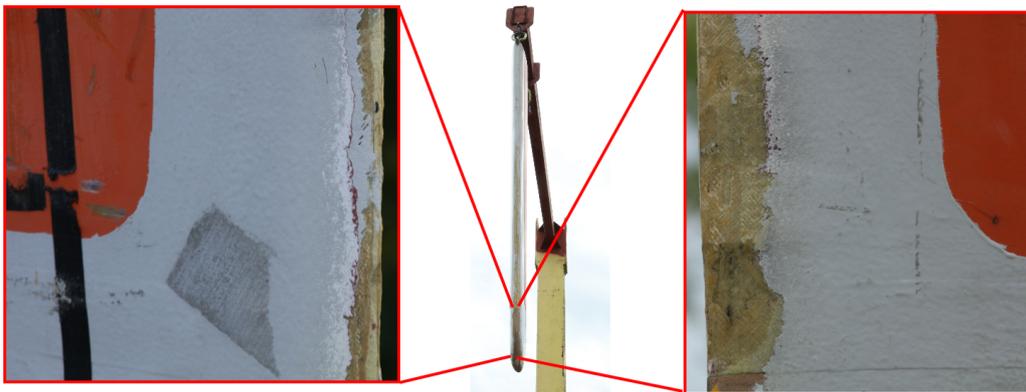
Figure 2. Testing blade together with the region chosen for reconstruction. The zoomed-in parts are of the two sides of the blade

123 For the initial proof-of-principle study, a manual and hand-held image capturing was performed.
 124 A part of the wind turbine blade was chosen that contained a variation in surface topography across
 125 the leading edge - from very rough damaged areas to smoother clean areas. The part of the blade
 126 chosen for 3D reconstruction is shown in Figure 2.

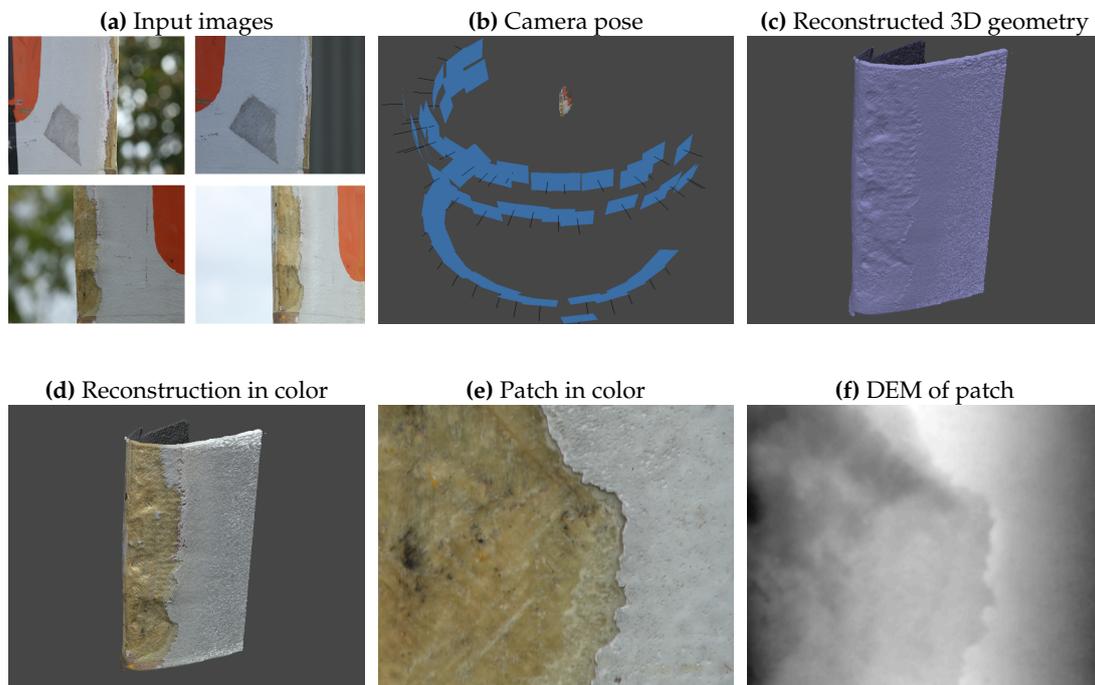
Figure 3. Pipeline for 3D reconstruction using SfM. 3a) Initially, images were acquired at every 10 degrees of a half circle around the wind turbine blade at three different heights and tilt angles. 3b) The camera pose of the images and points on the object surface were then calculated. The reconstructed surface geometry without 3c and with color 3d. Extracted patch from the reconstruction shown as 3e (color) texture and 3f resulting DEM.

149 The captured images 3a were imported to Metashape and a triangulation, feature extraction and
150 matching step were performed to find the camera positions and key feature points from the input
151 images 3b. From these positions and feature points, a sparse point cloud was formed. Next in the
152 reconstruction process a dense point cloud was created and meshed into a triangle mesh 3c. Finally a
153 (color) texture is build from the visual data from the input images 3d.

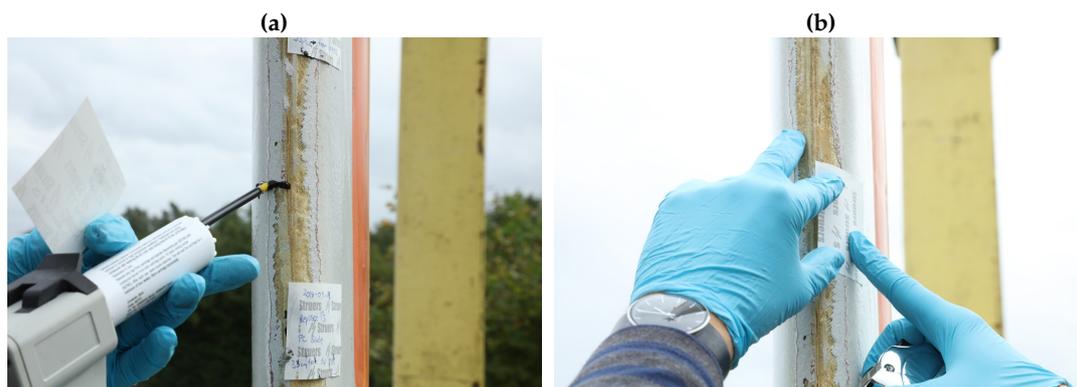
Figure 4. Replication of an area on the blade mock-up. Figure 4a illustrates the application of the combined polymer and curing agent from a static-mixing nozzle. Figure 4b shows the backing paper being attached by applying a gentle force to the replication material.

169 Replication was performed for each of the R1, R2 and R3 areas described in section 2.3. As a
170 replication material with a fast curing time and resolution down to 0.1 μm , Repliset T3 by Struers [61]
171 was selected. In previous studies, the replication of surface textures using Repliset has achieved a
172 sub-micrometer accuracy [55,62]. The RepliSet T3 is a black two-part silicone rubber which consists of
173 a polymer and curing agent. For replication, the two parts were pushed out of the cartridge, mixed in
174 a static-mixing nozzle and applied onto the blade surface 4a. Immediately after application, backing
175 paper was placed on top of the mixture and attached by applying a small force as shown in Figure 4b.
176 The mixture set for 15 minutes and then the replica was removed from the blade surface by hand.

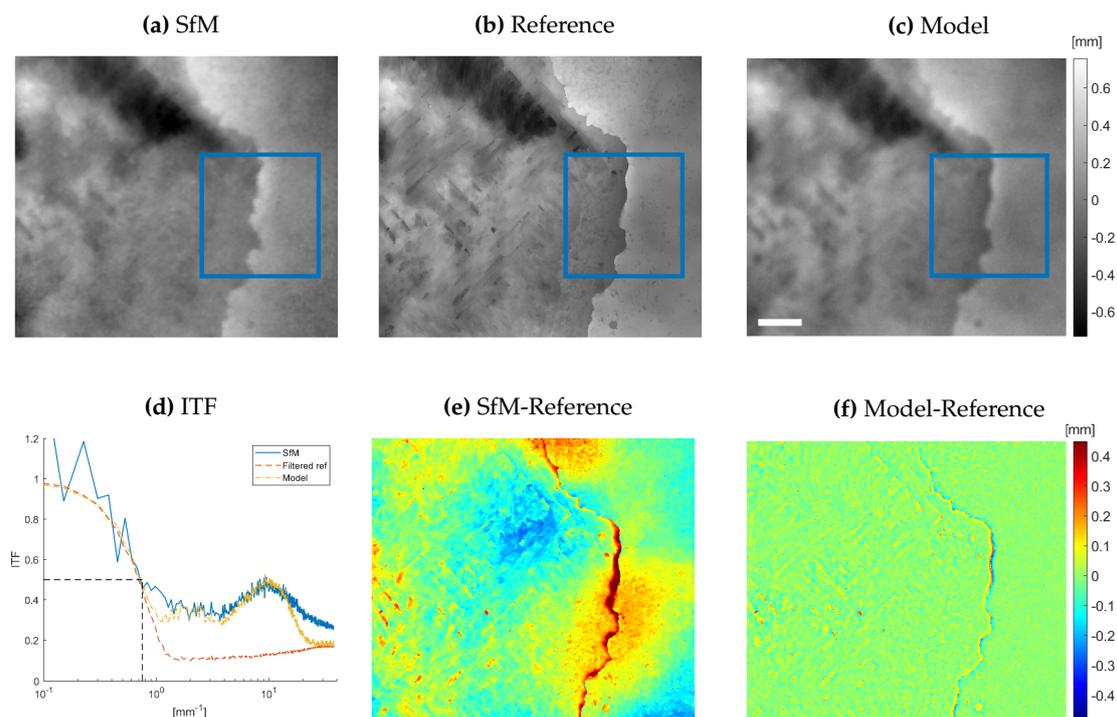
Figure 5. 5a Reference, 5b SfM and 5c model DEM of replication area R1. The blue box indicates the area used for the calculation of ITF50. The scalebar is 5 mm. 5d ITF for SfM and two model curves based on filtering the reference DEM with and without noise added. 5e-5f Residual of SfM and model DEM with respect to reference DEM.

226 The performance of the SfM reconstruction is illustrated in Figure 5. In 5a and 5b, the SfM and
 227 reference DEM of replication area R1 are shown. Both have been processed as described in section
 228 2.6. The blue box indicates the subregion used for the ITF analysis. As seen in panel 5a, the SfM DEM
 229 captures the main topographic features although the resolution is less than for the reference in 5b.
 230 While short wavelength topography variations are missing, holes, edges and the larger glass-fiber
 231 structures are visible in the SfM DEM.

232 The ITF function was calculated from the SfM and Reference DEM of area R1 as described in
 233 section 2.6.1. The ITF was not calculated for R2 and R3 as no height step was present in these areas. In
 234 5d, the ITF function for SfM is shown (blue solid line) with the 50% value indicated in dashed black
 235 lines. As stated in Table 2, the ITF50 spatial wavelength was 1.3 mm.

low-pass filter to the reference DEM. A filter with a FWHM of 0.65 mm was used to give the model DEM the same ITF50 value as the SfM. As seen in Figure 5d, the ITF of the filtered reference (dashed red line) matches the long wavelength values of the SfM ITF. However, at higher frequencies the filtered reference has lower values than the SfM. In a second step, structured noise centered at 0.5 mm and 0.1 mm wavelengths was added (dash-dotted yellow line). The two noise components was constructed through Gaussian low-pass filtering of Gaussian noise with an amplitude selected to match the SfM ITF. In 5c, the model DEM using Gaussian filter and noise added is shown for area R1. Similarly, a model DEM was created for both area R2 and R3 using the same Gaussian FWHM and noise settings.

In Table 2, CCF_{max} and RMSD values for both SfM and model DEM are shown for all replication areas. The CCF_{max} values for the model were close to 1 for all areas. For SfM, the values were >0.9 for both R2 and R3 indicating a very close horizontal spatial resemblance. A slightly smaller value was found for R1. Overall, the CCF_{max} values indicate that an accurate scaling of SfM was obtained. As seen in the table, the RMSD values for SfM are between 0.1-0.2 mm, which is several times larger than the model values between 0.03-0.04 mm. This discrepancy is illustrated in the residuals shown in Figure 5e and 5f. While large differences are observed near sharp edges for both model and SfM DEM, the SfM residuals also contain a waviness that accounts for the larger RMSD value. The waviness has a wavelength in the order of 10 mm which shows up as large variations in the long wavelength part of the ITF in Figure 5d.

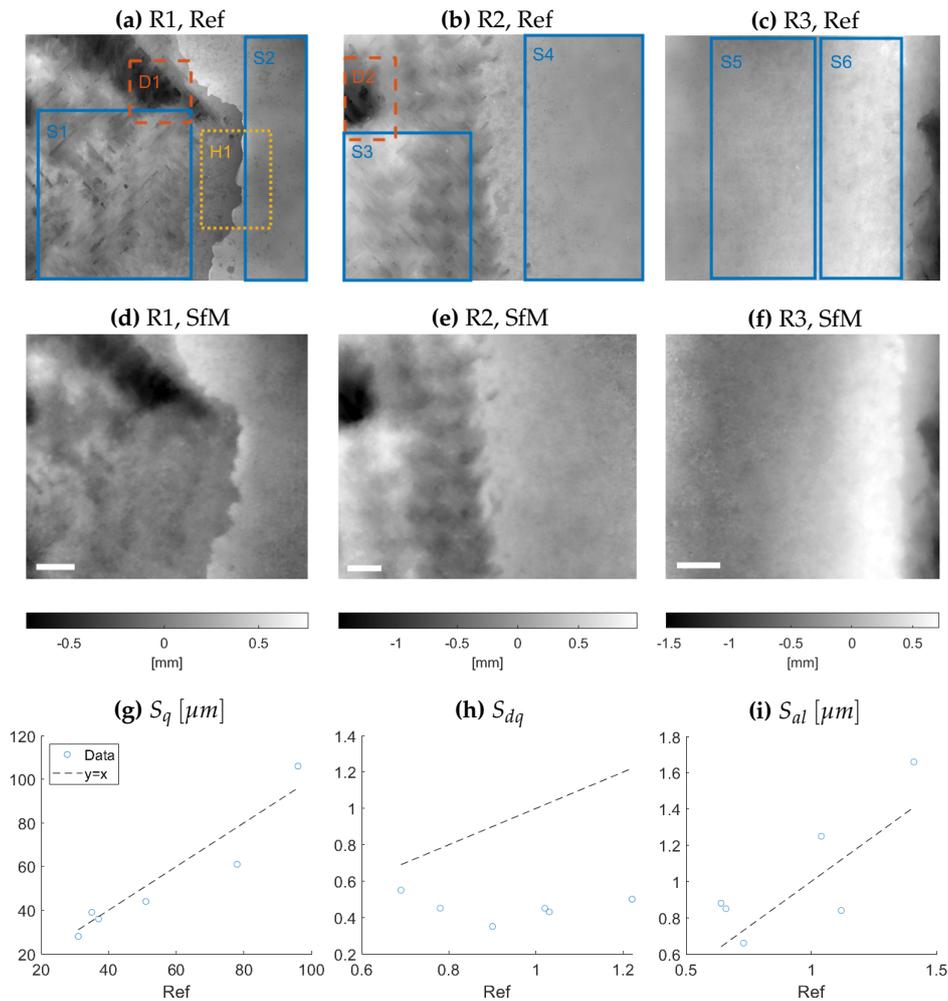
Figure 6. 6a-6c Reference and 6d-6f SfM DEMs of area R1, R2 and R3, respectively, with prior image processing as described in section 2.6. Surface roughness regions S1 to S6 are indicated with solid blue lines. Depressions D1, D2 and ridge H1 are indicated with dashed red and dotted yellow lines, respectively. The scalebar is 5 mm. 6g-6i Scatter plots of SfM and reference values for S_q , S_{dq} and S_{al} , respectively. The dotted line indicates where SfM values are equal to reference values.

To evaluate the surface roughness of the SfM reconstruction, two regions within each of the R1, R2 and R3 areas were selected as shown with blue solid lines in Figure 6a to 6c. Of the six regions named S1 to S6, an extensive erosion of S1 and S3 resulted in a topography dominated by glass-fiber structures while S2, S4, S5 and S6 still had an intact surface coating.

The roughness parameters S_q , S_{dq} and S_{al} were calculated for each of the S1 to S6 regions as described in section 2.6.2. The roughness values for both SfM and reference are shown in Table 3 and illustrated in scatter plots in Figure 6g to 6i. Overall, both SfM and reference values show a larger roughness for the eroded S1 and S3 regions than the regions with intact coating. However, when comparing the three roughness parameters on the scatter plots, some differences are clear. While the SfM values for S_q and S_{al} vary within around 10%-20% of the reference values, the SfM values for S_{dq} are systematically lower than the reference by around 50%. The absolute RMSD deviations for S1 to S6 were 9 μm for S_q , 0.5 for S_{dq} and 0.2 mm for S_{al} .

Three distinctive topographic features were selected in the R1 and R2 areas; Two depressions D1 and D2 (red dashed lines) and a height step H1 (yellow dotted lines) as shown in Figure 6a and 6b. For all features, the depth and height measurements for the SfM DEM are close to the reference as shown in Table 3. The relative deviations between SfM and reference are less than 16%, and the absolute deviations were less than 0.2 mm with an RMSD of 0.1 mm.

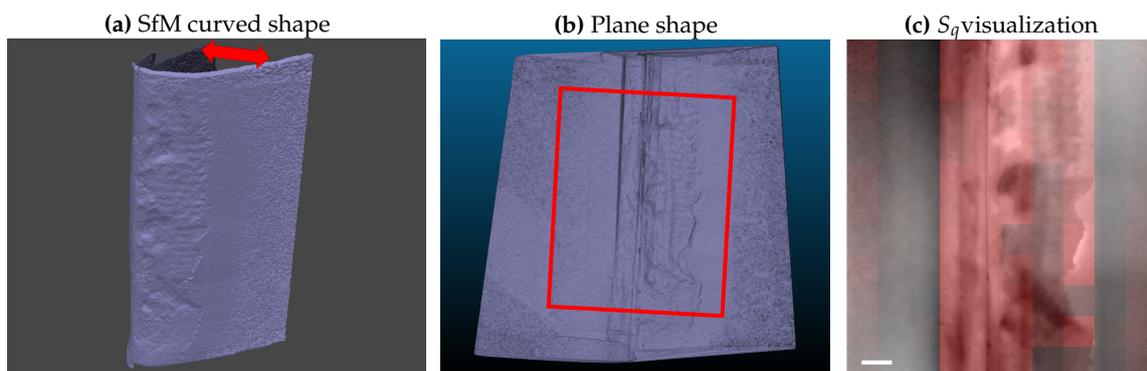
Figure 7. Visualization of LER. The curved blade geometry seen in 7a was unfolded to a flat shape shown in 7b from which a region centered on the LE was selected as indicated by the box. For each $10 \text{mm} \times 10 \text{mm}$ square in the region, the S_q parameter was calculated. In 7c, the strength of the red color indicates the S_q value in each square. The scalebar is 10mm .

299 The potential for using the S_q parameter in quantitative characterization of LER is illustrated in
 300 Figure 7. First, the SfM reconstruction was unfolded to a flat shape and extracted as a DEM using
 301 CloudCompare. A region centered on the LE was selected as indicated with a box in Figure 7b. For
 302 each $10 \text{mm} \times 10 \text{mm}$ square in the region, the S_q parameter was calculated and visualized in red in
 303 Figure 7c. The strength of the red color indicates the S_q value in each square with a lower bound of $20 \mu\text{m}$
 304 (μm (no color) and upper bound of $100 \mu\text{m}$ (color saturated). As seen, the S_q values are low for areas
 305 with the coating still intact, and high along the eroded leading edge. This indicates the potential for
 306 high resolution SfM for quantitative inspection of LER.

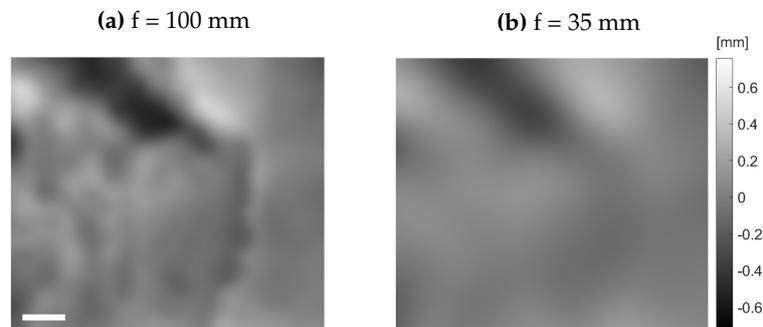
Figure 8. Model DEM of a SfM acquisition of area R1 with 8a 100 mm and 8b 35 mm focal length. The model DEMs were created by Gaussian low-pass filtering of the R1 reference DEM of Figure 5b with FWHM of 1.9 mm and 5.5 mm, respectively. The scalebar is 5 mm.

316 Had the SfM resolution been lower by e.g. using a shorter focal length, the surface roughness
 317 and smaller topographic features would not have been visible. This is illustrated in Figure 8 by a
 318 model DEM of a SfM acquisition of area R1 with a 2 m capturing distance using a 100 mm (8a) or 35
 319 mm (8b) focal length. **These settings correspond to a GSD of 0.08 mm and 0.24 mm, respectively.** The
 320 model DEMs were created from the R1 reference DEM of Figure 5b by applying a Gaussian low-pass
 321 filter with a FWHM of 1.9 mm and 5.5 mm, respectively. As seen, already for the 100 mm focal length,
 322 the glass fiber structures are becoming blurred. For the model of a 35 mm focal length, even the
 323 topographic features appear blurred.
