Moisture related challenges in the Greenlandic building sector – results from a survey

Published in:
Journal of Physics: Conference Series (Online)

E J de Place Hansen

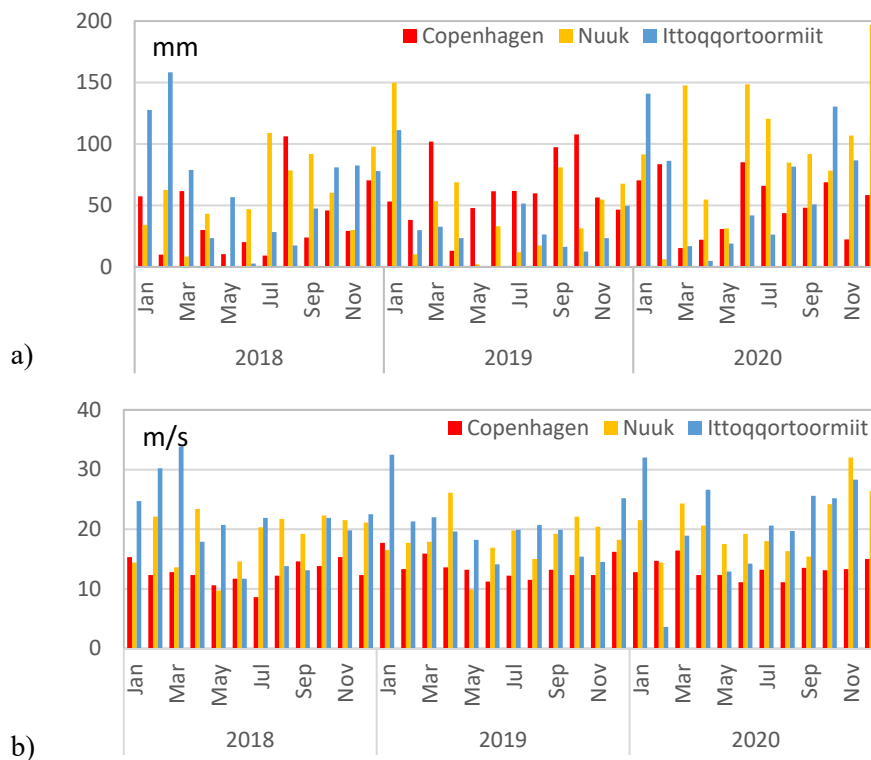
Figure 2. Precipitation [mm] (a) and wind speed [m/s] (10 minutes maximum) (b) in Copenhagen, Nuuk and Ittoqqortoormiit. Monthly average values for a 3-year period (Jan 2018 – Dec 2020) to illustrate variations. [2].

The buildings in Greenland are in urgent need of renovation, mainly due to the combination of no tradition to maintain buildings, and extreme weather conditions with monthly average temperatures at 5 °C in summer and -10 to -15 °C in winter, combined with occasionally high wind speed and precipitation compared to Copenhagen (Figure 2). This makes it difficult to prevent high moisture content in building materials and components in the construction phase, resulting in high drying costs, or moisture related damage uncovered at a later stage, as a result of inexpedient actions during construction. These challenges highlight the need for guidance on how to handle moisture especially in the construction phase, both during renovation or when erecting new buildings.
