# Interior insulation of solid brick walls in cold climates

Erik Brandt <sup>1</sup>, Tommy Bunch-Nielsen <sup>2</sup>, and Georg Christensen <sup>3</sup>

<sup>1</sup> *Danish Building Research Institute, Aalborg University, Hørsholm, Denmark*

Keywords: brick walls, interior insulation, moisture, problems, mould

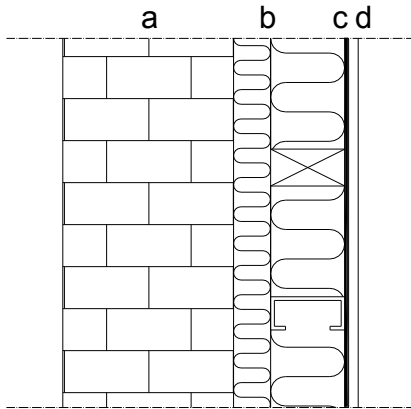
Fig. 1a. Interior insulated brick wall.  
 a. Solid brick wall  
 b. Insulated stud wall (or insulating panel)  
 c. Vapour barrier  
 d. 13 mm gypsum board

Traditionally stud walls are constructed as seen in fig. 1a. A vapour barrier is placed on the warm side of the insulation material. In fig. 1b is shown the distribution of the water vapour pressure under winter conditions in the ideal situation if the vapour barrier has a high water vapour resistance as e.g. a 0,15mm PE-foil. Theoretically there is no risk of condensation on the old brick surface since the partial vapour

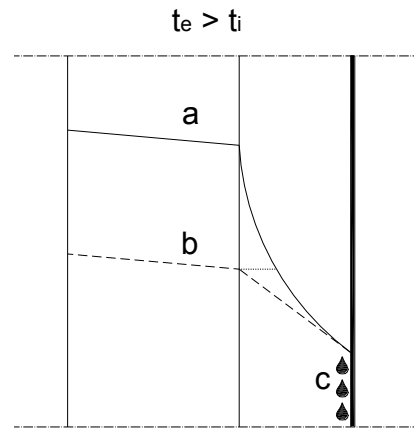
Fig. 1d. Vapour pressure distribution, sun.  
 a. Saturated vapour pressure  
 b. Actual vapour pressure  
 c. Condensation

A brick wall may under summer conditions be wet due to absorption of driving rain. In this case capillary action and thermal forces caused by sunshine may transport water from the exterior to the interior part of the wall. The moisture will condensate on the outside of the vapour barrier. This phenomenon is called "summer condensation". This is shown in fig. 1d. If a steel stud system is used this will in most cases not give any mould problems in the first place. However when the heat flow again goes outwards, moisture may condensate on the brick surface and a risk of mould growth will exist. It could be argued, that if no nutrient existed at this place mould growth would not occur. However practice has shown that complete absence of nutrient at this place is not possible – and mould will occur.

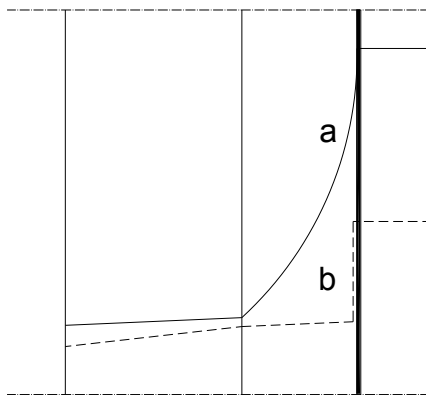
Fig. 1b. Vapour pressure distribution, PE-foil.  
 a. Saturated vapour pressure  
 b. Actual vapour pressure (no interstitial condensation)

pressure is lower than the saturated vapour pressure at this place. The calculation of water vapour pressure through a multilayer wall has been explained by H. Glaser many years ago (Glaser 1958) and (Glaser 1959) and the theory behind will for this reason not be repeated here.

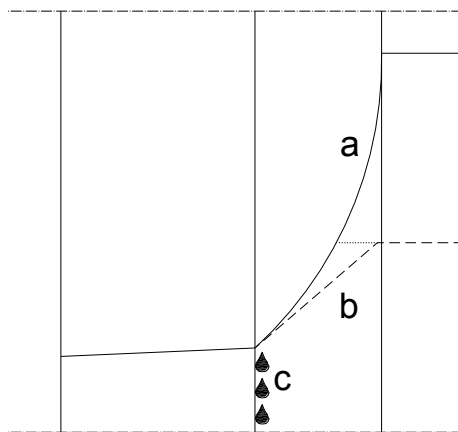
Fig. 1c. Vapour pressure distribution, air leakage  
 a. Saturated vapour pressure  
 b. Actual vapour pressure  
 c. Interstitial condensation

However, if the vapour barrier is not absolutely air tight especially at the top and the bottom indoor warm and humid air may circulate behind the insulation due to convective forces. In this case condensation is unavoidable. This is shown in fig. 1c. (For clarity the vapour barrier is omitted in the figure).

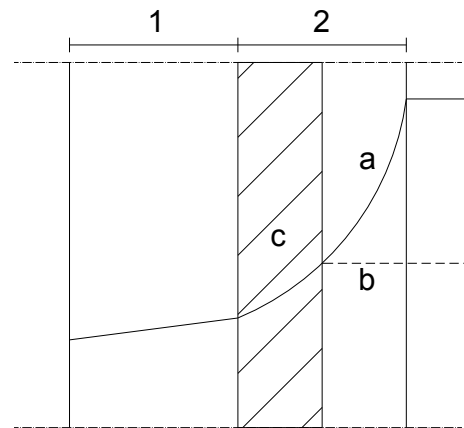
Fig. 1e. Zone with critical moisture content.  
 1. Solid brick wall  
 2. Calcium silicate boards  
 a. Saturated vapour pressure  
 b. Actual vapour pressure  
 c. Area with critical moisture content

situation will be established. This phenomenon B. Voss (Voss 1967) has been explained many years ago by. In fig. 1e is shown the zone which is partly saturated when an equilibrium situation is established. However the saturation only comes to a certain point called the “critical moisture content”. This is a situation when the meniscuses are just no longer connected which means, that moisture transport in the form of water is not possible. This is shown in fig. 2 where it can be seen how the meniscuses are just separated. In popular terms it could be stated that moisture transported into the wall by diffusion is transported away from the zone with critical moisture content by means of capillary forces as no vapour barrier is used.

This partly wetted zone has of course a smaller thermal resistance (may be one third) but even with a moderate insulation thickness the total thermal resistance is in most cases acceptable – especially if the problem mainly is to avoid condensation and mould growth on the surface.
