## Dynamic Properties of the Painter Street Overpass at Different Levels of Vibration

*Published in:*  
Structural Dynamics EURODYN 2005

# Dynamic properties of the Painter Street Overpass at different levels of vibration

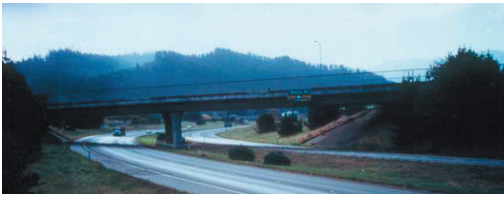
Figure 1. North side view of Painter Street Overpass.

The Painter Street Overpass (PSO) is a two-span, prestressed concrete box-girder bridge that was constructed in 1973 to cross over the four-lane US Highway 101 in Rio Dell, California (see Fig. 1). Its construction is typical of the type of California bridges used to span two or four lane highways. The bridge is 15.85 m wide and 80.79 m long (Fig. 2a).
