A Holistic Evaluation of a Typical Coast Nourishment on the Danish West Coast

ICCCM'07 : Proceedings of the 2nd International Conference on Coastal Conservation and Management in the Atlantic and Mediterranean

A HOLISTIC EVALUATION OF A TYPICAL COAST NOURISHMENT ON THE DANISH WEST COAST

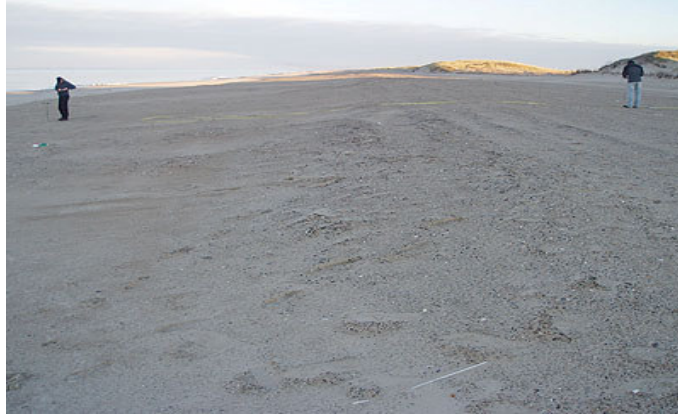
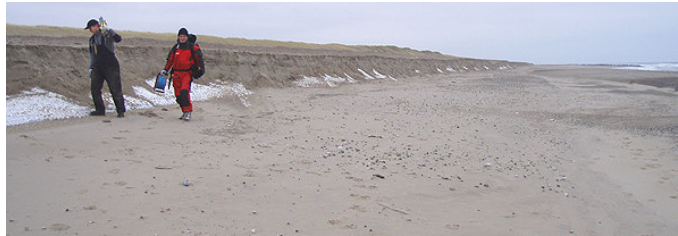
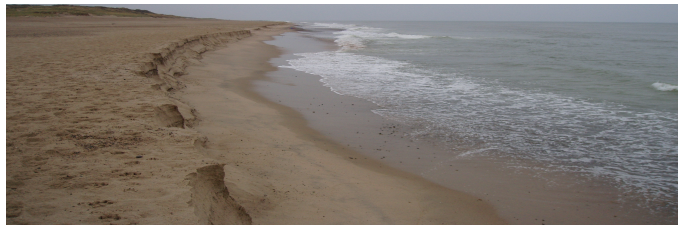
Figure 2. Beach development: gentle slope leading to the shore generates in a dangerous and ugly cliff.

Figure 2 gives examples of the development of the coast nourishment at Ferring. The top photo shows a nice gentle slope beach with characteristics as wanted, while the 2 other photos show an example of the unwanted local cliffs and progressing degradation of the beach. The stick is indicating 1 m height, as much as the vertical extension of the specific slope.

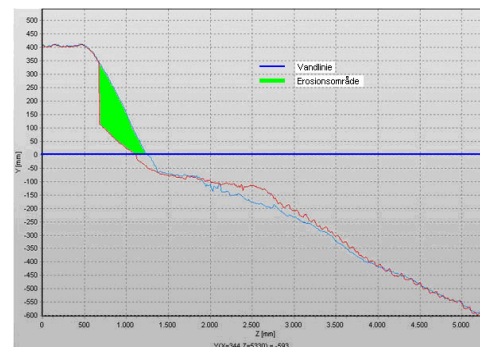
Figure 7. The laser profile and a measurement of the eroded area (section). (Holmgren et al. 2006a).

Measurements have been done at the beginning and at the end of each test (Figure 6). A laser profiler mounted on rails on the flume enabled the estimation of the damage to the protection (Figure 7 left). The laser profiler can plot the results of the profile measurements in real time and constitutes a user friendly interface with the EPro software. In a second time it is possible to calculate the damage in terms of lost volumes to the protection (Figure 7 right). Waves have been measured by wave gauges and generated by AwaSys 5.

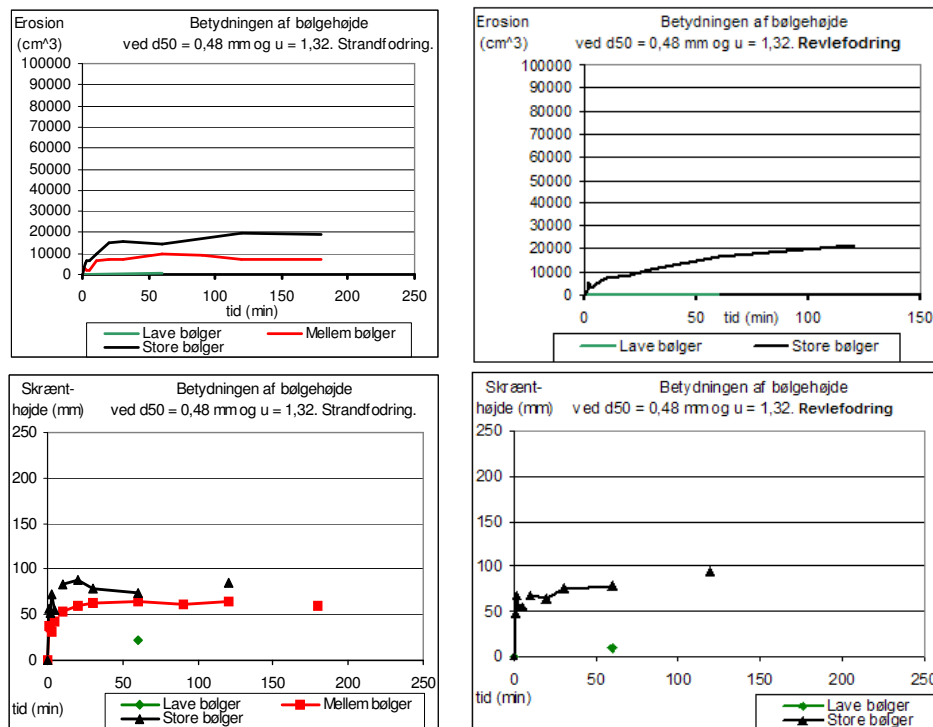
Figure 8. Laboratory results of erosion in volumes (top) and height (down) for the beach (left) and for the sandbanks (right) for a mix sand.

In figure 8 the erosion of the nourishment on the beach (left) and on the sandbanks (right) is reported. On the top, the eroded volumes under small, medium and storm wave regimes for the mixed sand nourishment ($d_{50} = 0.48$ mm and $d_{50} = 1.32$ mm in equal parts) appear to increase constantly on the beach. As it is obvious, the higher erosion occurs for storm waves. On the lower graphics, the height of the erosion is plotted against time. It seems as if the erosion of the sandbank reaches the equilibrium before the erosion on the beach.
