River Restoration Creates Artificial Habitats...or, why you should know the Reference Conditions when Restoring River Hydromorphology

Pedersen, M. L., Friberg, N., & Kronvang, B. (2009). *River Restoration Creates Artificial Habitats...or, why you should know the Reference Conditions when Restoring River Hydromorphology*. Poster presented at Defining Hydromorphological Condition and Links to Ecology, Ballater, Scotland, United Kingdom.

RIVER RESTORATION CREATES ARTIFICIAL HABITATS...OR, WHY YOU SHOULD KNOW THE REFERENCE CONDITIONS WHEN RESTORING RIVER HYDROMORPHOLOGY

Morten Lauge Pedersen, Aalborg University, Department of Civil Engineering, Denmark

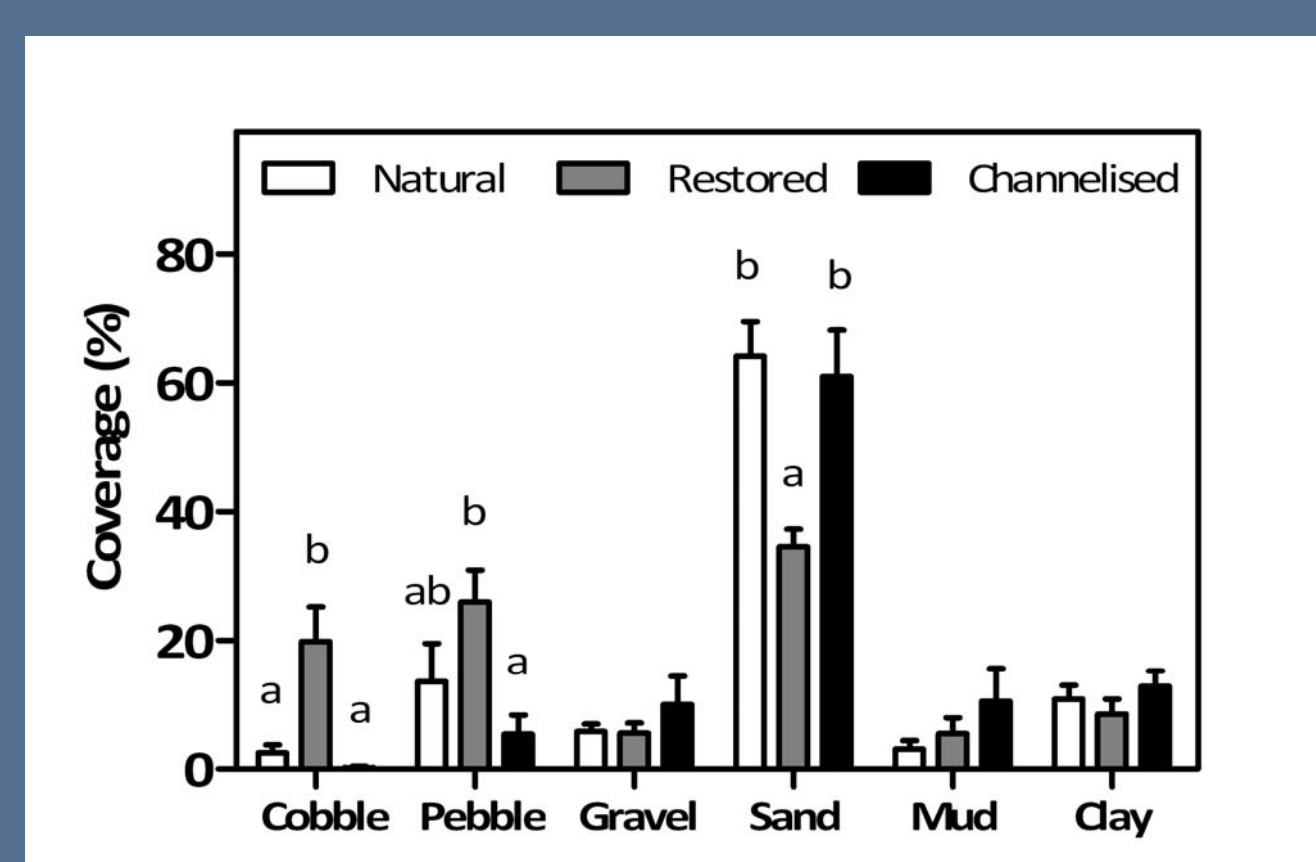
Figure 1. Substrate composition in naturally meandering, channelised and restored streams. Differences in coverage of individual substrates were tested using 1-way ANOVAs and pair wise differences were tested using Bonferroni-corrected post hoc tests. Lower case letters indicate significant differences.

The restored streams clearly had higher proportions of cobble and pebble substrate compared to the natural streams and lower coverage of sand (Fig. 1). The abundance of Ephemeroptera, Plecoptera and Trichoptera (EPT) taxa was significantly lower in channelised reaches, intermediate in natural reaches and highest in restored reaches (Fig 3).

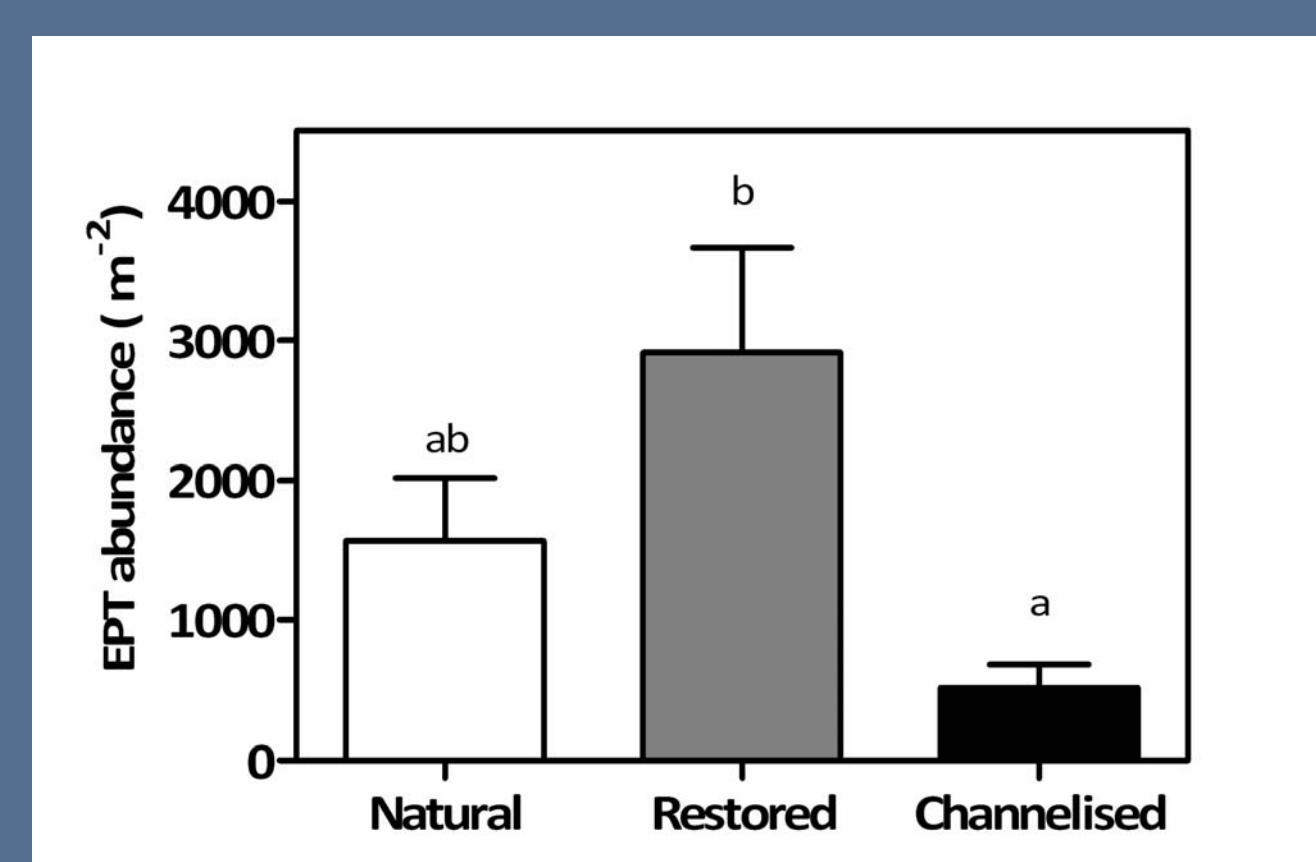
Figure 2. Abundance of EPT taxa in naturally meandering, restored and channelised streams. Differences in EPT abundance were tested using 1-way ANOVA and pair wise differences were tested using Bonferroni-corrected post hoc tests. Lower case letters indicate significant differences.
