Prediction of Short-Circuit-Related Thermal Stress in Aged IGBT Modules

Published in: Proceedings of IEEE Energy Conversion Congress and Exposition (ECCE), 2016

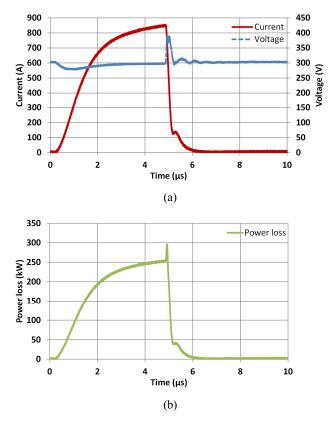
Fig. 7. Typical short-circuit operation: (a) Measured short-circuit voltage/current, (b) Short-circuit power loss.

the NDT is to perform repetitive tests up to the physical limits of the IGBT module to enable studying common instabilities of the device while avoiding the device explosion. This feature is specifically desirable as it permits post failure analysis in the case of device damage. The NDT setup that is developed at the Center of Reliable Power Electronics (CORPE) of Aalborg University is shown in Fig. 6. The principles of the NDT operation are explained in [24]. The NDT is rated at 6 kA/1.1 kV to test MW-scale IGBT modules. Nevertheless, in the device under study 850 A/300 V in 5 μ s has been applied which gives a peak power loss of 250 kW. Fig. 7 presents the short-circuit current, voltage and calculated power losses of the IGBT module.

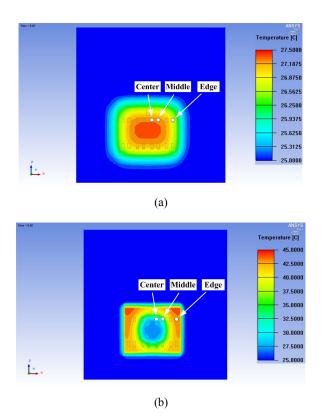
Fig. 8. Temperature distribution at the surface of IGBT chip at time = 20 ms: (a) Fresh solder; (b) Delaminated solder.

The FEM simulations are carried out for 1 second with varying time steps that start with smaller time steps and end in longer steps to reduce the simulation time. The short-circuit power loss is injected to the heat source for 5 μ s. Two cases with fresh solder and hard solder delamination have been compared and it is shown in Fig. 8. As assumed, in the model with solder delamination the outmost corners of the IGBT chip are the most stressed ones. The delamination area propagates by the number of thermal cyclings from the edges inwards until a significant part of the solder material vanishes (end of life) [12]. Solder delamination induces an inhomogeneous temperature field, which causes an increased stress in the regions above the delaminated area (including the chip surface).

For a better explanation, three bond wire foot positions have been selected (highlighted in Fig. 8) and their temperature profiles are extracted. As it is observed in Fig. 9, the peak temperature is identical for all cases, since the heat up is almost adiabatically due to the time frame of the power loss. However, after 1 ms, the generated heat propagates to the solder layer. In the delaminated solder condition, both bond wire foot positions at the edge and center show higher temperature response due to higher thermal resistance of the IGBT module. The reason originates from the delamination propagating from corners, hence the last remaining solder material is under the center of the IGBT chip. So, unlike to the fresh solder condition that the center bond wire experiences a higher thermal stress, in the delaminated solder condition, edge bond wire is stressed considerably higher than the center bond wire. Moreover, in

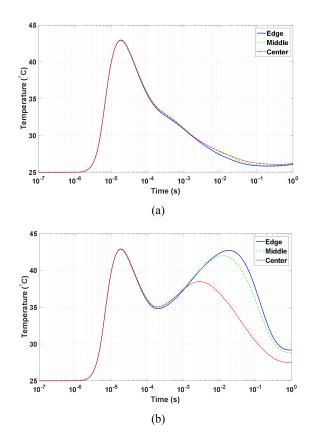
Fig. 9. Temperature profile at different bond wire foot positions (see Fig. 8): (a) IGBT module with fresh solder; (b) IGBT module with delaminated solder.

the time intervals after 1 ms, all of bond wires in the aged module (delaminated) are stressed up to 70% higher than the case of a fresh device. That in the case of large short-circuit currents, they may lift off immediately. On the other hand, the cooling system is not effective in short time scales due to the thermal capacitance of several layers underneath the IGBT chip. This analysis for the case of short-circuit can be generalized for the cases of normal thermal cycling with large dynamic loading in real applications.

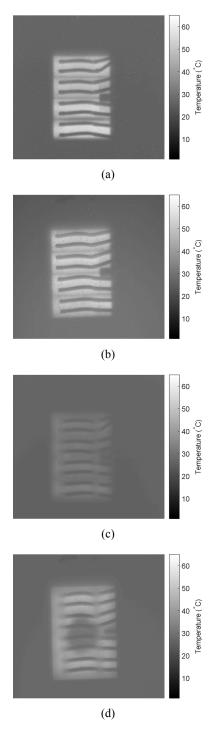
Fig. 14. Temperature distribution of IGBT module during shortcircuit: (a) Fresh solder at the peak of short-circuit current, (b) Delaminated solder at the peak of short-circuit current, (c) Fresh solder at 20 ms, (d) Delaminated solder at 20 ms.

In this paper, two samples have been tested in the NDT setup: one with fresh solder pattern and one with hard solder delamination as shown in Fig. 11 (a) and 11 (c). The IGBTs are switched with short-circuit (300 V/850 A with a time duration of 5 µs). The thermal images in different time intervals for both samples are shown in Fig. 14. It is observed that in the first micro seconds of the switching, the temperature is homogenously distributed on the surface of both IGBT modules. The reason originates from the thermal capacitance and the finite heat conduction of the silicon. During the operation of the IGBT, the heat is generated in the junction region of the chip and spreads down through different layers to the heatsink. However, due to the finite heat conductivity and the thermal capacitance of the materials, no heatsink is applicable to cool down the device in the short-circuit time scale. Moreover, as the heat which is generated in the chip cannot propagate to the solder layer in few micro seconds, the solder delamination does not initially affect the thermal stresses on the chip surface.

After 0.5 ms, the temperature profile on both samples becomes inhomogeneous. On the chip with fresh solder, the temperature at the center of the chip becomes higher rather than at the edges. However, in the chip with the delaminated solder the heat is concentrated in the edges and the temperature in the bond wire foot positions close to the edges become even higher rather than the temperature in the center of the sample with fresh solder. This phenomenon was also proven in the FEM simulations that aging of the solder layer leads to an increase in the thermal resistance of the IGBT module due to the less heat spreading. So, with higher thermal resistance at the edges of the aged module, the wires which are bonded closer to the edges will be highly stressed. This indirect thermal stress on the corner bond wires can lead to an unexpected high thermo-mechanical stress and faster lift-off particularly in the short-circuit event with a large ΔT in a short time.
