Laboratory tests on mineral deposition under sea water electrolysis

DCE Technical Report No. 268

This report is prepared to document the first phase of the project “**New material for wave energy sub-structures**”. Funding body: Energiteknologisk Udviklings- og Demonstrations Program (EUDP) . Area: wave energy and new sustainable materials for marine environment. Leading: Aalborg University Civil and Chemical, Esbjerg (DK). Other Partners: Resen waves (DK), Electrocell (DK), Wave Piston (DK), Biorok.inc.(USA). Case number: 50520010

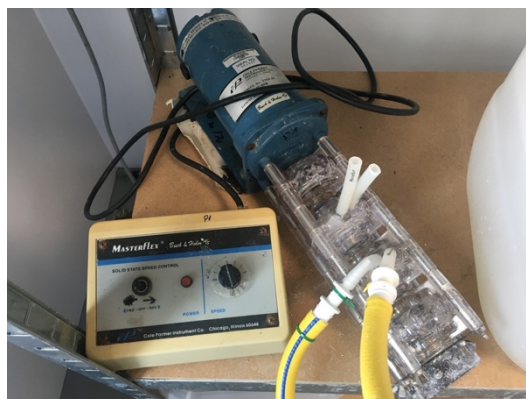
Figure 2 Masterflex peristaltic tubing pump

The pump used in the experiments was a Masterflex peristaltic tubing pump, as shown in Figure 2, pumping water at a flowrate of 300 mL/h. Two pump heads were connected to each pump, supplying to experimental setups with water. Two similar pumps were used in the experiment with the capacity of supplying four experimental setups in total.

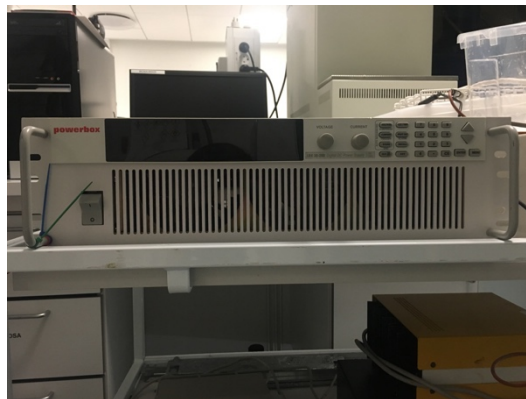
Figure 4 Power supply

The power supply used to supply the experimental setup with power was a Powerbox LBX 30-200 Digital DC Power Supply (0-30 V, 0-200 A) as shown in Figure 4. The electrodes were connected to the power supply with bolts through a metal ring in the end of the electrode cable. Up to four experiments were connected to the power supply. The power supply made it possible to run experiments at either constant current (voltage is varied) and at constant voltage (current is varied). The experiments described in this report were running at constant current, as it was seen as convenient to have a constant current density at the cathode for production of electrodeposited mineral material.

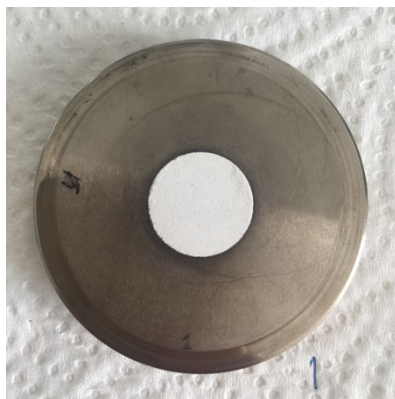
Figure 6 Tablet prepared for XRD analysis

When sufficient amounts of material were available a tablet was prepared as shown in Figure 6, but if less material was available the powder were spread on a zero-background plate shown in Figure 7.

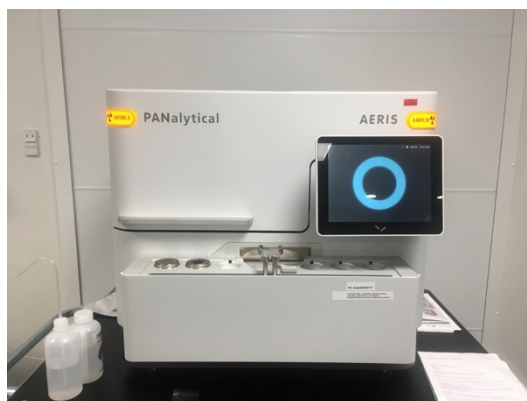
Figure 8 XRD instrument

The powder was analysed using XRD (PANalytical AERIS) illustrated in Figure 8. The samples were scanned from at the detector angle from $15-90^\circ\theta$. The XRD results were used to identify the components the produced material consisted of, and was followed by Rietveld refinement to find the distribution of the components. All samples were analysed three times with a few expectations (stated in Table 4 to Table 24).

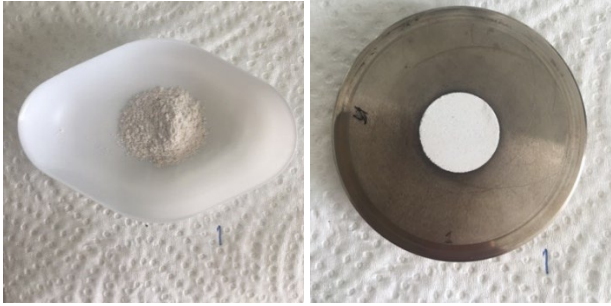
Run 1

1.0380 g removed for XRD analysis corresponding to the material at one side of the cathode. The material is white and relatively thick. It was surprisingly hard to remove the material compared to the other cathodes.

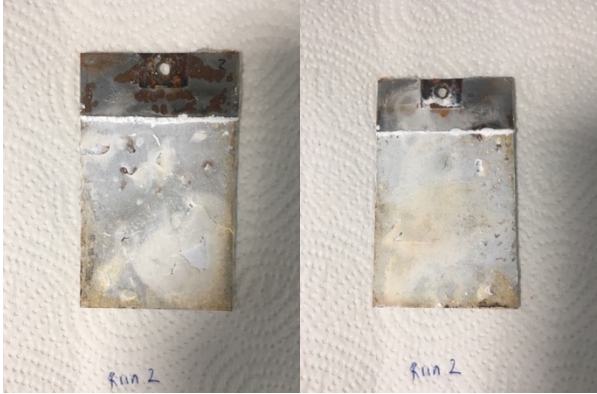
Run 2

Material from Run 2. Large flakes that is easily removed. White material under the outer flakes. The layers are white with some brown-orange color, and probably iron (rust) from the cathode. The cathode seems to have been relatively well corrosion protected. 0.9042 g of material (mainly from the material surface) was removed and used for XRD analysis.

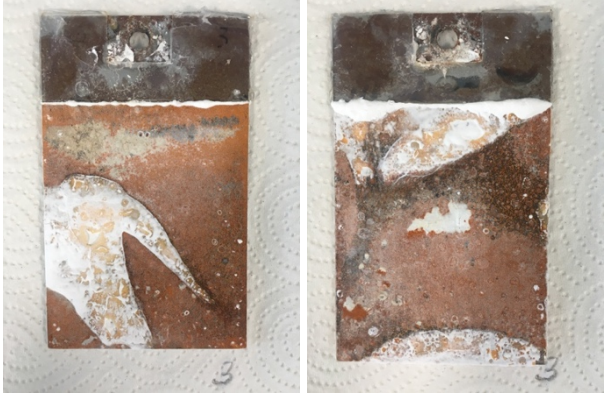
Run 3

A part of the electrode is covered by a white material. The rest of the cathode is covered by corrosion material. The thickness of the material is approximately 1 mm, and sticks out of the cathode. The white material was removed. The material is easy to remove and consist of an outer material and an inner material. The outer material is easy to remove and the inner layer is harder to remove from the cathode. 0.9471 g was removed from one side of the cathode for XRD-analysis.

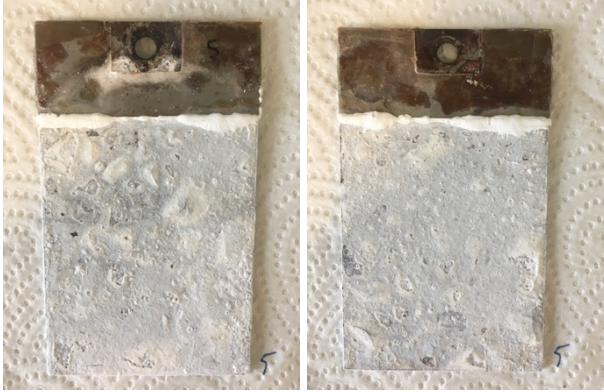
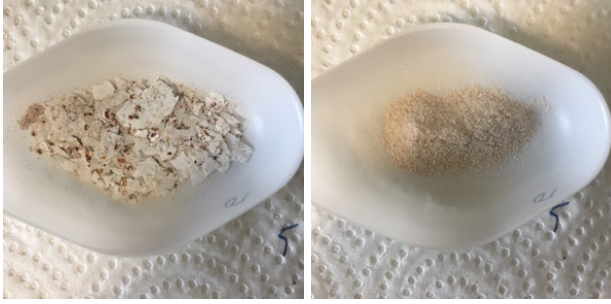
Weight bf. [g]	Weight af. [g]	Weight gain [g]													
<u>98.7371</u>	<u>102.2014</u>	<u>3.4643</u>													
		<table border="1"> <thead> <tr> <th></th> <th>% Aragonite</th> <th>% Brucite</th> <th>% Calcite</th> </tr> </thead> <tbody> <tr> <td>Avg</td> <td>28.8</td> <td>71.1</td> <td>0.0</td> </tr> <tr> <td>SD</td> <td>1.9</td> <td>1.8</td> <td>0.1</td> </tr> </tbody> </table>		% Aragonite	% Brucite	% Calcite	Avg	28.8	71.1	0.0	SD	1.9	1.8	0.1	
	% Aragonite	% Brucite	% Calcite												
Avg	28.8	71.1	0.0												
SD	1.9	1.8	0.1

Run 5 and Run 5NY were supposed to give the same results, but there is a large difference. The Run 5 sample gave 69.5% brucite while 99.6% brucite was produced when the experiment was repeated. The mass of the produced samples also indicates that the conditions for production was different, as four times more material was produced when the experiment was repeated.

The applied current was the same in each of the experiments, but the applied voltage was much higher (up to $\approx 3.2\text{ V}$) in Run 5NY than in Run 5 (up to 2.43 V). In Run 5NY only one setup was connected to the power supply. Can this have caused the difference?

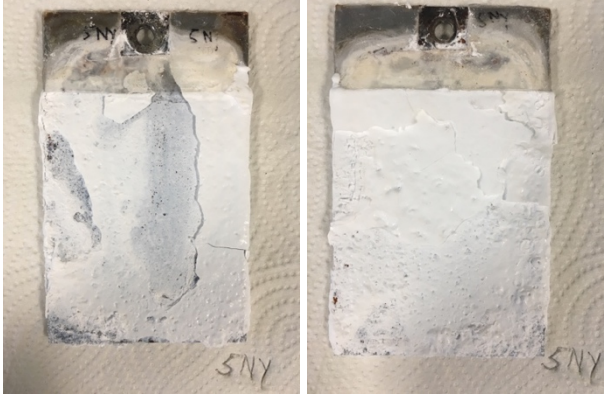
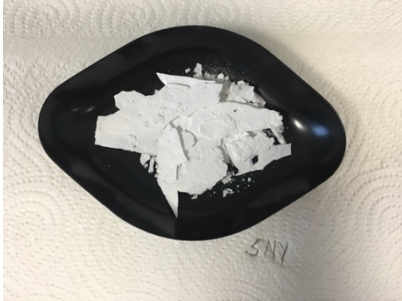
Run 5NY

Weight bf. [g]	Weight af. [g]	Weight gain [g]													
<u>97.5584</u>	<u>110.5552</u>	<u>12.9968</u>													
		<table border="1"> <thead> <tr> <th></th> <th>% Aragonite</th> <th>% Brucite</th> <th>% Calcite</th> </tr> </thead> <tbody> <tr> <td>Avg</td> <td>0.2</td> <td>99.8</td> <td>0.0</td> </tr> <tr> <td>SD</td> <td>0.2</td> <td>0.2</td> <td>0.0</td> </tr> </tbody> </table>			% Aragonite	% Brucite	% Calcite	Avg	0.2	99.8	0.0	SD	0.2	0.2	0.0
	% Aragonite	% Brucite	% Calcite												
Avg	0.2	99.8	0.0												
SD	0.2	0.2	0.0

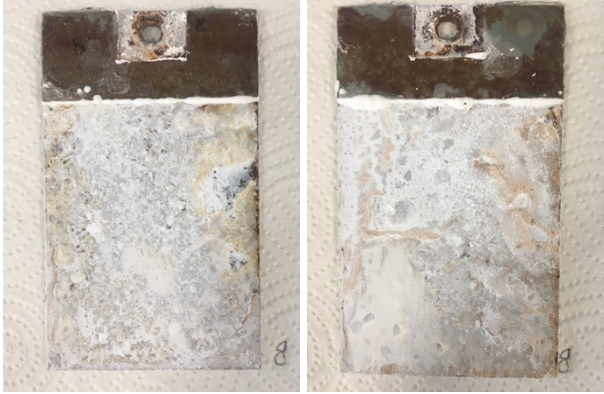
Run 8

The material was thin and was relatively easy to remove. The material is white with some corrosion. 0.6879 g was removed for XRD-analysis.

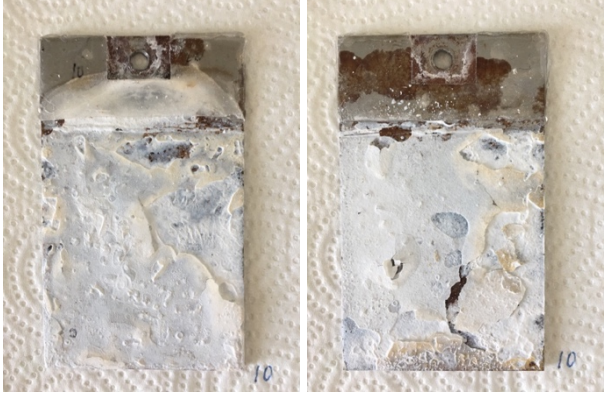
Run 10

The material is white, there is some corrosion on the cathode. The material consists of a brittle outer layer that is easy to remove. An inner layer is hard and harder to remove. 0.9288 g was removed from one side of the cathode for XRD-analysis.

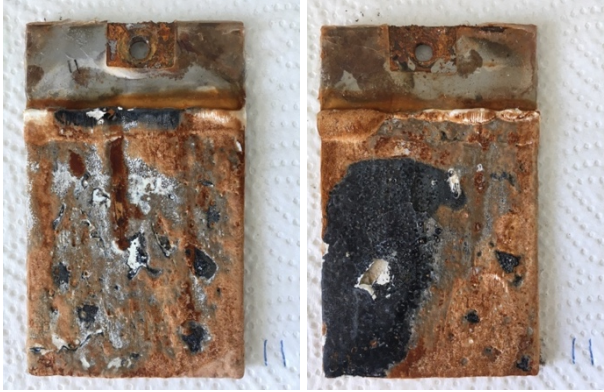
Run 11

The cathode seemed to be corroded, and the produced material was very dark in color compared to all the other samples. On one side, parts of the material are completely black. The material is also thicker than the other samples. White material is hidden below the outer layer. The inner layer is very porous. 3.0176 g was removed from the cathode for XRD-analysis. The material is thick and it is more difficult to make it into a powder compared to the other samples.

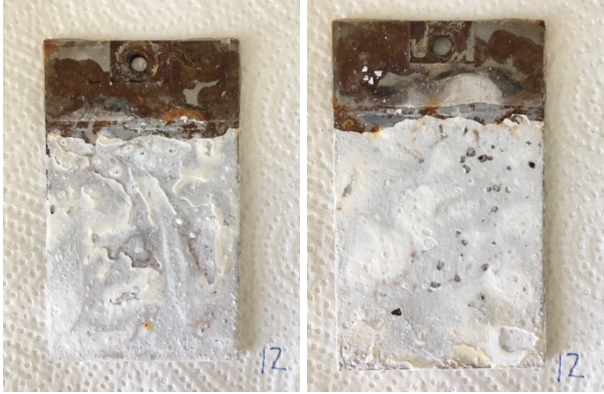
Run 12

The material is white and brittle. It was easy to remove. There was an inner and an outer layer. Small amount of the inner layer that is relatively hard to remove. Some corrosion under the material. 1.7810 g was removed from one side for XRD-analysis.

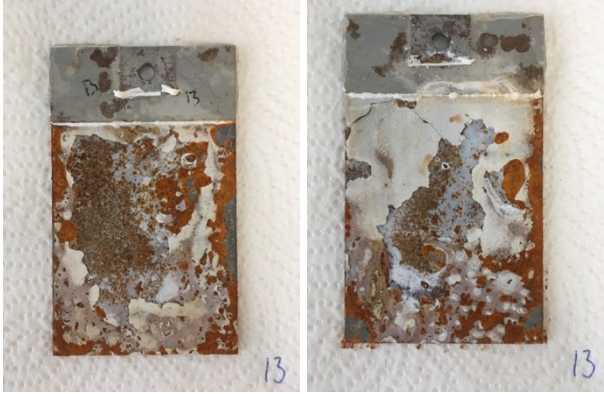
Run 13

The cathode is corroded with only a thin white material. It seems like there has been a disconnection from the power supply. The material is relatively easy to remove, but in small amounts. Material removed from one side for XRD-analysis.

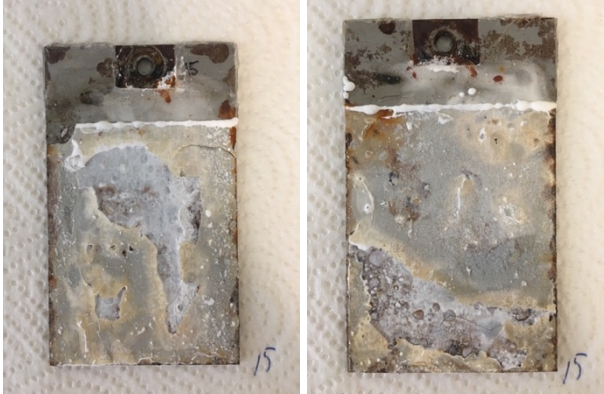
Run 15

The material is easy to remove from the cathode. It is divided into two layers, an outer brown (corrosion) layer and an inner white layer. The inner layer is thicker and more porous (brucite?), while the outer is thinner and brittle. 1.0826 g was removed from one side of the cathode was removed for XRD-analysis.

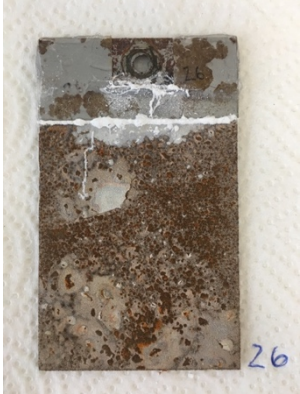
Run 26

The cathode is totally corroded. Small amount of material, but it is all brown (corrosion material). A small area of the cathode is covered by a white material (0.5x0.5 cm). 0.2988 g was removed for XRD analysis (material from one side of the cathode). The material is brown, possibly corrosion.

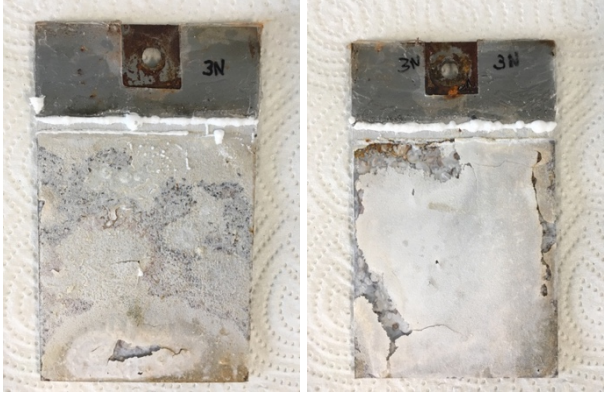
Run 3N

The material consists of an inner and an outer layer. The outer layer can easily be removed in one single piece. The outer layer was light orange in color. Not much corrosion on the cathode. The inner layer is whiter than the outer layer and is thinner. The inner layer is harder to remove opposite the outer layer. 0.8394 g was removed for XRD analysis and was taken from the inner and the outer layer.

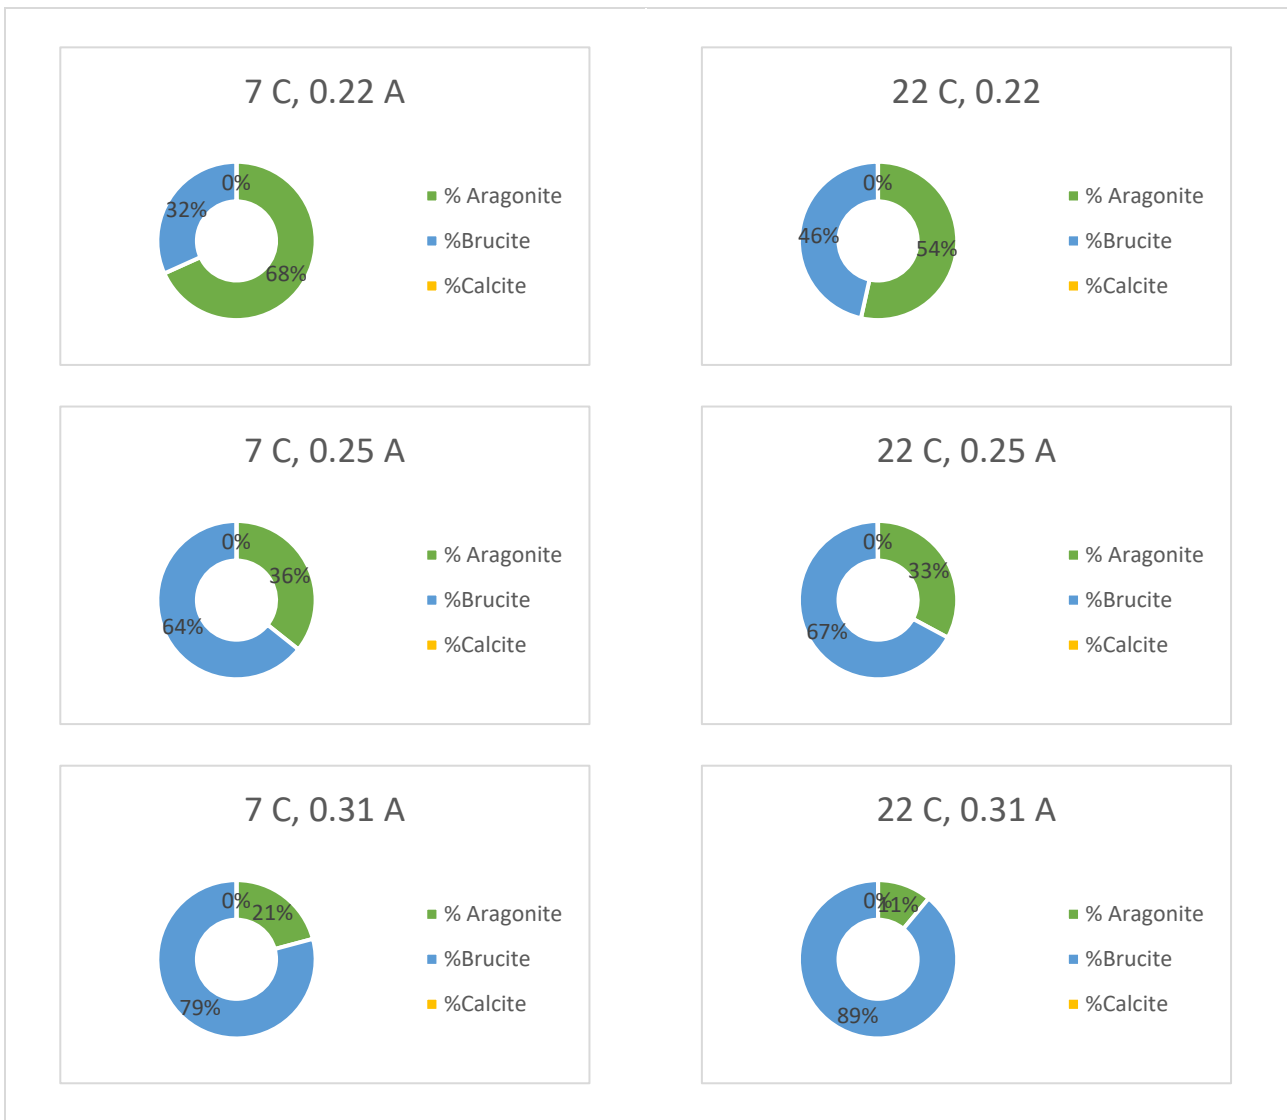
Figure 10 Average material composition at given temperatures and applied currents

The circle diagrams in Figure 10 show the average composition of the mineral material, an average of the composition produced at a given temperature and a given applied current. This means that the seawater composition parameters and the anode material parameters are combined and the percentage given in the diagrams are averaged values. The figures indicate that lower the applied current results in a higher percentage of aragonite, and the percentage is decreasing with increased applied current. In contrary to what was expected from the literature, these results indicate that lower temperature results in a higher percentage of aragonite compared to when the material is produced at a higher temperature.
