Experimental Study

Proceedings of 2019 1st International Conference on Electrical, Control and Instrumentation Engineering (ICECIE)

LiDAR Assisted Camera Inspection of Wind Turbines: Experimental Study

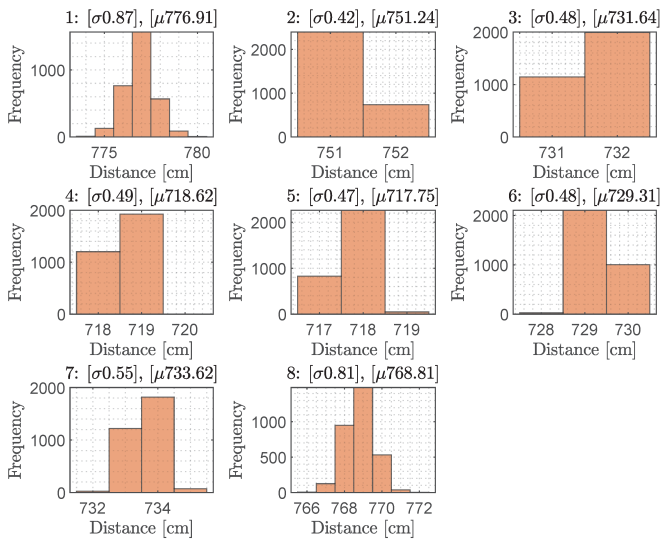
Fig. 3. Distance data from each LiDAR beam when tested facing a white wall.

The LiDAR was tested in a laboratory setting to evaluate its performance. An initial test was performed with the LiDAR facing a white wall at a fixed distance of 710 cm, collecting distance measurements at 10Hz for a period of 315 seconds. A histogram, shown in figure 3, represents the measurements of the 8 individual beams. As it can be expected, the distances measured increase, the further from the center of the light beam they are performed. As expected, the quality of the data collected in this experiment is exceptional. We measured a small standard deviation below 0.5 cm for the center beam and a maximal standard deviation of 0.87 for beam 1, which complies with the 1cm resolution stated in the specification of the instrument.

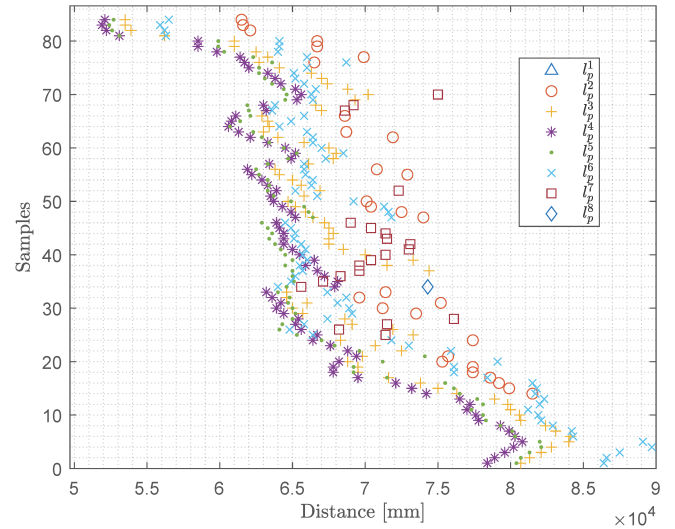
Fig. 5. Distance data collected during the experiment.

The experiment was performed by flying the UAV from the bottom of the wind turbine to the hub, with an ascending velocity of approximately 1m/s. Images from the wind turbine were captured every second. The collected data is plotted in figure 5, showing the profile of the wind turbine.

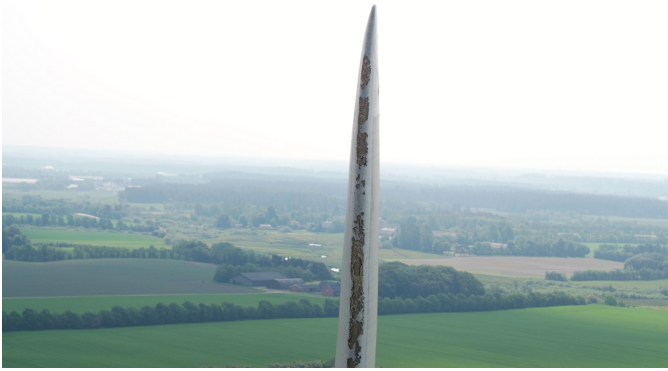
Fig. 9. Wind turbine's blade tip seen from the leading edge side.

as sketched in figure 8, at the blade tip are exposed to severe conditions when moving at a high velocity ($\approx 80ms^{-1}$) and are constantly struck by rain droplets and hailstone impacts at high speed ($100ms^{-1}$). This produces a large impact force [19], that eventually leads to what is referred to as leading edge erosion. This will produce over time edge delamination, which is the final stage of the erosion process. One such case is shown in figure 9, where the composite material has degraded due to erosion, and the blade is in a state of delamination.

For the erosion example shown in figure 9, no LiDAR data was available. The data we obtained corresponds to the image shown in figure 10, which is approximately 7 meters below the image in figure 9. The data collected here was a single point measurement at 7.03meters.

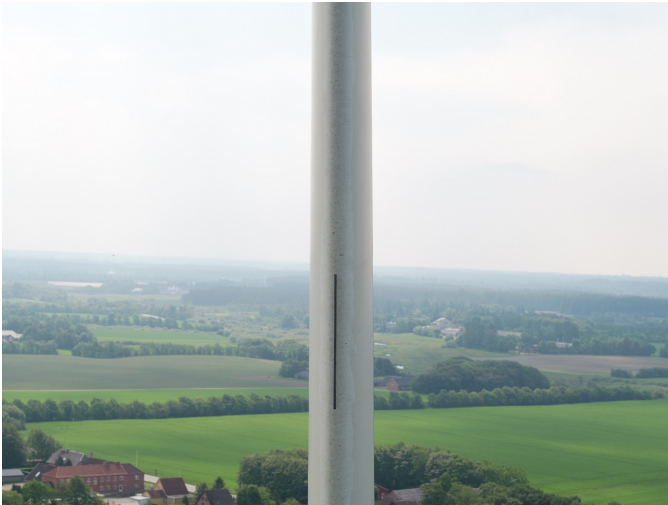
Fig. 10. Leading edge of the wind turbine, approximately 7 from the blade tip.

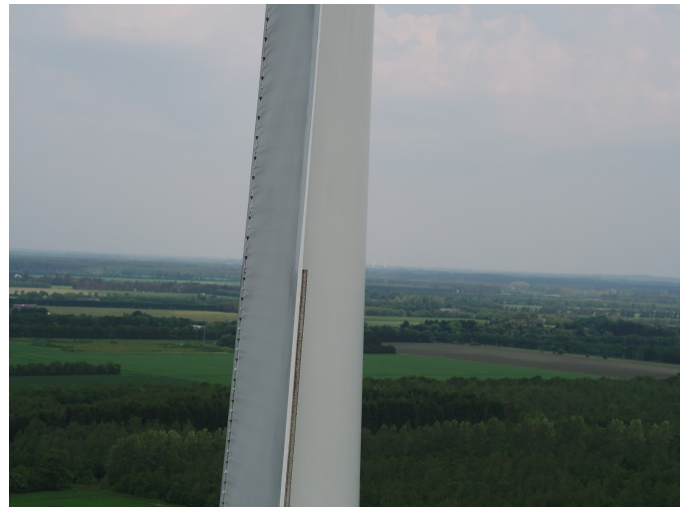
Fig. 11. Trailing edge of the wind turbine blade, approximately 26 from the blade tip.

This data collection problem is even more acute when trying to measure the trailing edge of the wind turbine blade, due to its sharp features. Figure 11, shows the trailing edge that is approximately 26 meters below the tip of the blade. Applying the LiDAR to this feature and the rest of features up in the blade did not produce any LiDAR measurements.
